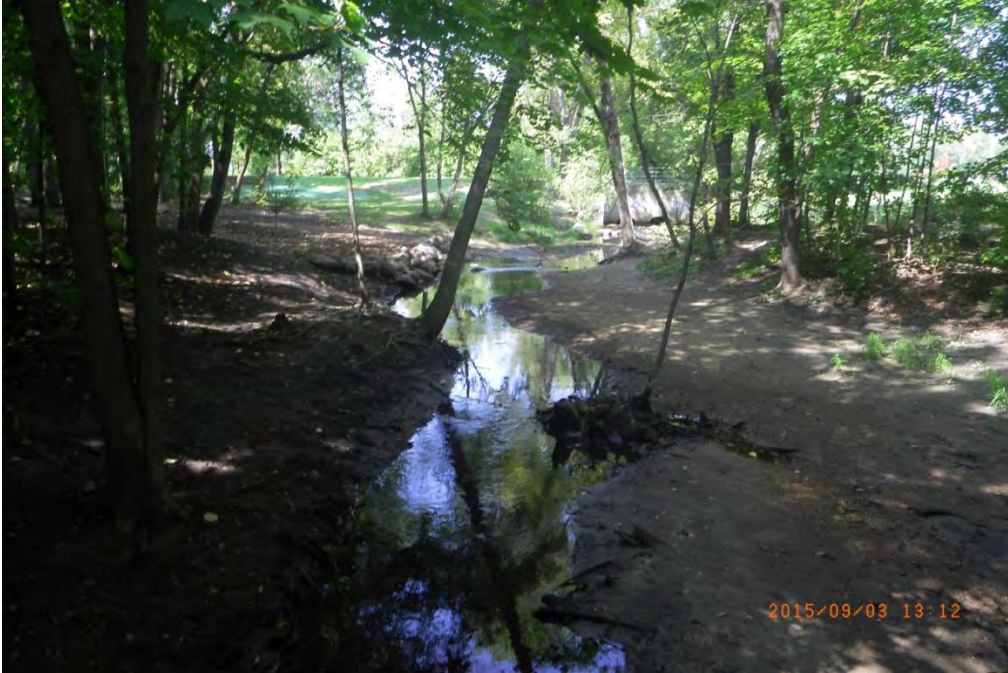
Photo 1. Site 1. Historic meander in right overbank (photo is looking upstream)

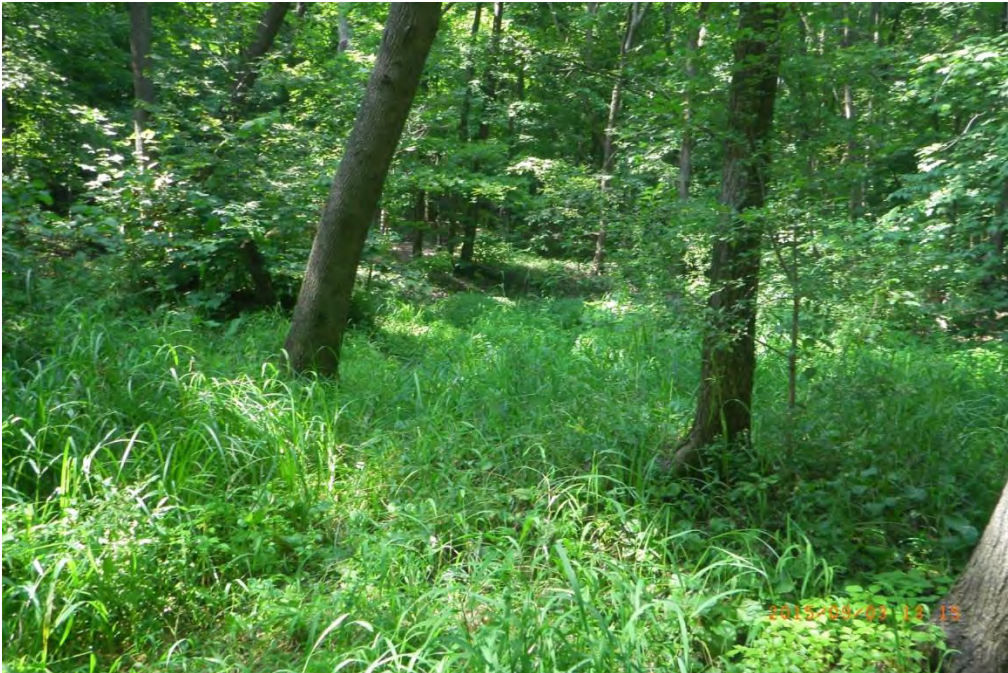
Photo 2. Site 2. Historic meander

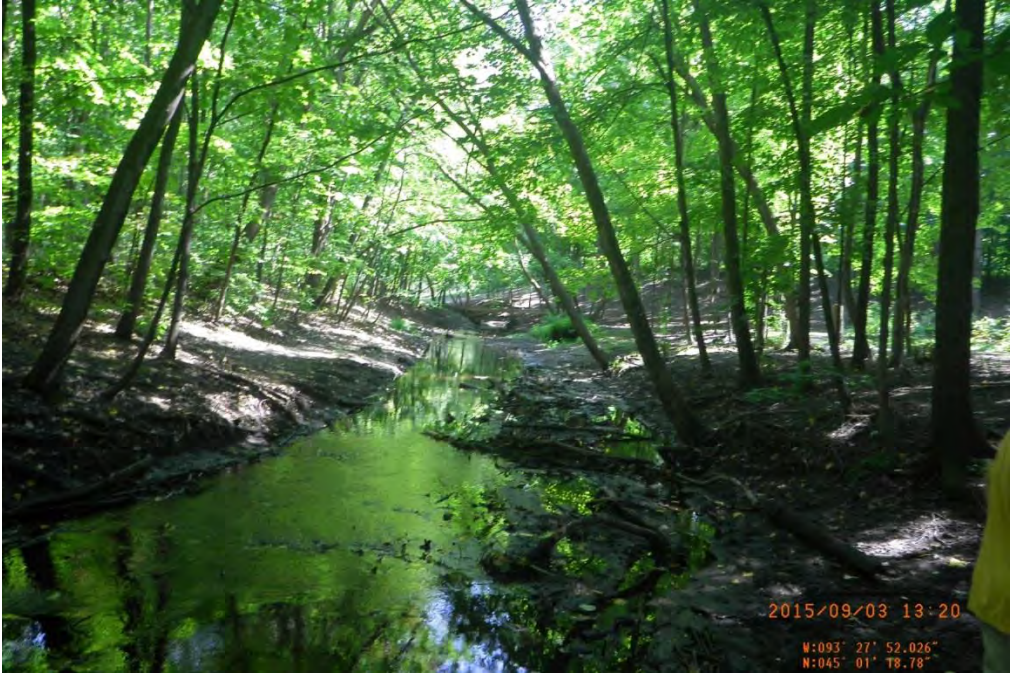
Photo 3. Site 3. Over-widened stream reach

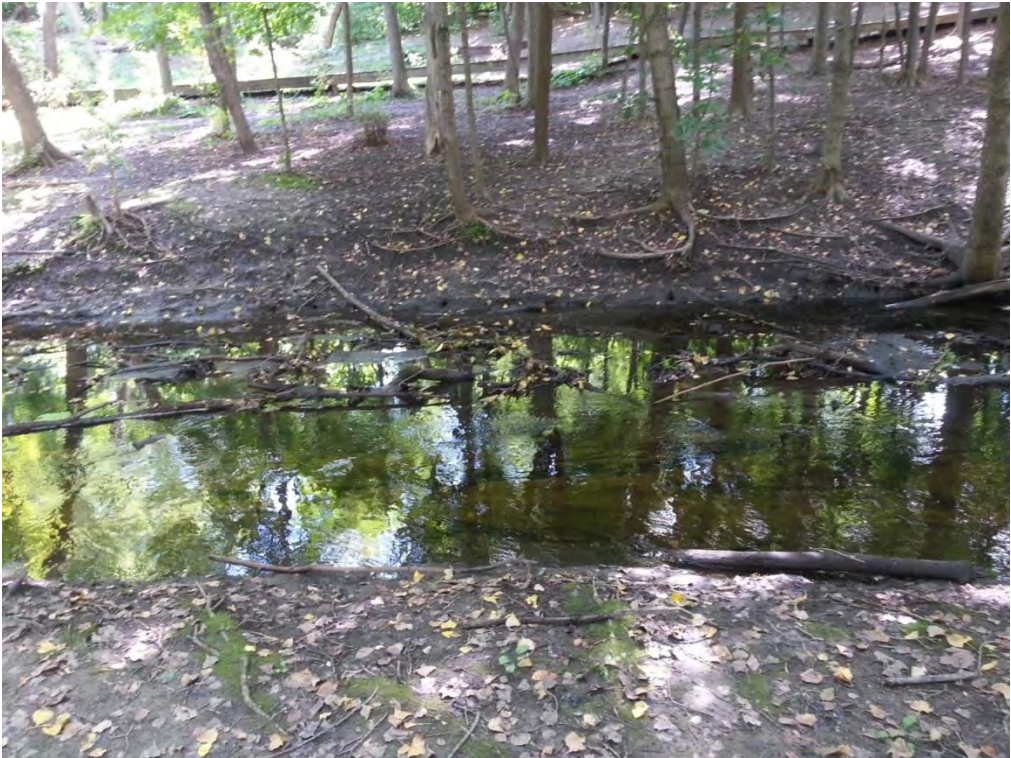
Photo 4. Site 4. Unvegetated overbanks contributing to stream

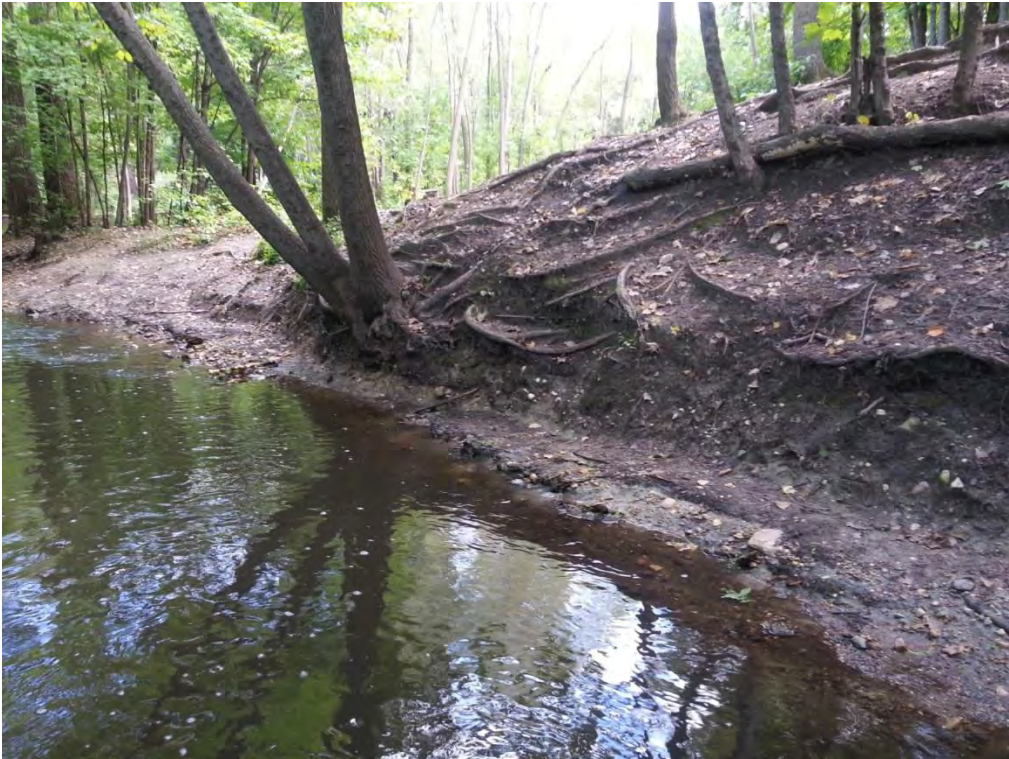
Photo 5. Site 5. Minor to moderate erosion on steep bank

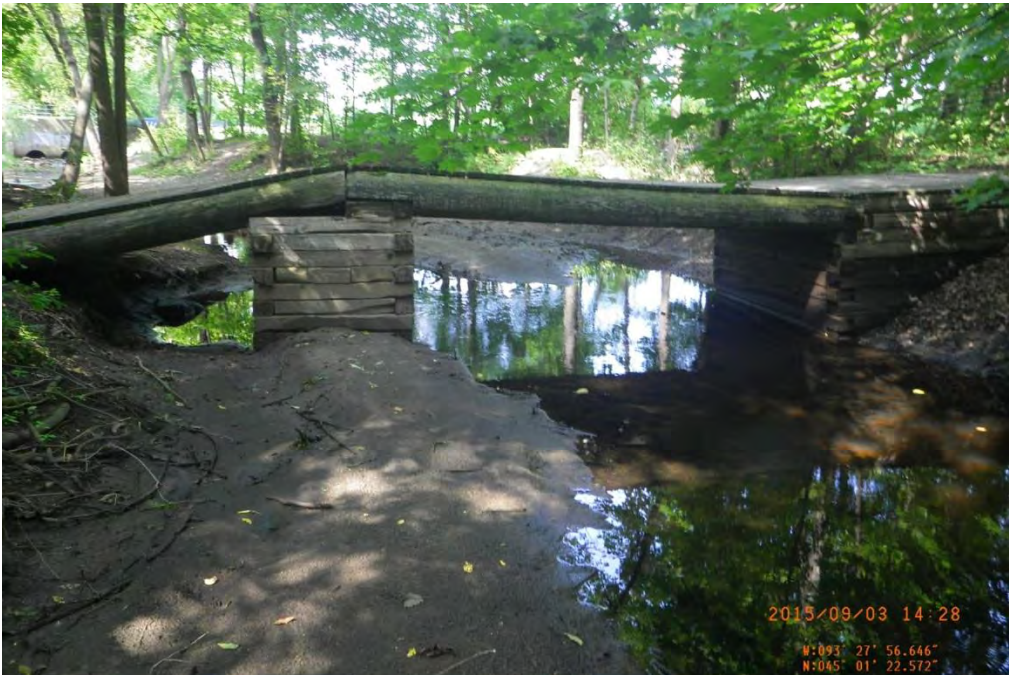
Photo 6. Site 6. Erosion around bridge abutments

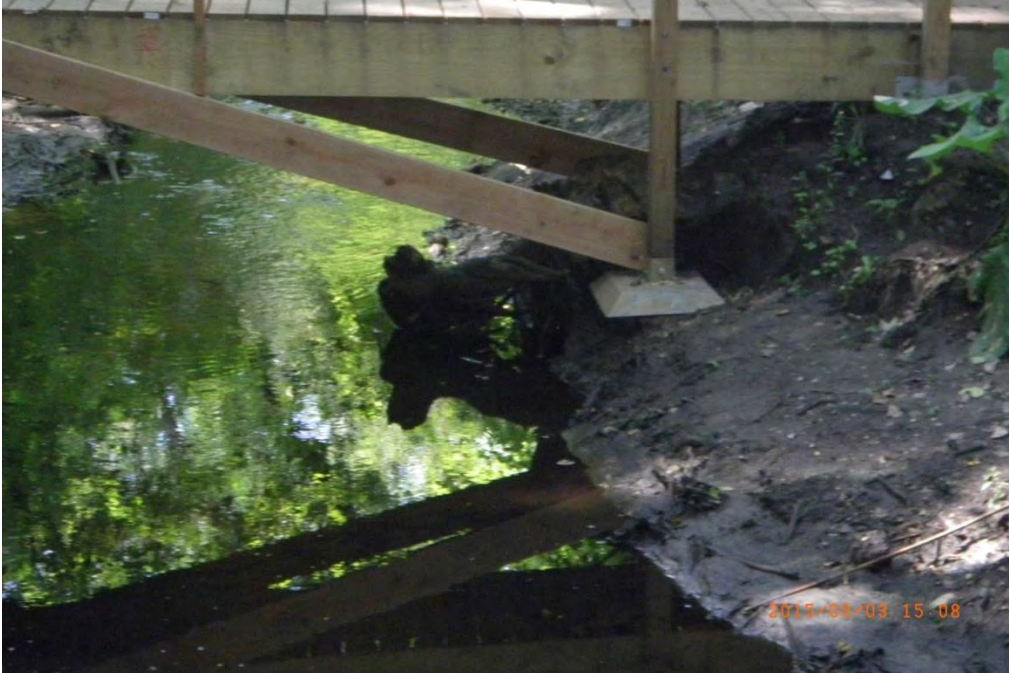
Photo 7. *Site 8.* Erosion around bridge abutments

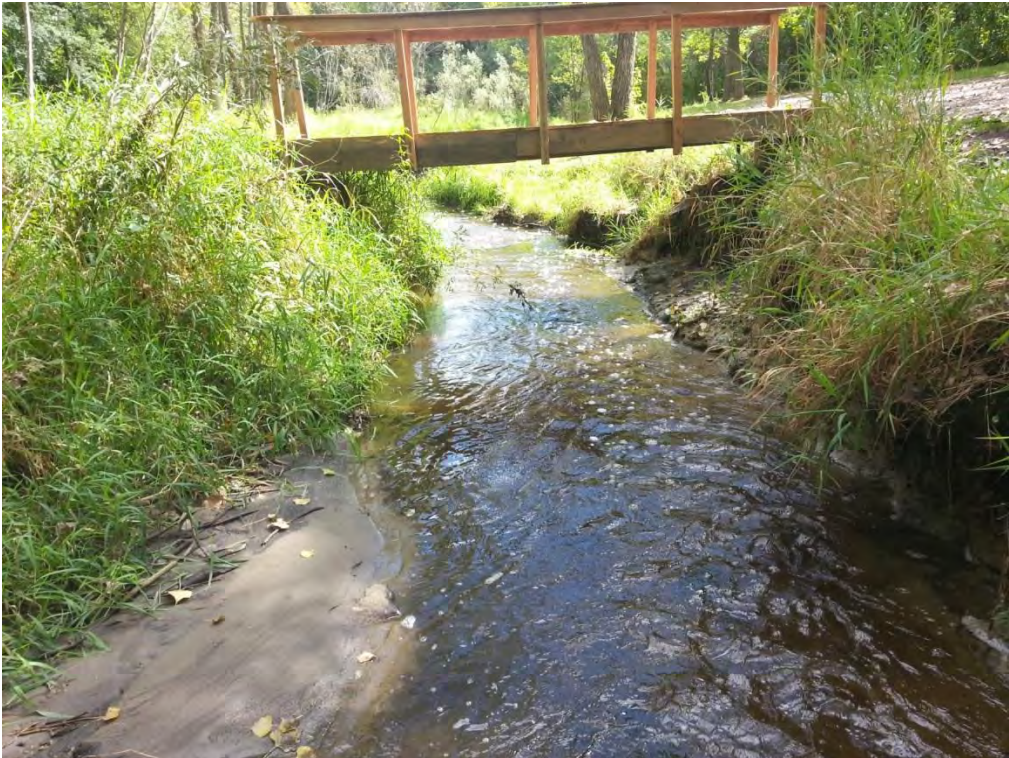
Photo 8. *Site 9.* Erosion around bridge abutments

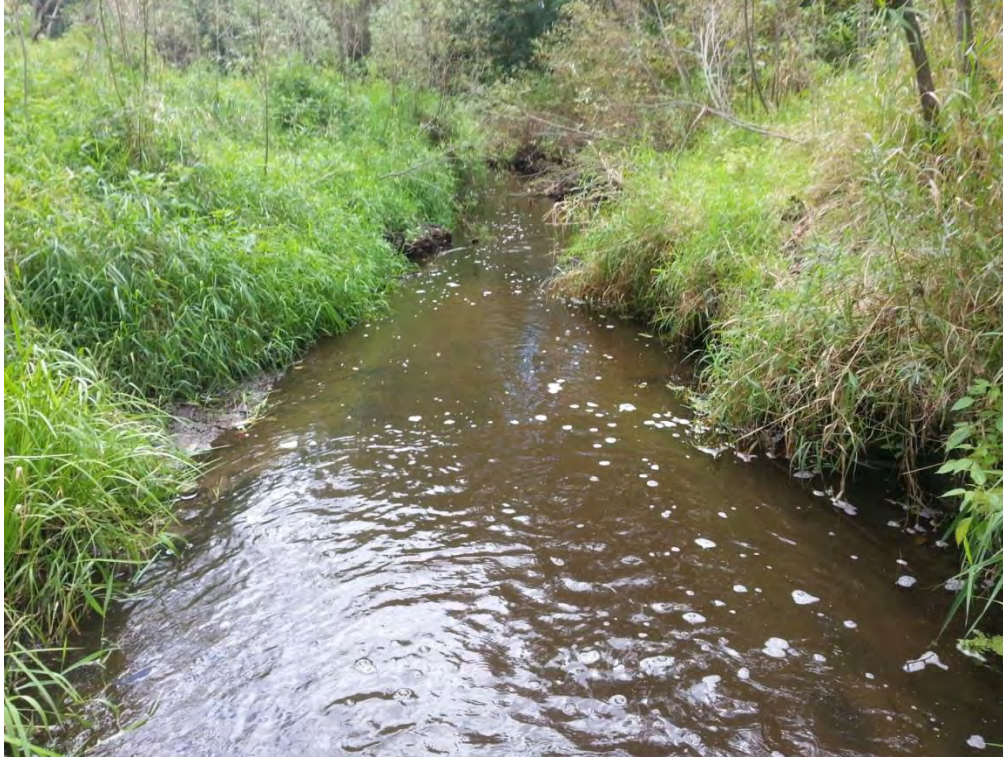
Photo 9. *Site 10.* Incised stream bed

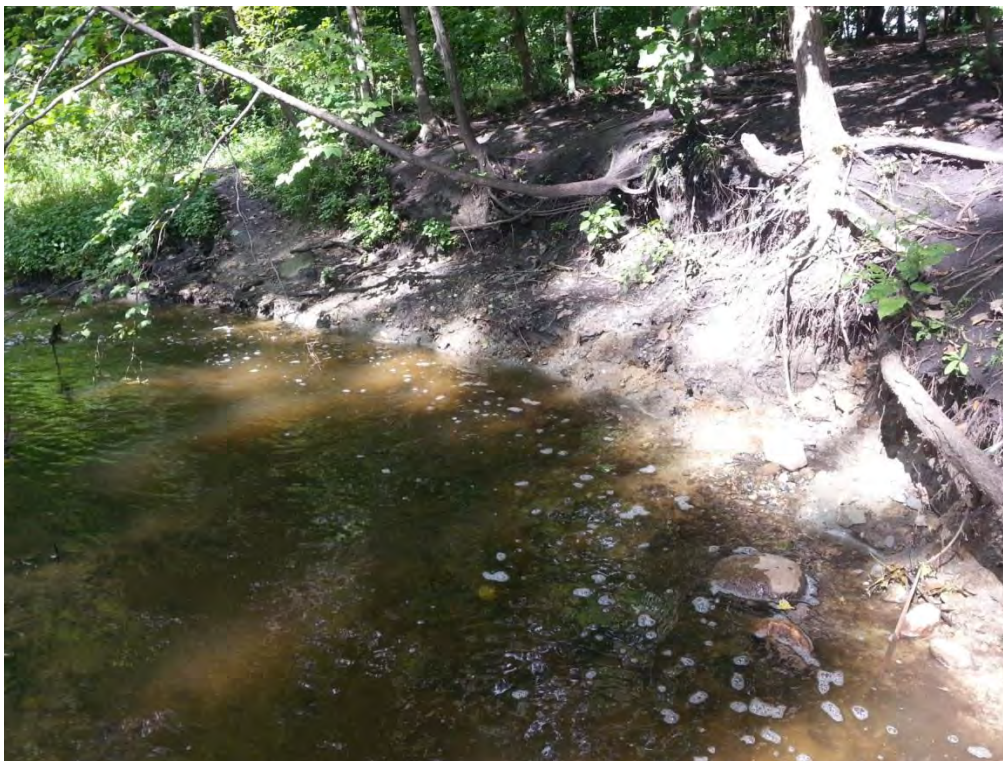
Photo 10. *Site 11.* Minor to moderate erosion on outside of bank meander

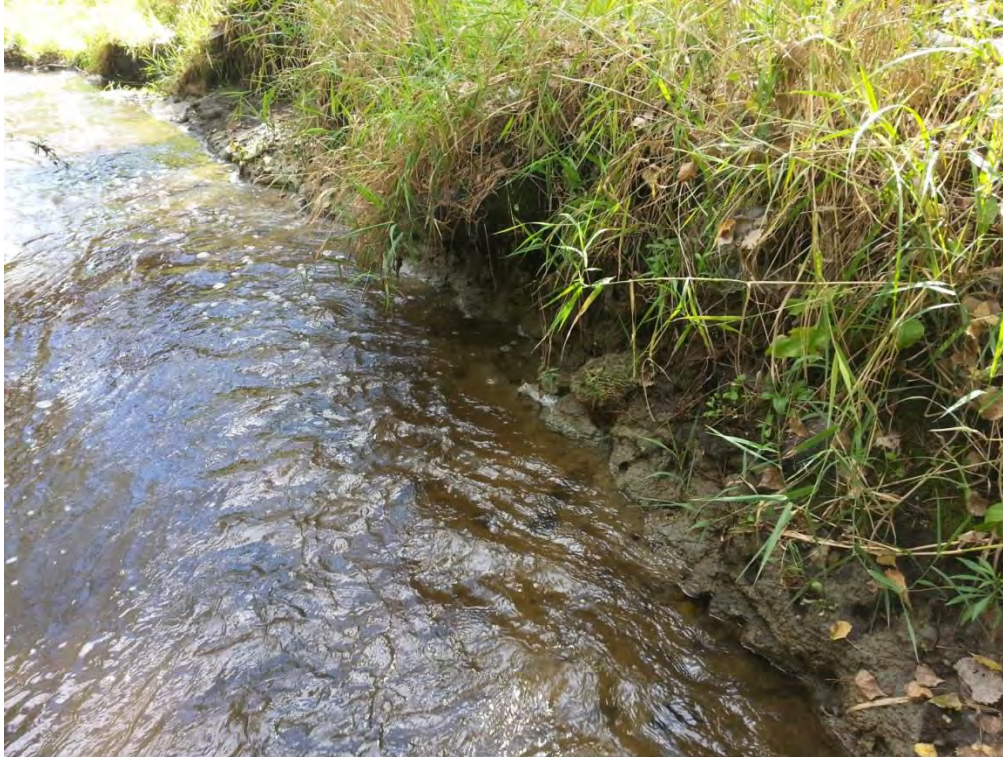
Photo 11. *Site 12.* Minor to moderate erosion on stream bank

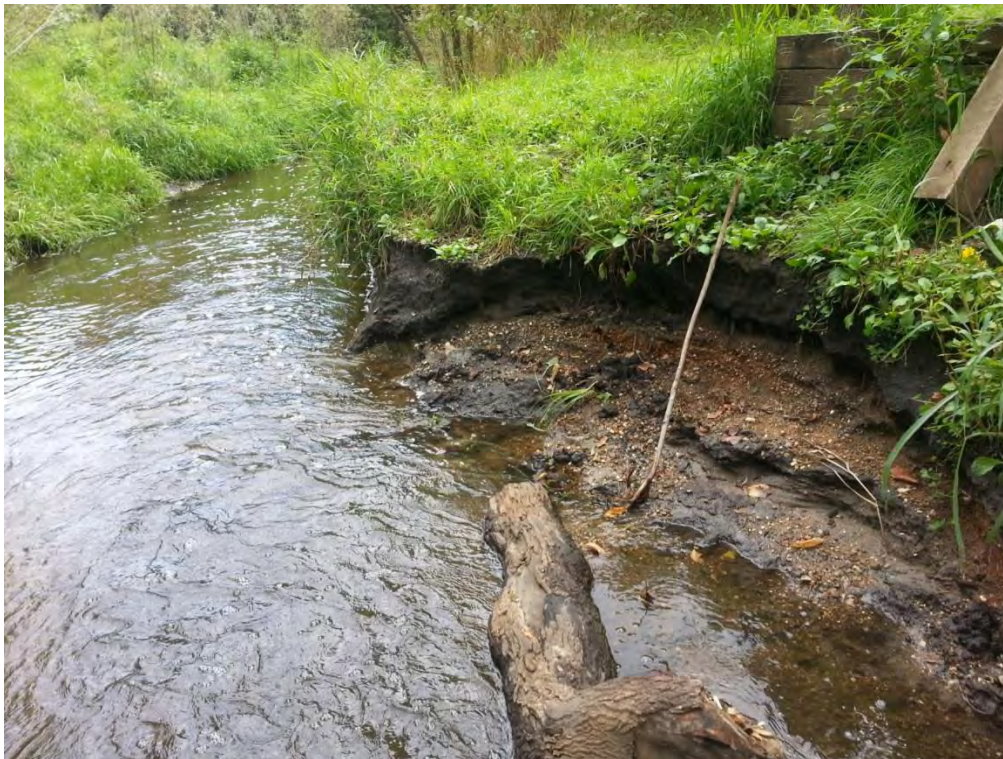
Photo 12. *Site 13.* Minor to moderate erosion on outside of bank meander

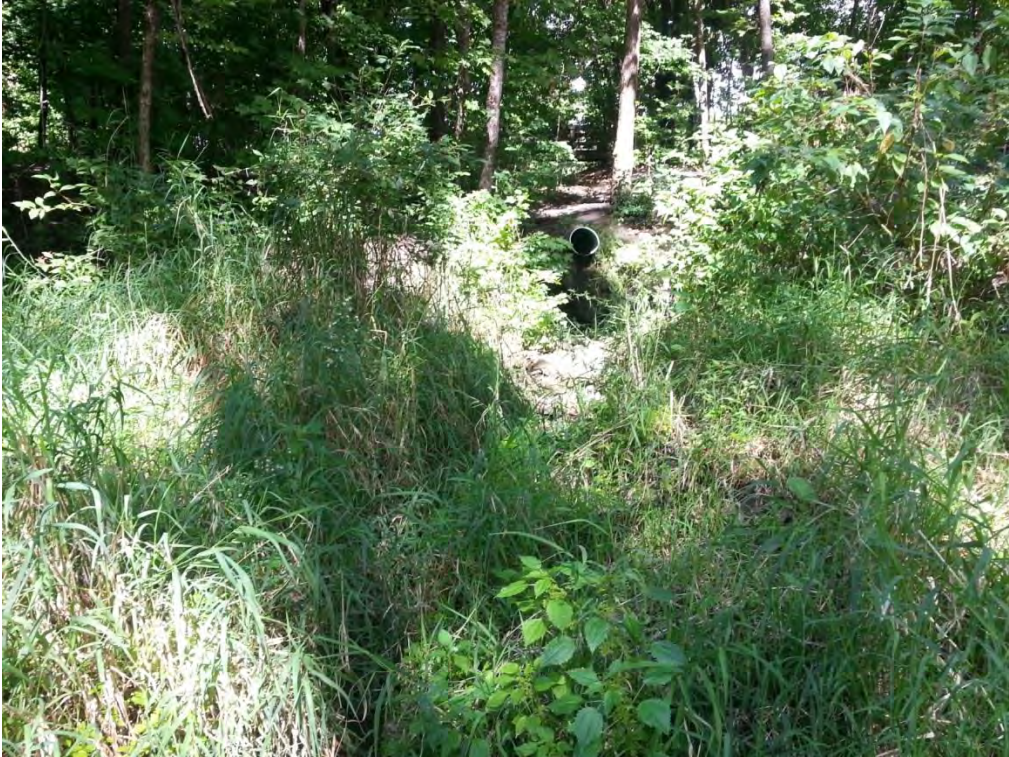
Photo 13. *Site 14.* Eroded culvert outfall

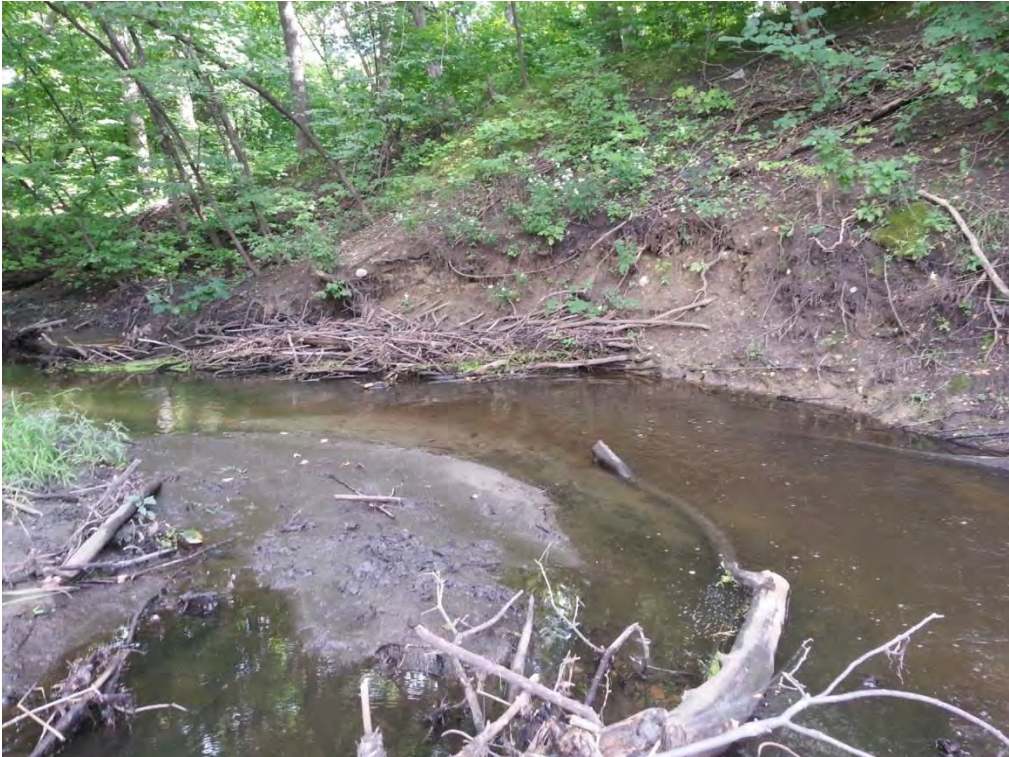
Photo 14. *Site 15.* Minor to moderate erosion on outside of stream bend

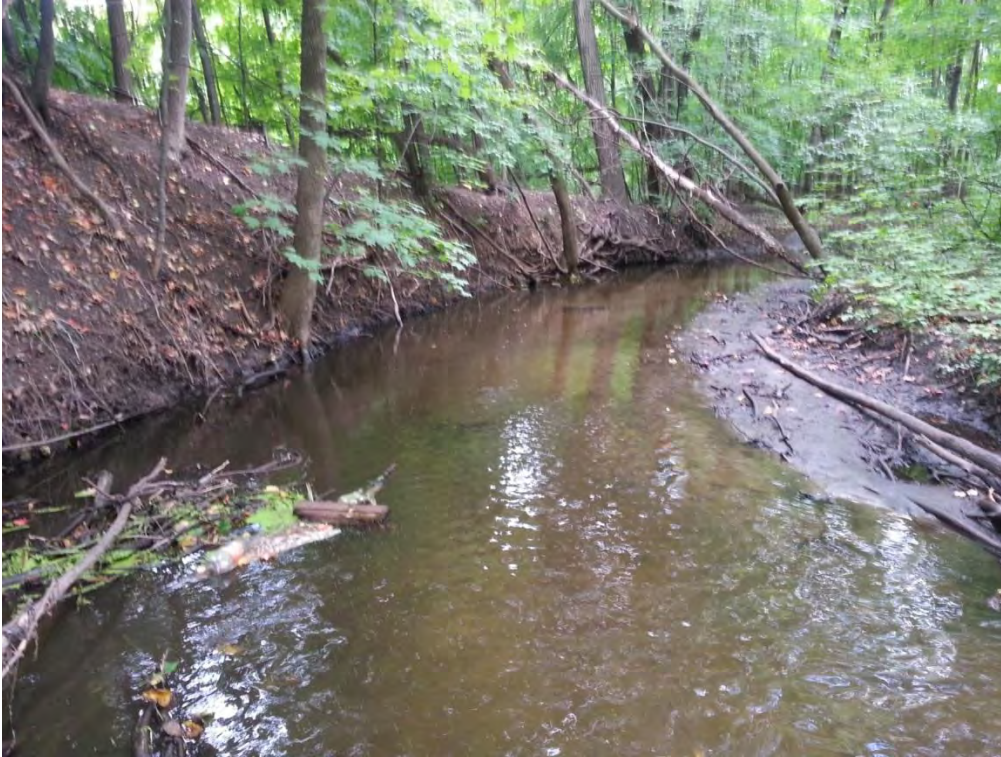
Photo 15. *Site 16.* Significant erosion on outside of stream bend

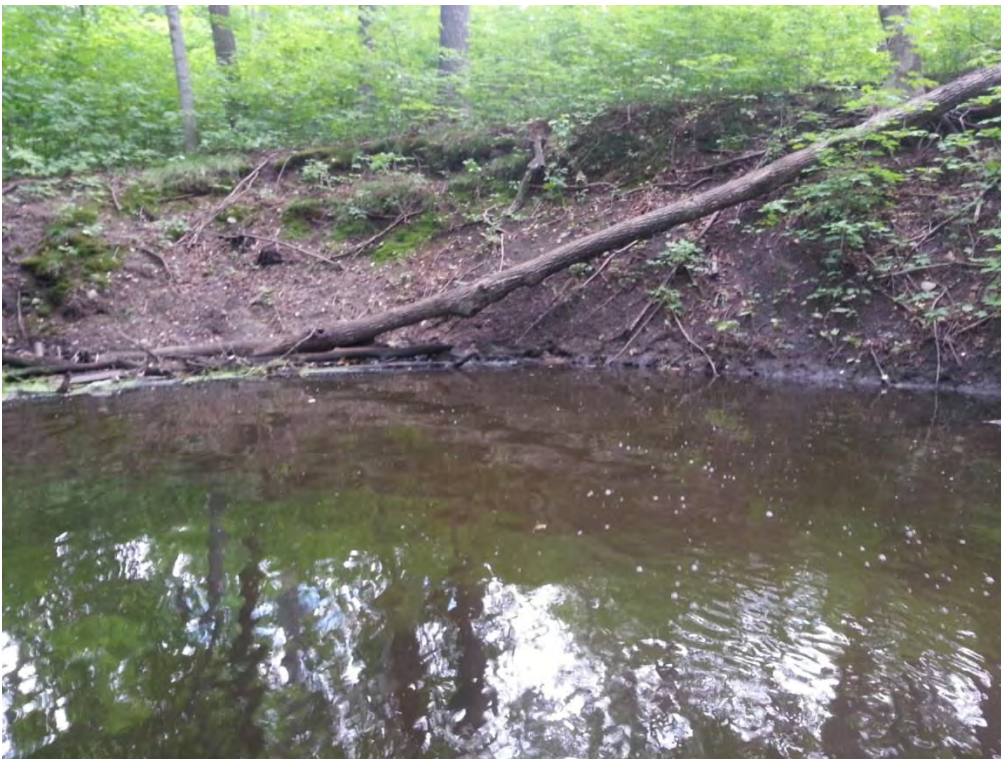
Photo 16. *Site 17.* Minor to moderate erosion on outside of stream bend

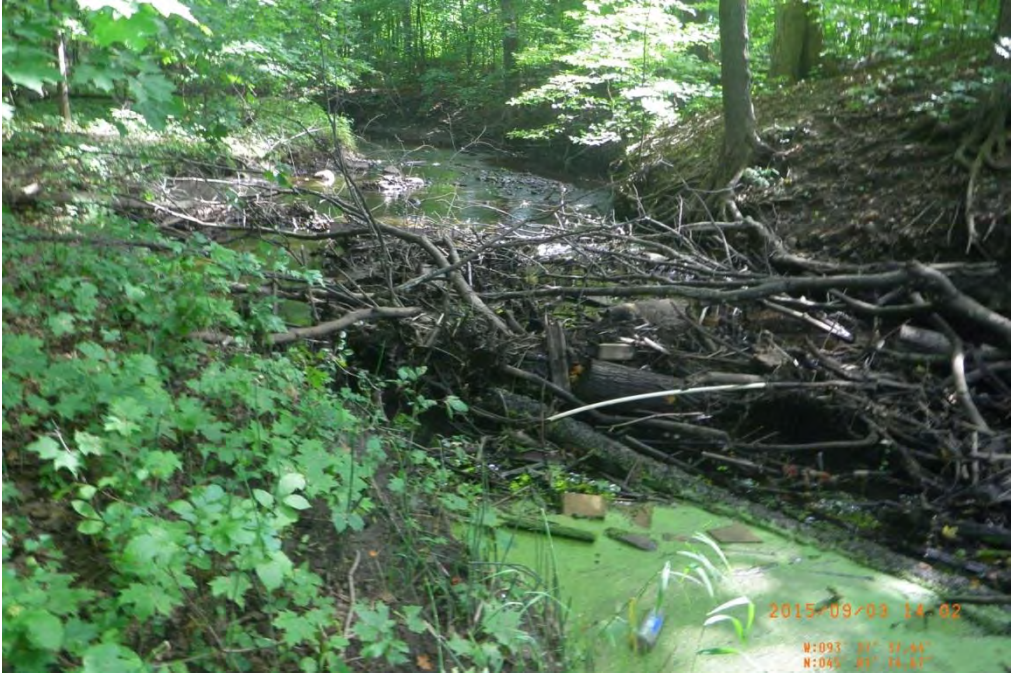
Photo 17. Site 18. Large woody debris in stream

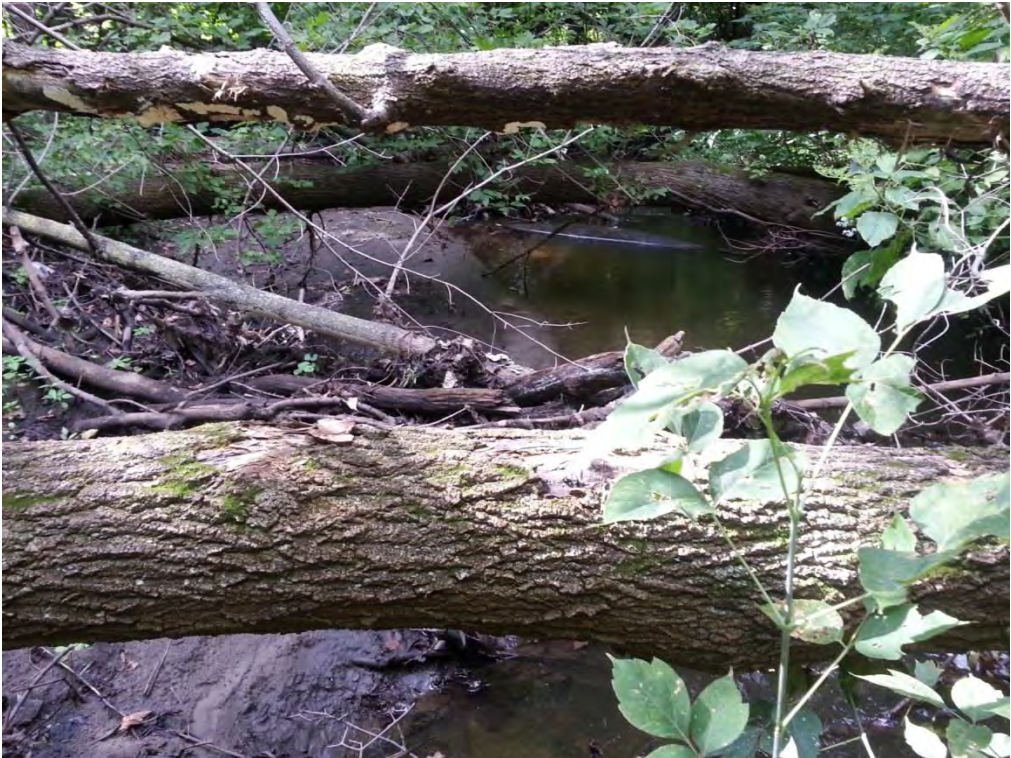
Photo 18. Site 19. Large woody debris in stream

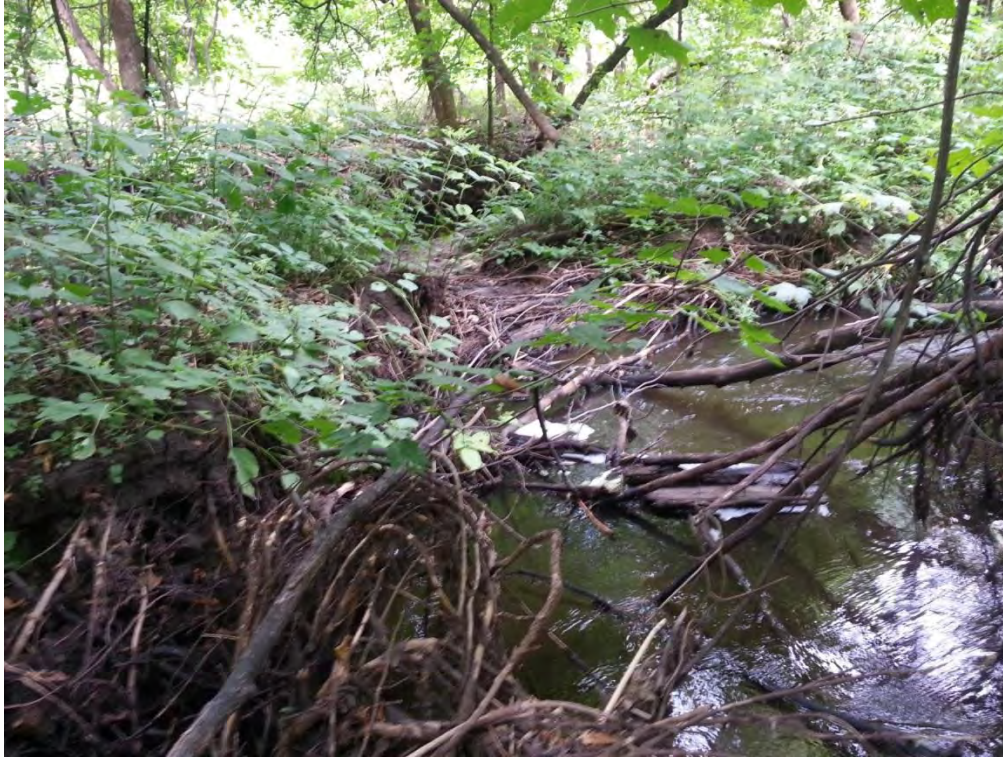
Photo 19. *Site 20.* Meander in process of being cut off

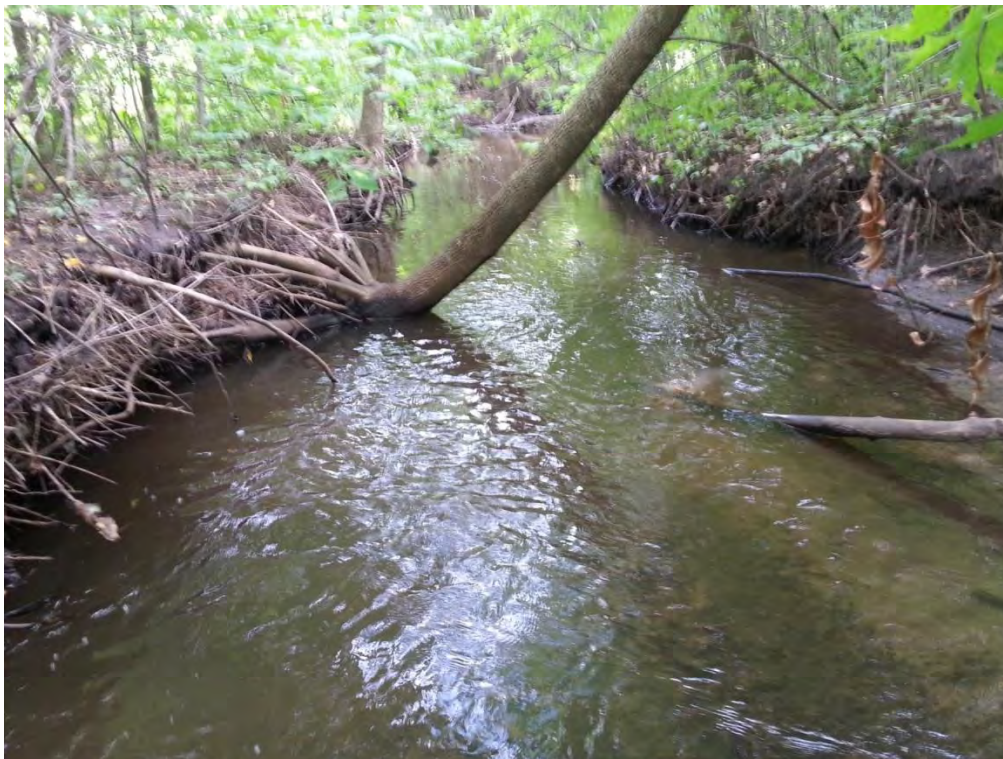
Photo 20. *Site 21.* Over-widened stream reach
