Memorandum

To: Bassett Creek Watershed Management Commission (BCWMC)
From: Barr Engineering Co.
Subject: Bassett Creek 2018 Flood Control Project Inspection
Date: December 12, 2018
Project: 23/27-0051.42 2018 4065

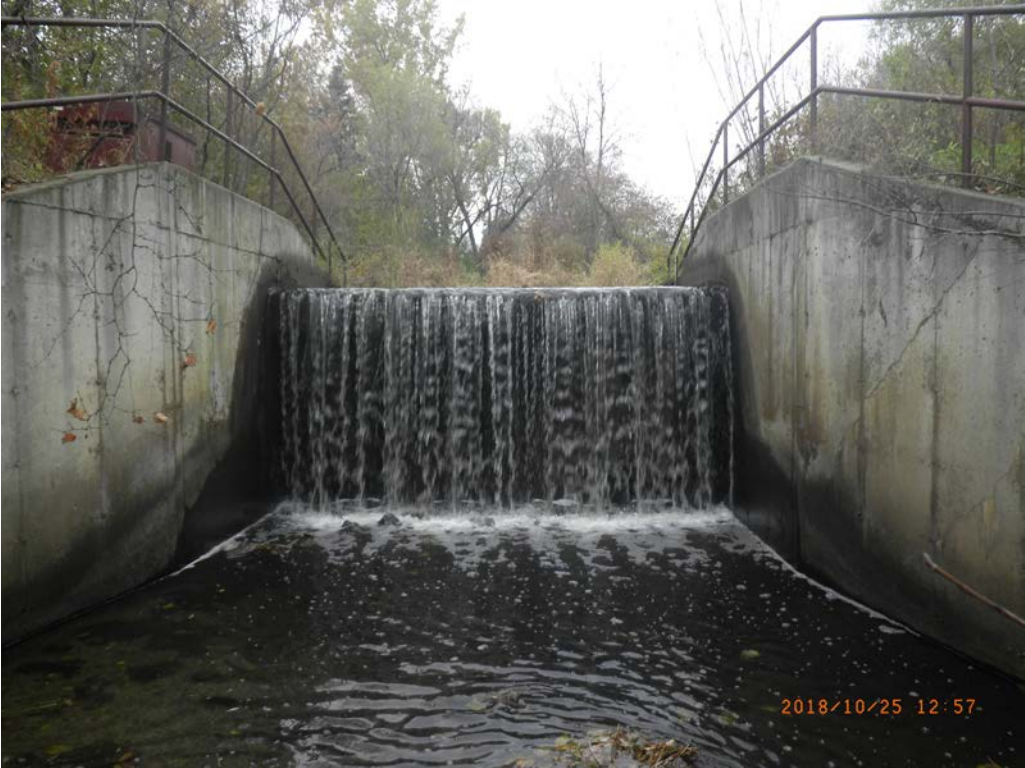
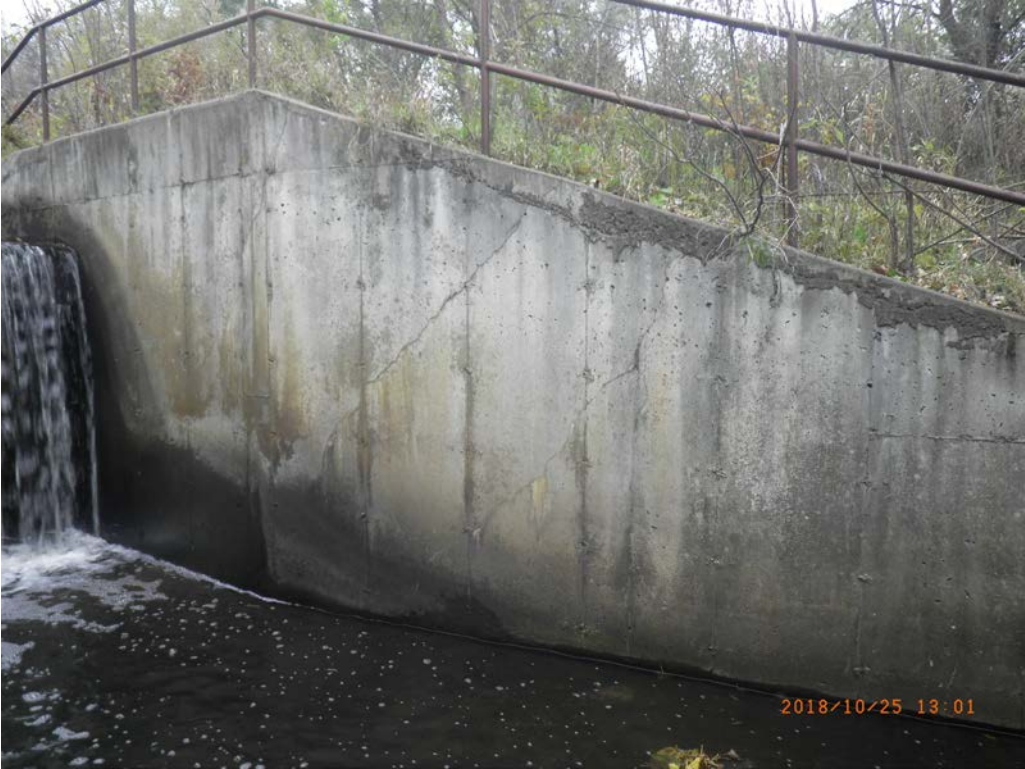
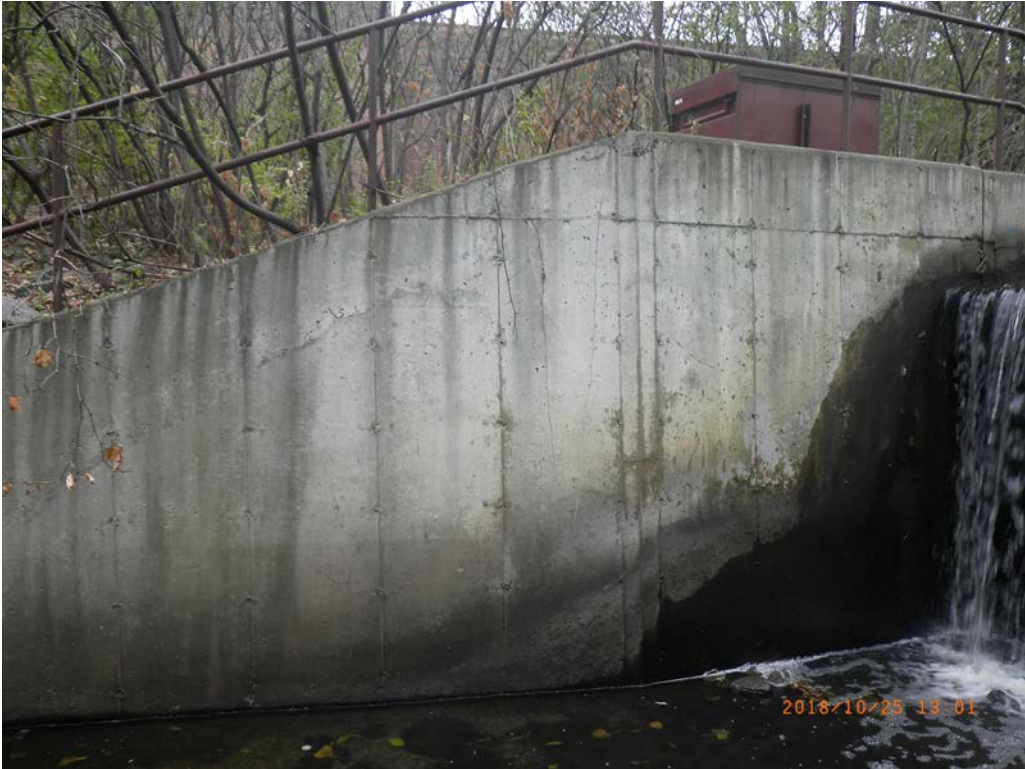
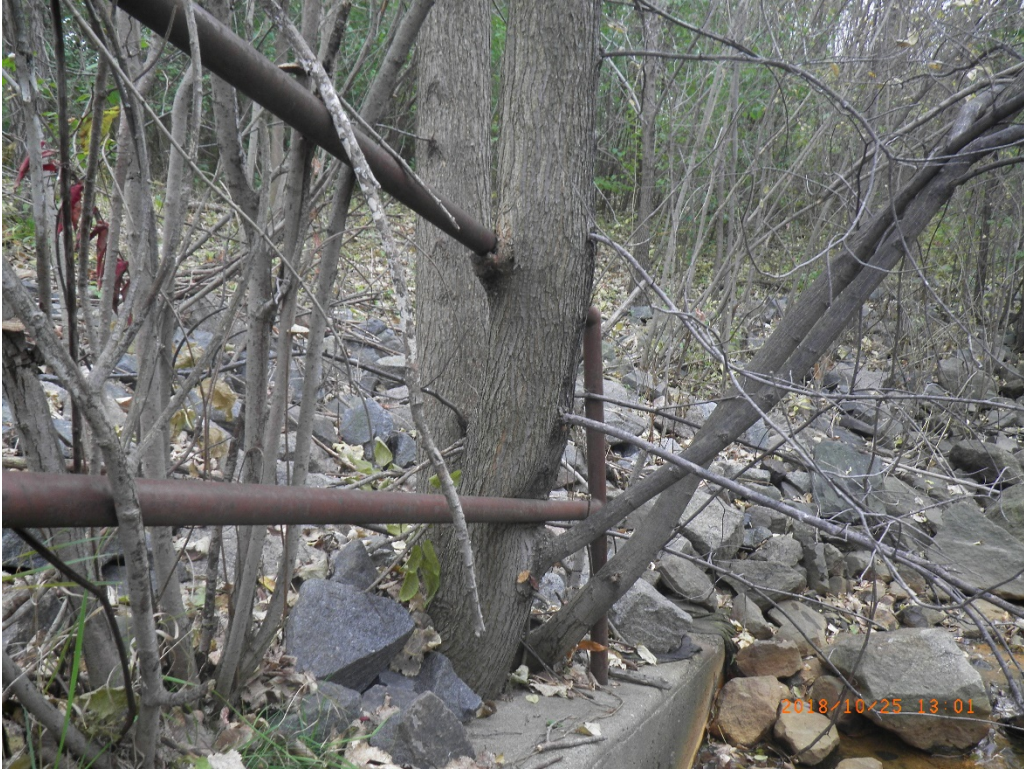
Plymouth Creek Fish Barrier (Plymouth)

- a. The structure appeared to be in satisfactory condition.
- b. The water level at the staff gage was at 0.20 feet and the depth of water flowing over the weir was 0.10 feet at the time of the inspection.

- c. Sediment has accumulated in the pool upstream of the structure and formed a delta, which was overgrown with vegetation. The deposited sediment was generally creating meander in the creek toward the east (left) bank. Deposited sediment has been noted since 2005 and appears to be increasing.

- d. The railings at the upstream end of the structure, on the east (left) and west (right) sides, have rusted off below the water level. This is consistent with previous inspections and has been noted since 2015.

- e. The abutment walls have expansion joints in the middle, just upstream of the weir. The west (right) expansion joint gap was first measured in 2002 at 7/8 inches for comparison with future inspections. The west (right) expansion joint gap was measured at 7/8 inches this year.

- f. Three cracks were observed on the downstream west (right) wing wall. This is consistent with previous inspections and has been noted since 2004.
- g. Seven diagonal cracks were observed on the downstream east (left) wing wall. Three of the cracks are very prominent. Observation of the three prominent cracks is consistent with previous inspections and has been noted since 2002. The other four cracks are minor and less noticeable.

- h. A tree was observed growing adjacent to the downstream east (left) wing wall and through the railing.
- i. Small trees and shrubs were observed growing on the embankment and downstream channel banks.

- Remove accumulated sediment from the upstream pool. (Note: In 2010, the City of Plymouth submitted an Environmental Assessment Worksheet (EAW) to the Minnesota Pollution Control Agency (MPCA) for a channel improvements project. The MPCA informed the City of Plymouth that the Clean Water Act expressly prohibits the use of creeks, streams, lakes, and wetlands from being used as a pollution treatment system except in the extreme situations, therefore dredging of the sediment upstream of the fish barrier, in order to continue to utilize the area upstream of the fish barrier as a sedimentation pond, was prohibited by the MPCA

and not permitted. It is recommended that the City of Plymouth coordinate with the MPCA to discuss viable alternatives to remove the sediment since the project intent was not as a sediment basin but as a fish barrier.)

- Repair railings on the upstream side of the structure.
- Remove trees and vegetation on embankment and channel banks. Chemically treat stumps with Garlon 3A herbicide (or other specialty herbicide for use in wetland sites and waterways) to prevent regrowth.
- Monitor concrete cracks and the width of the expansion joints.

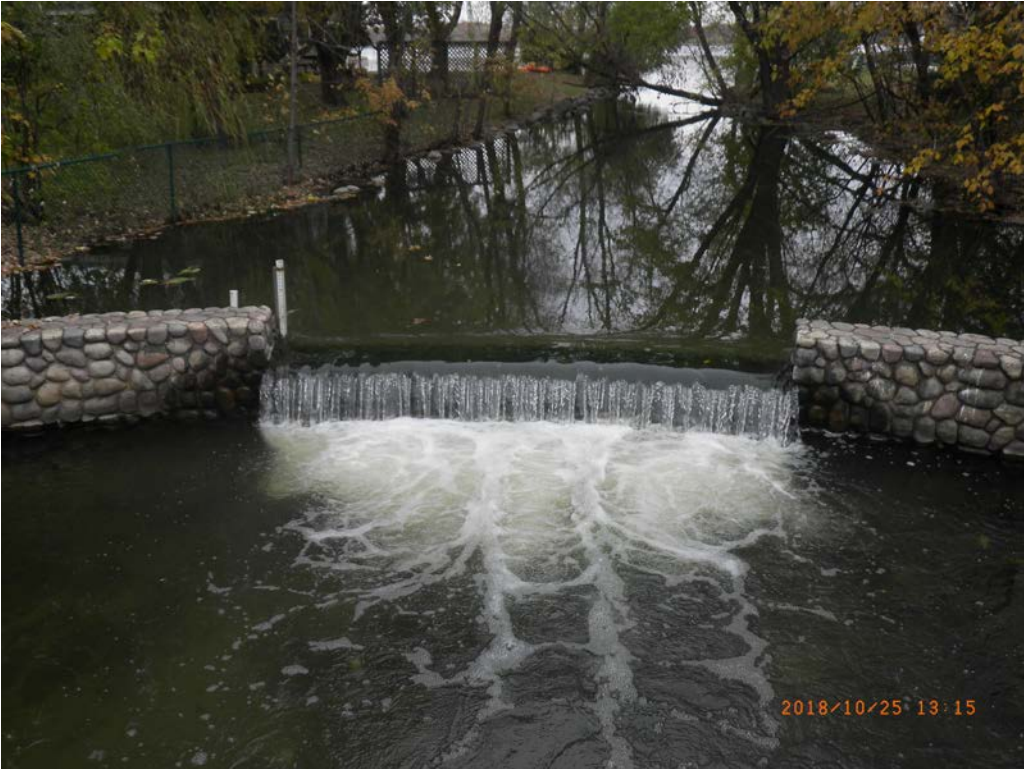
Medicine Lake Outlet (Plymouth)

- a. The channel between the Medicine Lake and the outlet structure was clear of debris and flowing full.
- b. The outlet structure appeared to be in satisfactory condition.
- c. The water level at the staff gage was at 1.05 feet and the depth of water flowing over the structure was 0.67 feet.
- d. The east (left) bank contained a large dead or dying tree adjacent to the private chain link fence and upstream of the outlet structure. In previous inspections, the tree appeared to be leaning away from the channel, exposing soil and roots, and a risk to fall and leave a void in the channel bank. However, this year it appeared that the tree had been trimmed and was less of a threat to fall and leave a void in the channel bank.

- Monitor dead or dying tree along the upstream east (left) bank. Consider coordinating with landowner to remove tree and stabilize channel bank.

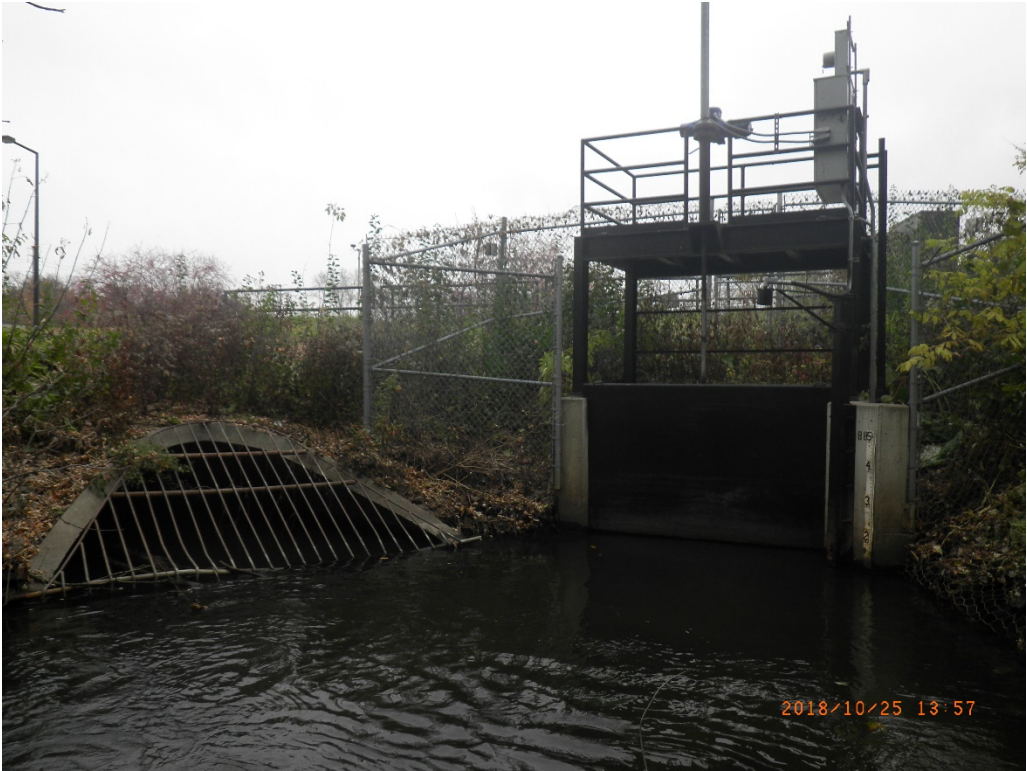
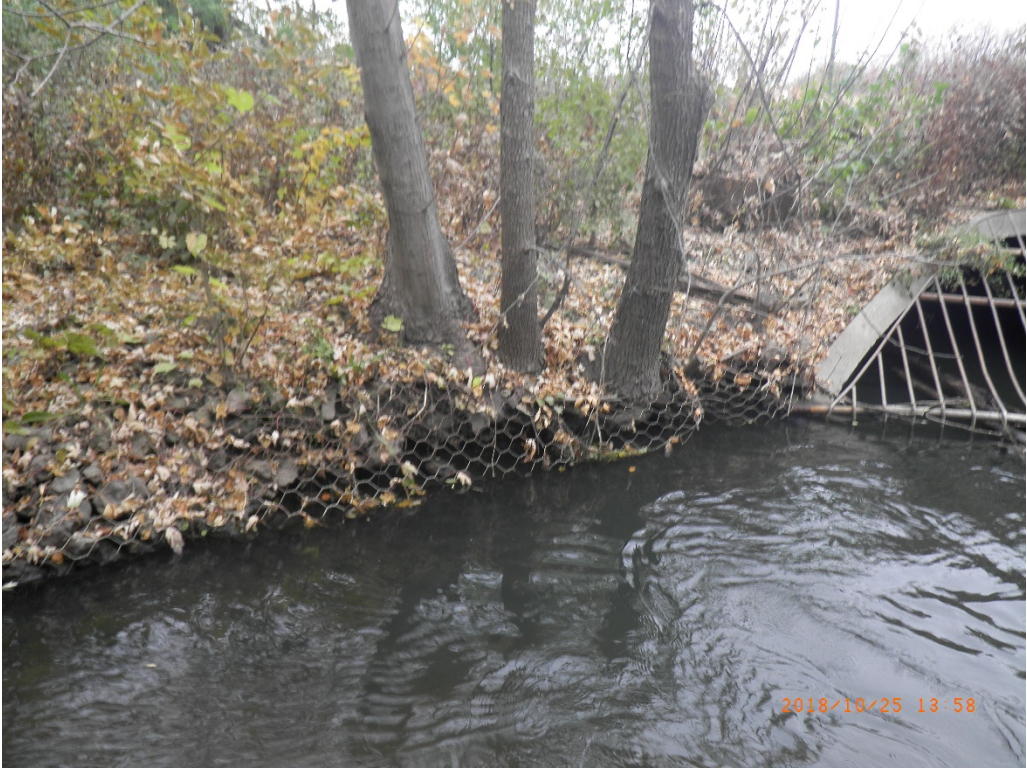
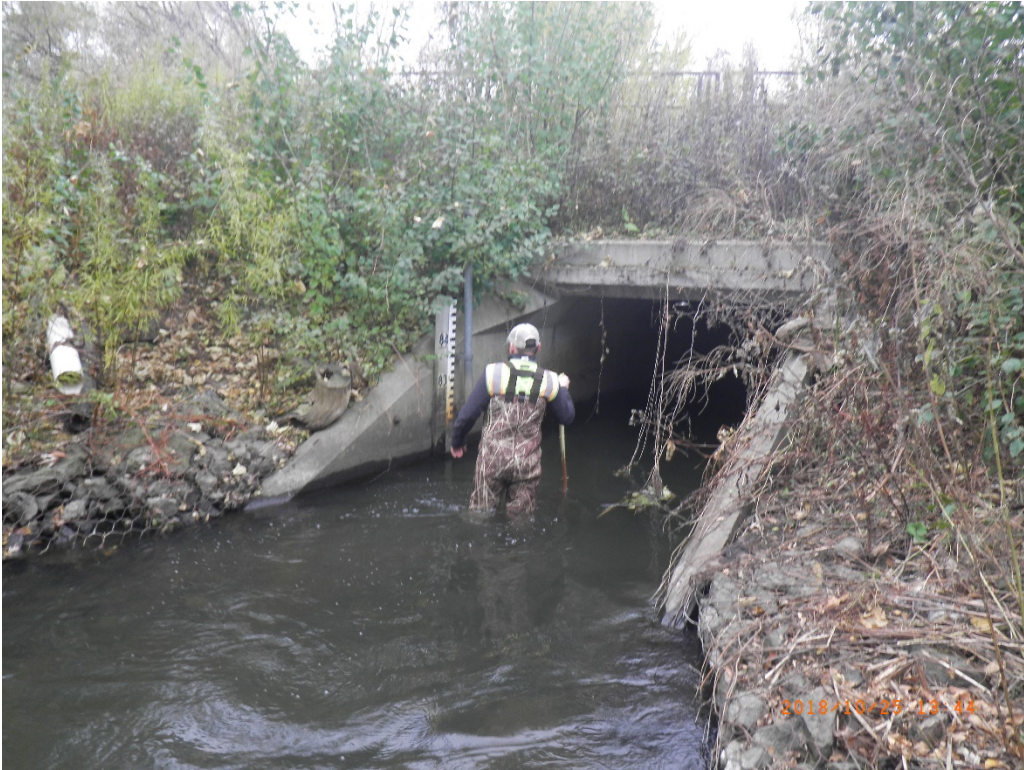
Wisconsin Avenue Control Structure (Golden Valley)

- a. The concrete culvert appeared to be in satisfactory condition.
- b. The water level at the staff gage was at 881.0 feet both upstream and downstream of the culvert.
- c. The flood gate was approximately 4 inches above the down position at the time of the inspection and appeared to be in satisfactory condition.
- d. Deposited sediment was observed in the bottom of the culvert, ranging from 0-2 inches deep. This is consistent with previous inspections and has been noted since 2006.

- e. Some of the gabion baskets upstream and downstream of the culvert have deteriorated or broken and riprap had fallen out of the baskets at some locations. Although the gabion baskets are no longer functioning as installed, no significant erosion was observed.
- f. The railings at the upstream and downstream ends of the culvert were in satisfactory condition.
- g. Small trees and brush are growing around the downstream end of the culvert.

- Cut and remove trees and brush near culvert ends. Chemically treat stumps with Garlon 3A herbicide (or other specialty herbicide for use in wetland sites and waterways) to prevent regrowth.
- Monitor deposited sediment in the culvert.
- Monitor upstream and downstream banks for erosion.

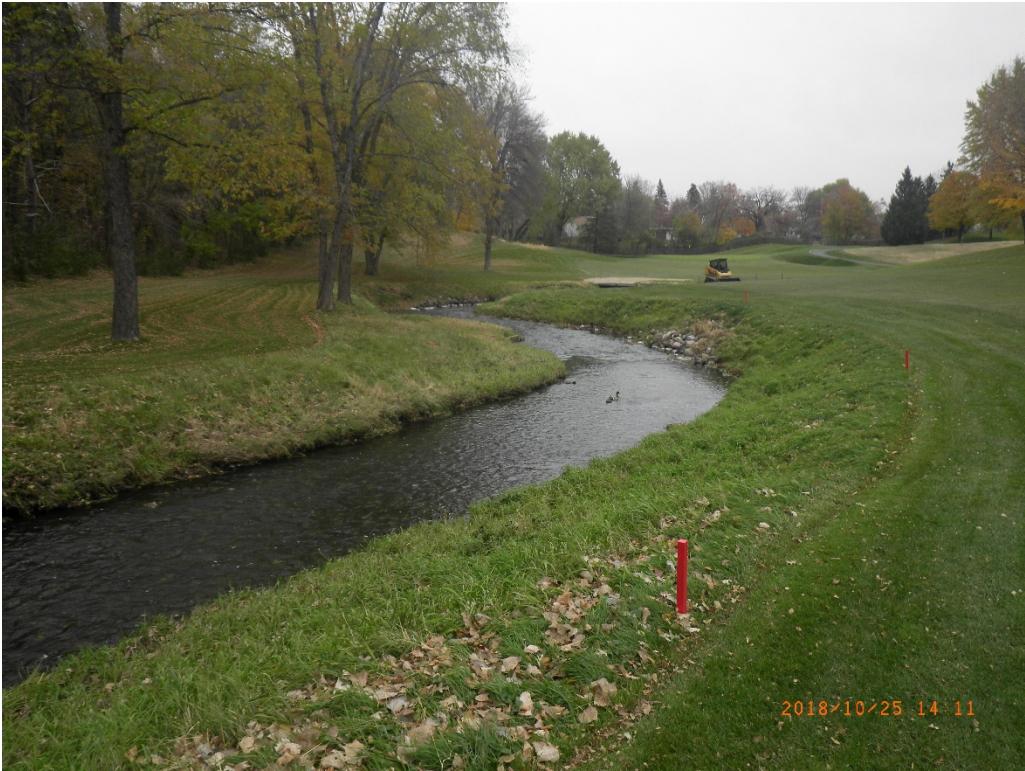
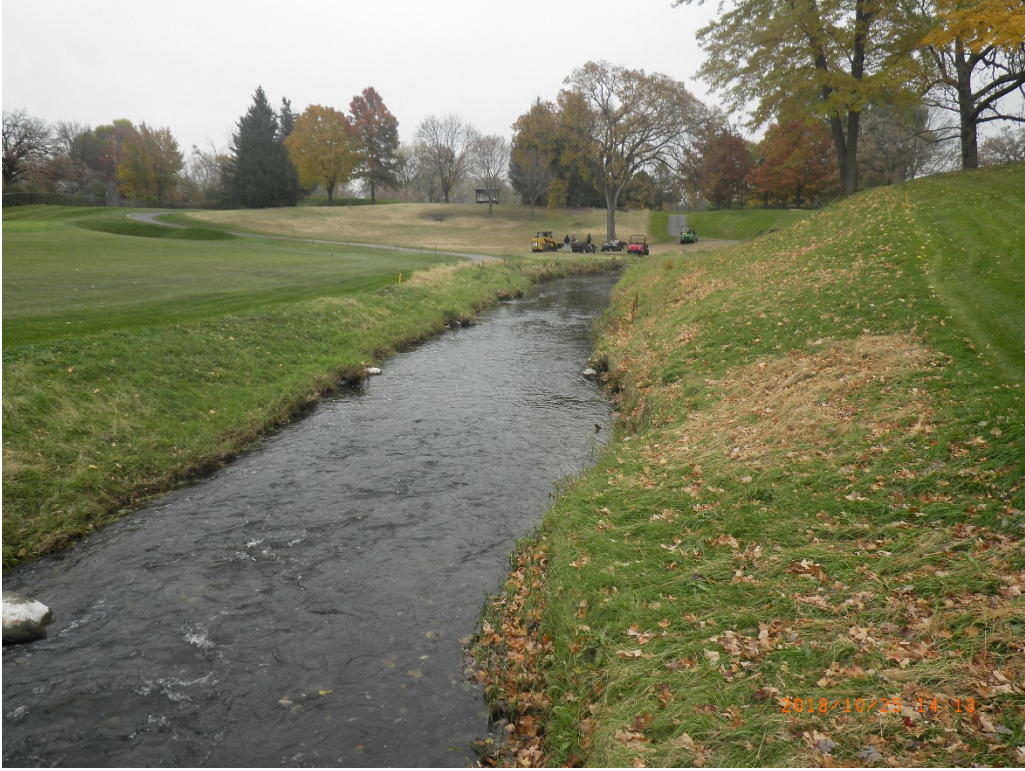
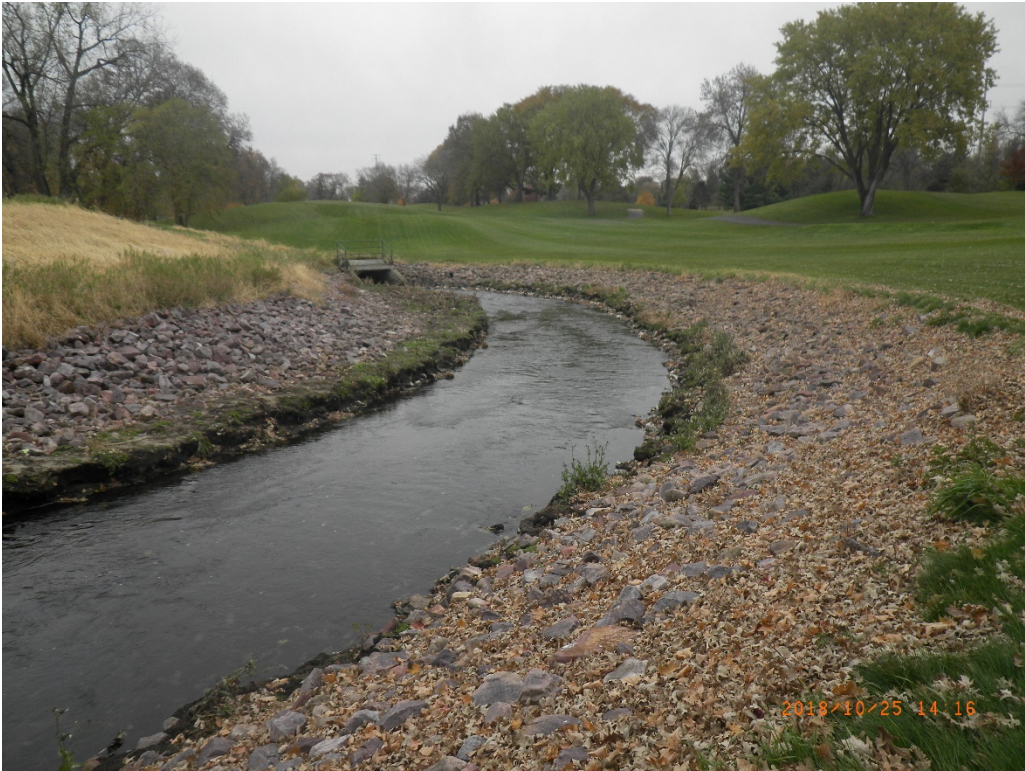
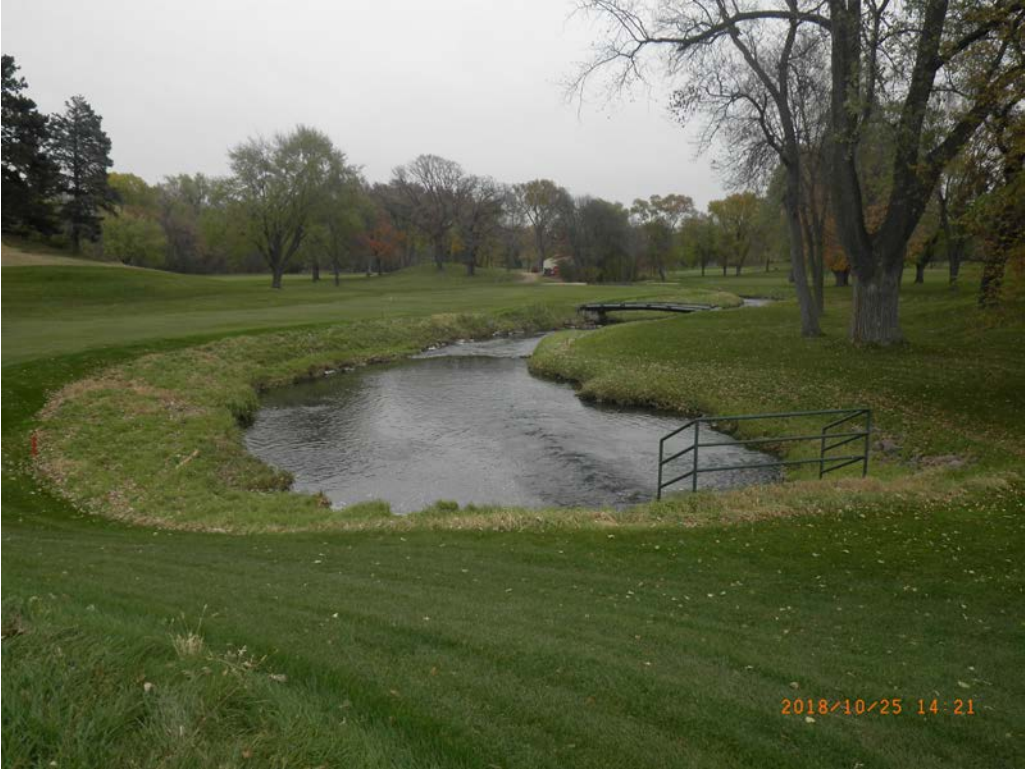
Golden Valley Country Club (Golden Valley)

- a. The channel and riprap armoring from Pennsylvania Avenue to the box culvert appeared to be in satisfactory condition.
- b. The box culvert, joints, and railings appeared to be in satisfactory condition.
- c. The overflow weir (earth berm) appeared to be in satisfactory condition and has been maintained by the Golden Valley Country Club staff as manicured fairway turf.

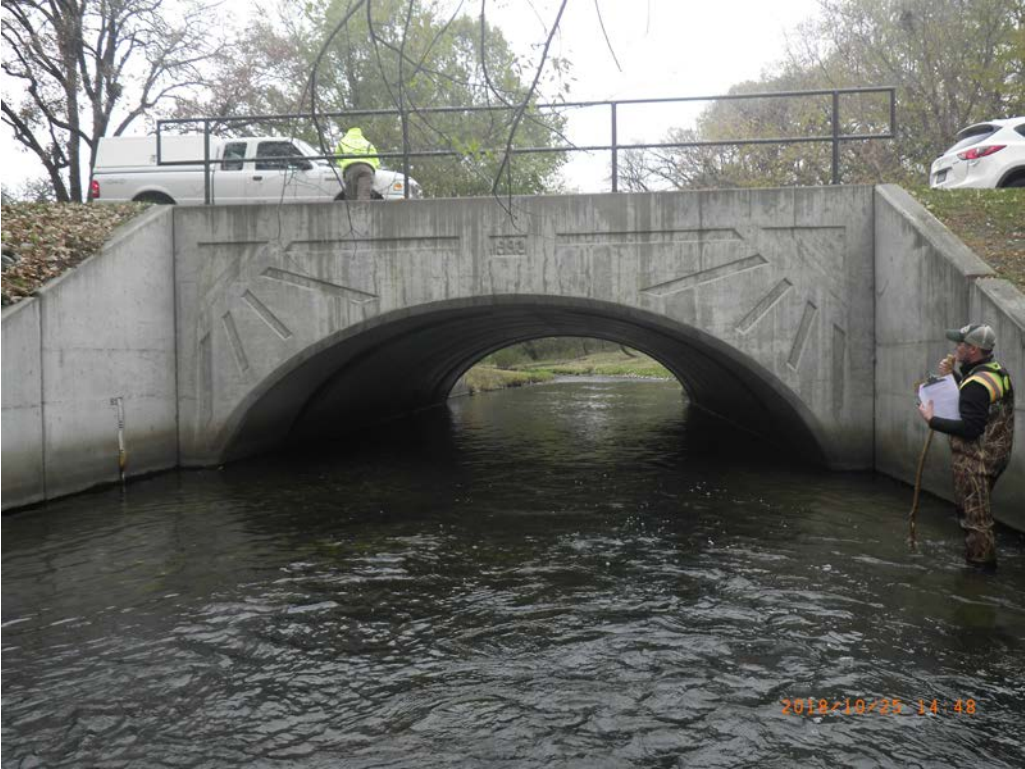
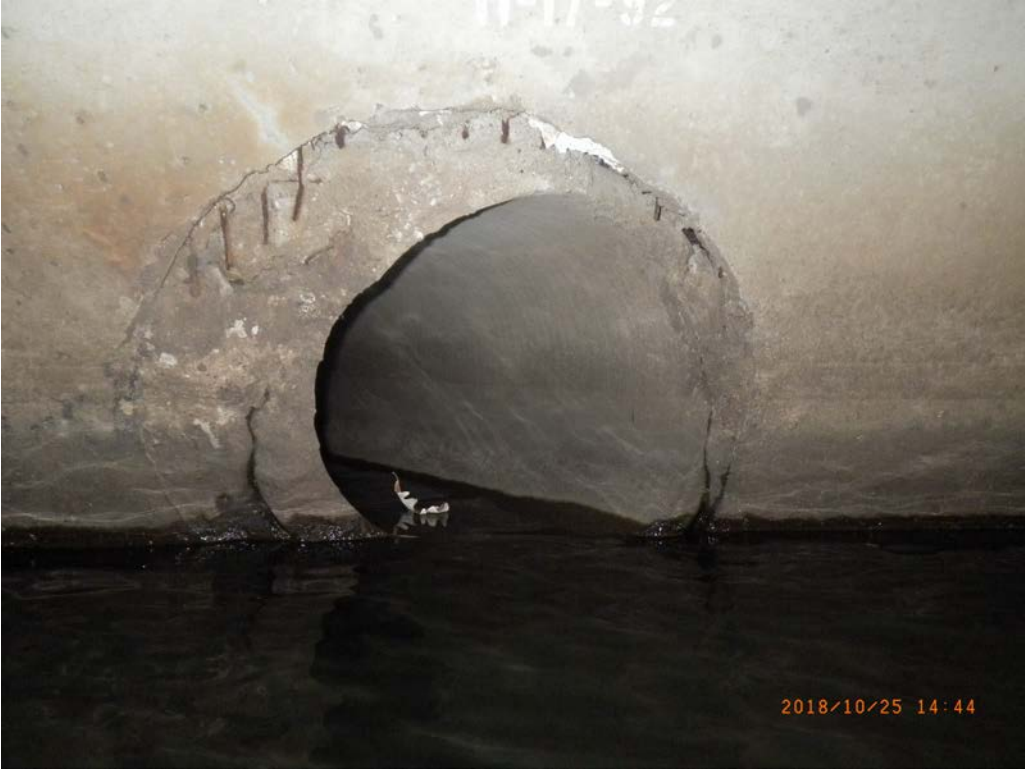
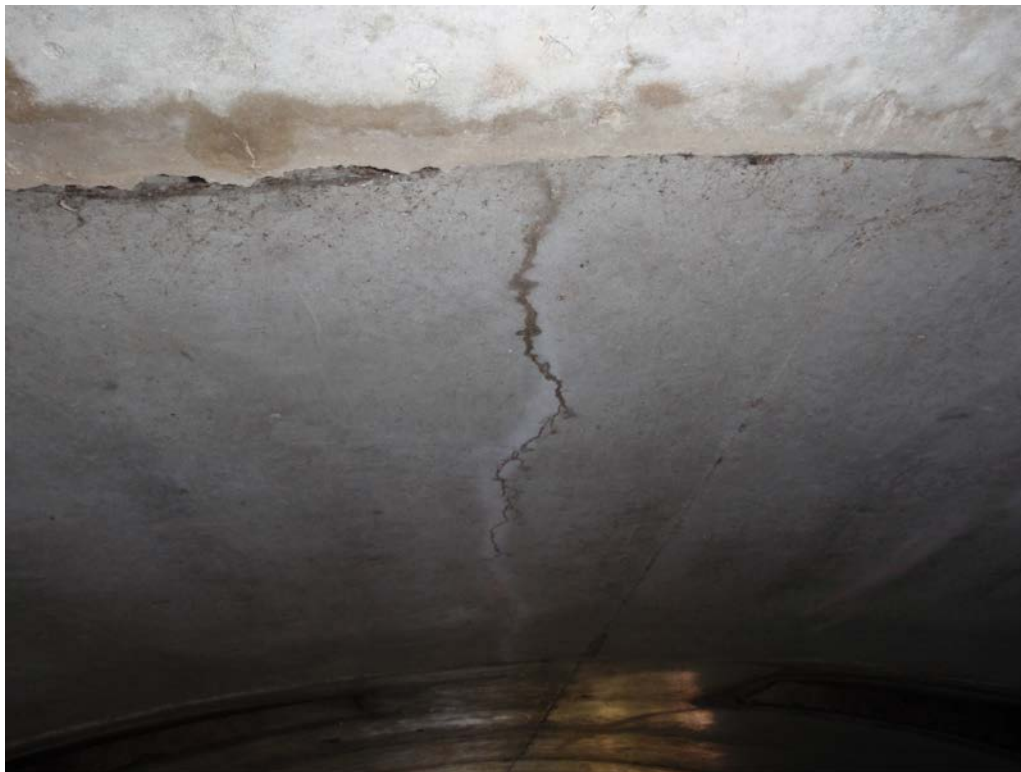
Westbrook Road Crossing (Golden Valley)

- a. The concrete Bebo culvert appeared to be in satisfactory condition.
- b. The water level at the staff gage was at 853.99 feet.
- c. Spalled concrete and exposed rebar was observed around the storm sewer pipe entering the culvert on the west (left) side.
- d. Longitudinal hairline cracks were observed on the top of sections of the Bebo culvert, extending across the entire section (pre-cast section) width. The cracks are approximately 2 feet off-center of the structure. These cracks are consistent with previous inspections and have been noted since 2002.
- e. A joint gap and separation was observed between the two furthest downstream sections of the culvert and there are signs of pressure points where the last section has pushed against the top of the two wing walls. Fractured concrete was observed on the east (right)

side of the culvert, potentially due to the movement. This is consistent with previous inspections and has been noted since 2015.

- f. Spalled concrete was observed at multiple locations upstream and downstream of the culvert at the top of the wing walls and head wall. This is consistent with previous inspections and has been noted since 2007.
- g. Cracks were observed in the road pavement above the structure. This is consistent with previous inspections and has been noted since 2010.
- h. The inlet grate for one of the catch basins that drains into the culvert was missing one of the cross bars.
- i. The railings appeared to be in satisfactory condition.

- Repair spalled concrete and exposed rebar at storm sewer connection on west (left) side of culvert.
- Repair or replace catch basin inlet grate.
- Monitor cracks in the culvert.
- Monitor joint gap and fractured concrete at pressure points.
- Monitor spalled concrete at wing walls and head walls.
- Monitor cracks in the road.

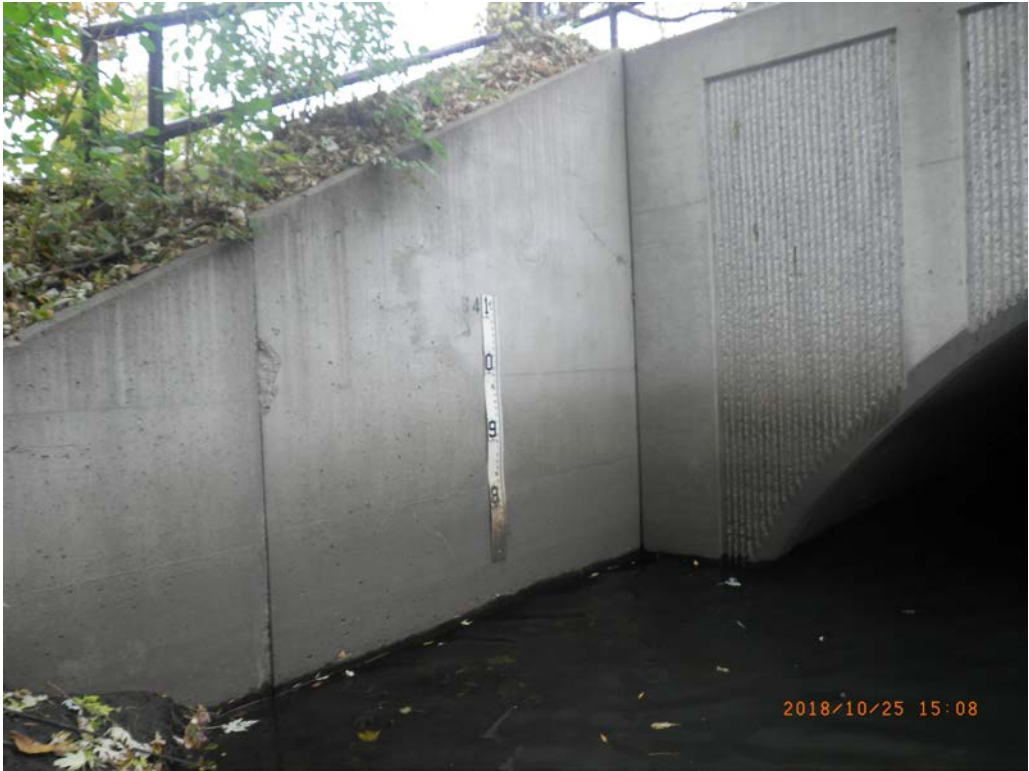
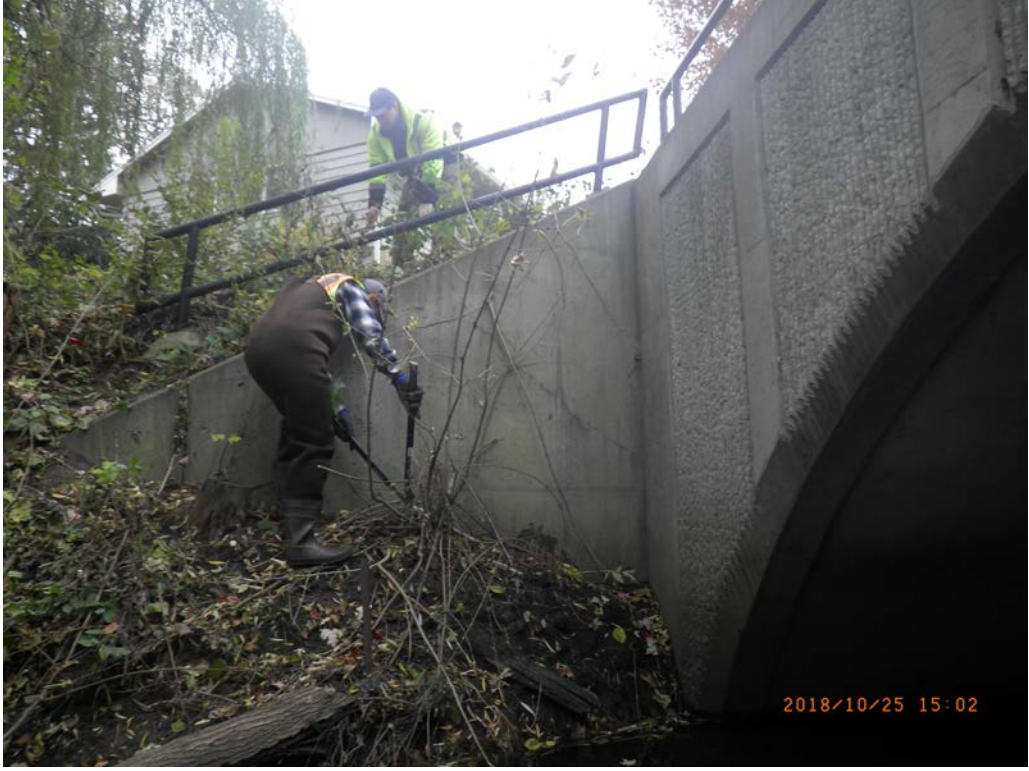
Regent Avenue Crossing (Golden Valley), continued

- a. The concrete Bebo culvert appeared to be in satisfactory condition.
- b. The channel bottom was very soft and mucky and the water level was below the staff gauge.

- c. Spalled concrete was observed at the middle joint of the upstream north (left) wing wall. This is consistent with previous inspections and has been noted since 2002.

- d. A crack was observed at the upstream, north (left) wing wall. The crack was near the top of the wing wall and travels at a 45 degree angle down to the headwall. This is consistent with previous inspections and has been noted since 2002.

- e. Multiple cracks were observed at the upstream south (right) wing wall. This is consistent with previous inspections and has been noted since 2008.

- f. Spalled concrete was observed around the storm sewer pipe entering the culvert on the north (left) side.
- g. A crack was observed at the downstream south (right) wing wall. The crack was near the top of the wing wall and travels at a 45 degree angle down to the headwall. This is consistent with previous inspections and has been noted since 2002.

- h. Flows appeared to have scoured the north (left) side of the creek bottom and deposited sediment on the south (right) side of the creek bottom.

- Repair spalled concrete at storm sewer connection on north (left) side of culvert.
- Monitor spalled concrete at the upstream north (left) wing wall.
- Monitor crack at the upstream north (left) wing wall.
- Monitor cracks at the upstream south (right) wing wall.
- Monitor crack at the downstream south (right) wing wall.
- Monitor creek bottom for scouring and deposition and, as needed, armor creek bottom along culvert foundation.

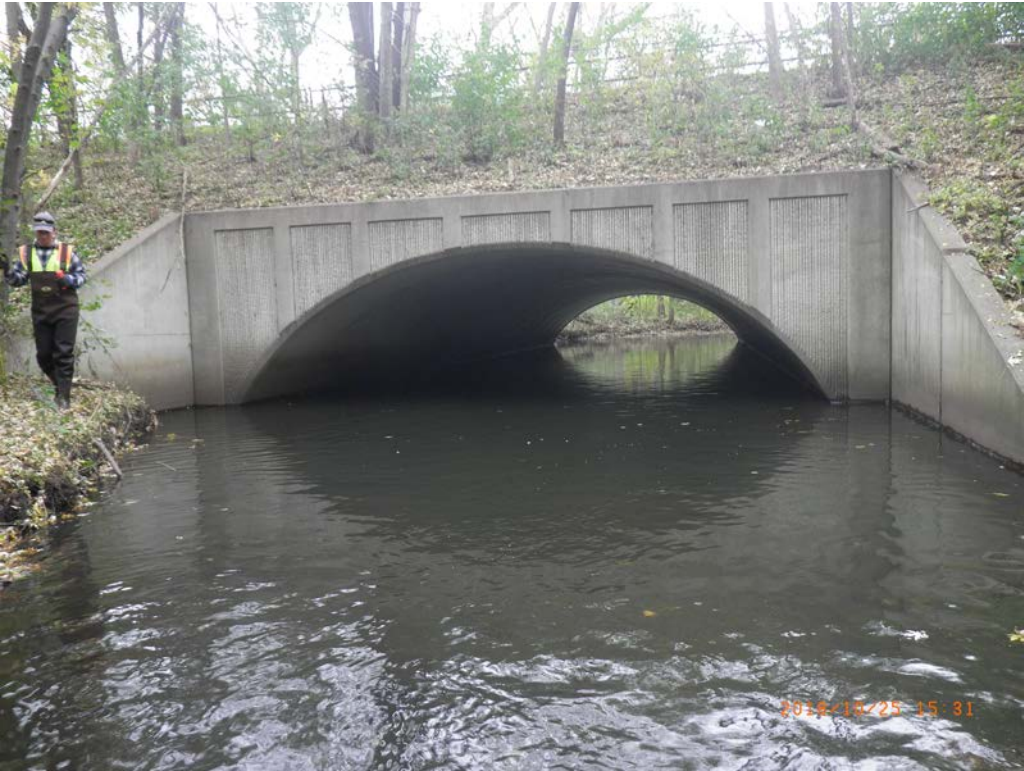
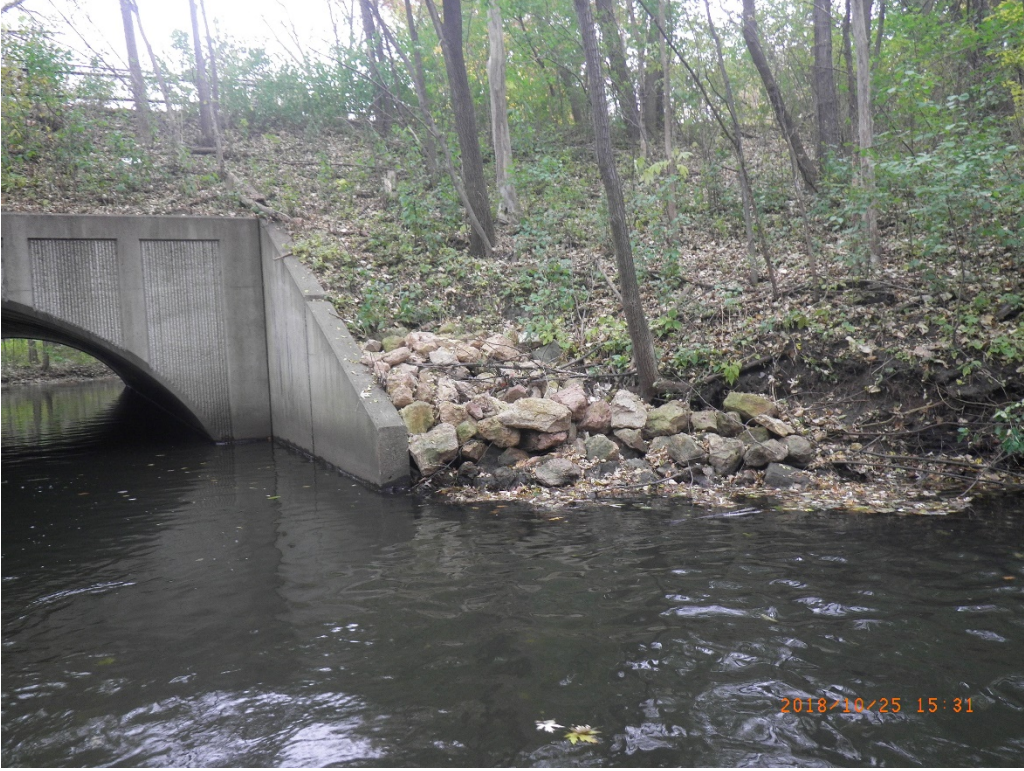
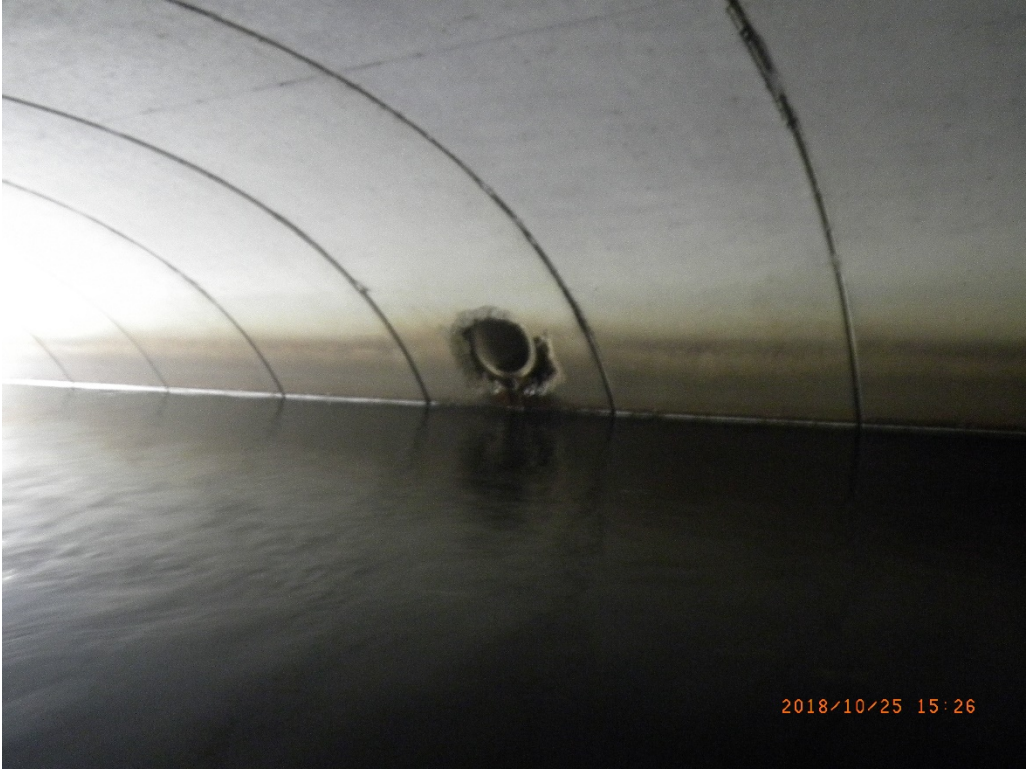
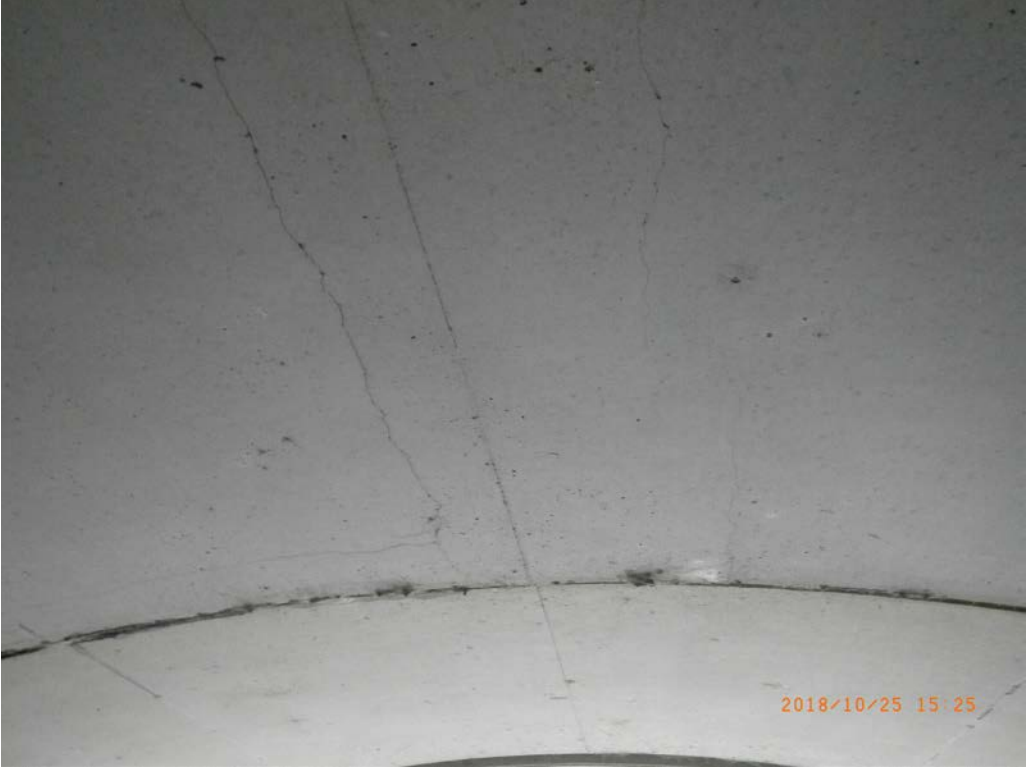
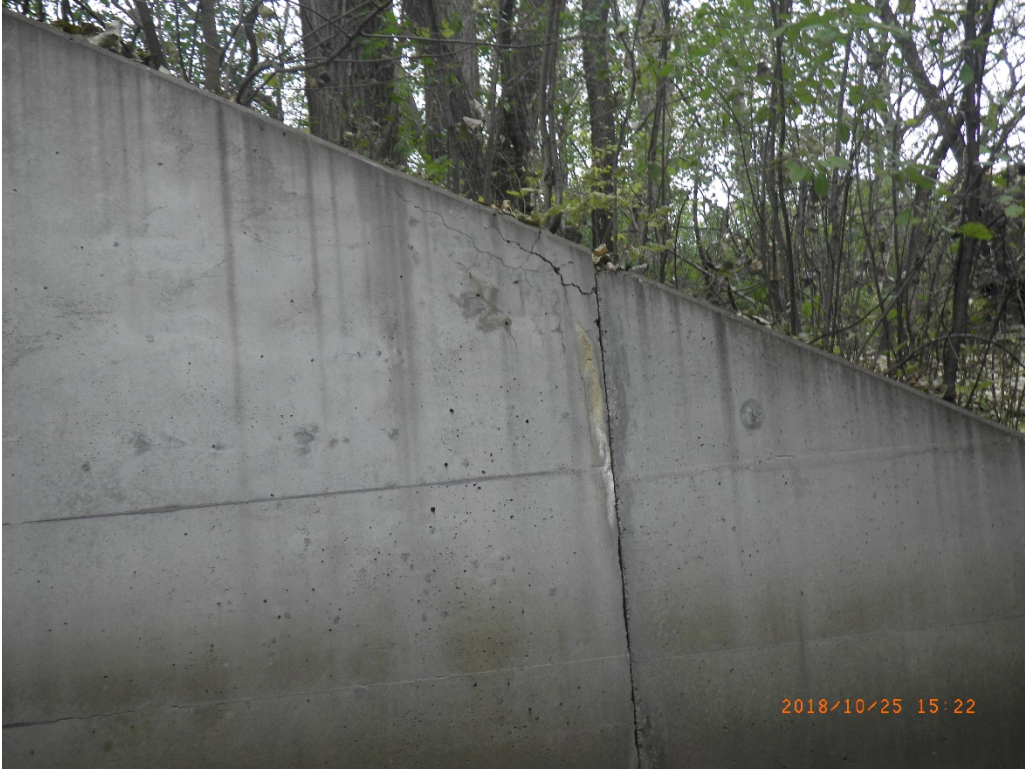
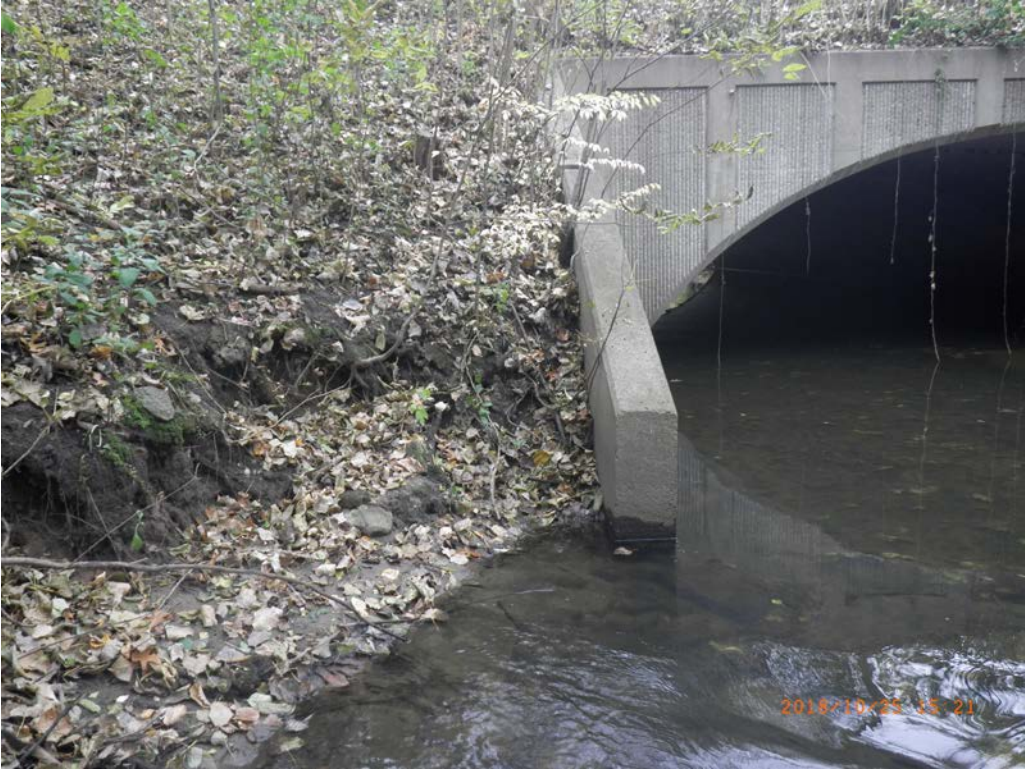
Noble Avenue Crossing (Golden Valley)

- a. The concrete Bebo culvert appeared to be in satisfactory condition.
- b. Longitudinal hairline cracks were observed throughout the length of the top of the culvert, extending across the entire section (pre-cast section) width. The cracks were either in the center of the structure or approximately 2 feet off-center of the structure. This is consistent with previous inspections and has been noted since 2002.

- c. Spalled concrete and exposed plastic joint material was observed approximately two feet either side of center throughout the length of the top of the culvert. The cement paste covering the plastic joint material has separated and exposed the plastic. This is consistent with previous inspections and has been noted since 2002.

- d. Spalled concrete and exposed rebar was observed around the storm sewer pipe entering the culvert on the north (left) side.
- e. Spalled concrete was observed at the downstream north (left) wing wall. This is consistent with previous inspections and has been noted since 2002.

- f. Multiple cracks were observed at the top of downstream north (left) wing wall. This is consistent with previous inspections and has been noted since 2007.

- g. The downstream south (right) wing wall was slightly leaning toward creek. The top of the lower wall was measured at 5/8" offset from the upper wall in 2002. The offset remained constant at 5/8" until 2005 when the offset was observed at 11/16". The offset was then measured at 1" in 2006 and remained at 1" offset until the 2009 inspection when a 1-1/8" offset was measured. The offset between the top of the lower wall and the upper wall has remained constant at 1-1/8" from 2009 to present.

- h. Minor bank erosion and scour was observed on both sides of the downstream wing walls. This is consistent with previous inspections and has been noted since 2002.

- i. Flows appeared to be scouring the north (left) side of the creek bottom.
- j. The paint on the railings is chipping and coming off in a number of locations.

- k. The City of Golden Valley installed riprap to reinforce the bank and minimize continued erosion at the outside edge of the upstream south (right) wing wall.

- Repair spalled concrete and exposed rebar at storm sewer connection on north (left) side of culvert.
- Add new coat of paint to railings.
- Monitor cracks and spalled concrete in the culvert and wing walls.
- Monitor bank erosion at downstream wing walls.
- Monitor creek bottom for scouring and, as needed, armor creek bottom along culvert foundation.
