Memorandum

To: Bassett Creek Watershed Management Commission (BCWMC)
From: Barr Engineering Co.
Subject: Bassett Creek 2018 Flood Control Project Inspection
Date: December 12, 2018
Project: 23/27-0051.42 2018 4065

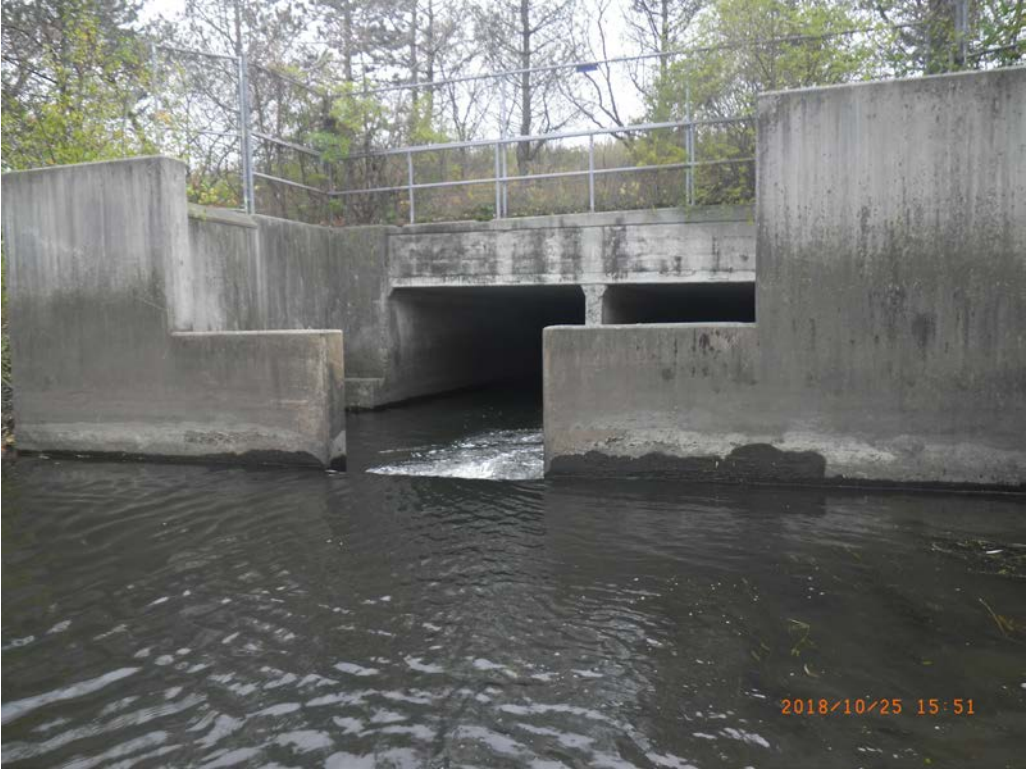
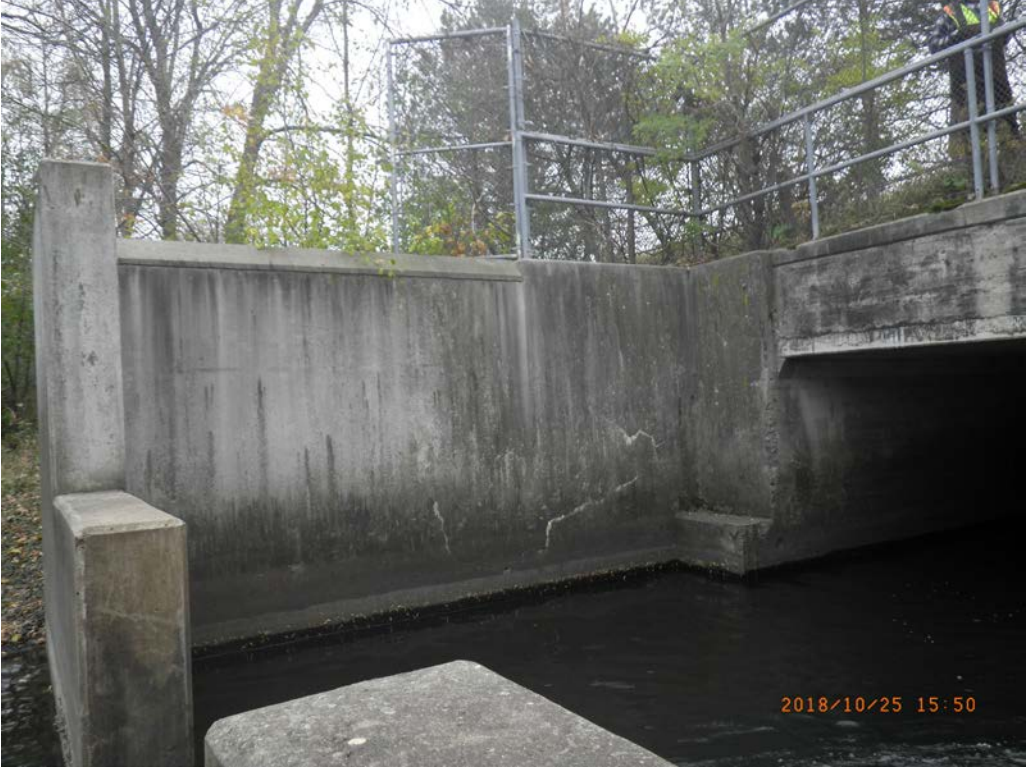
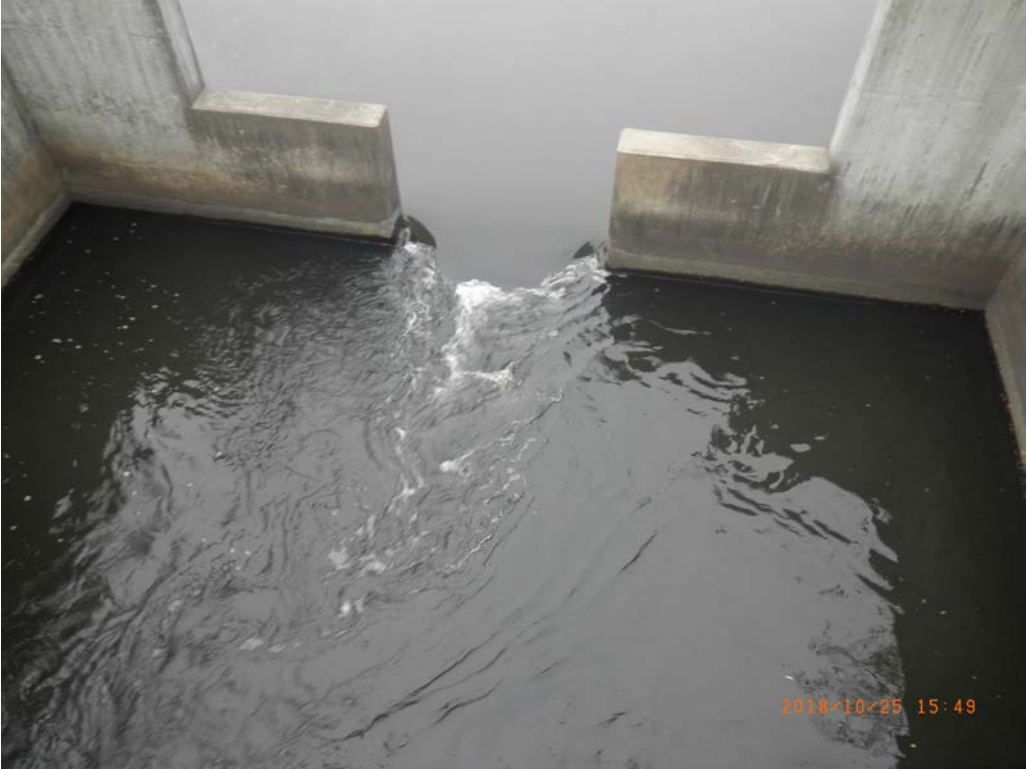
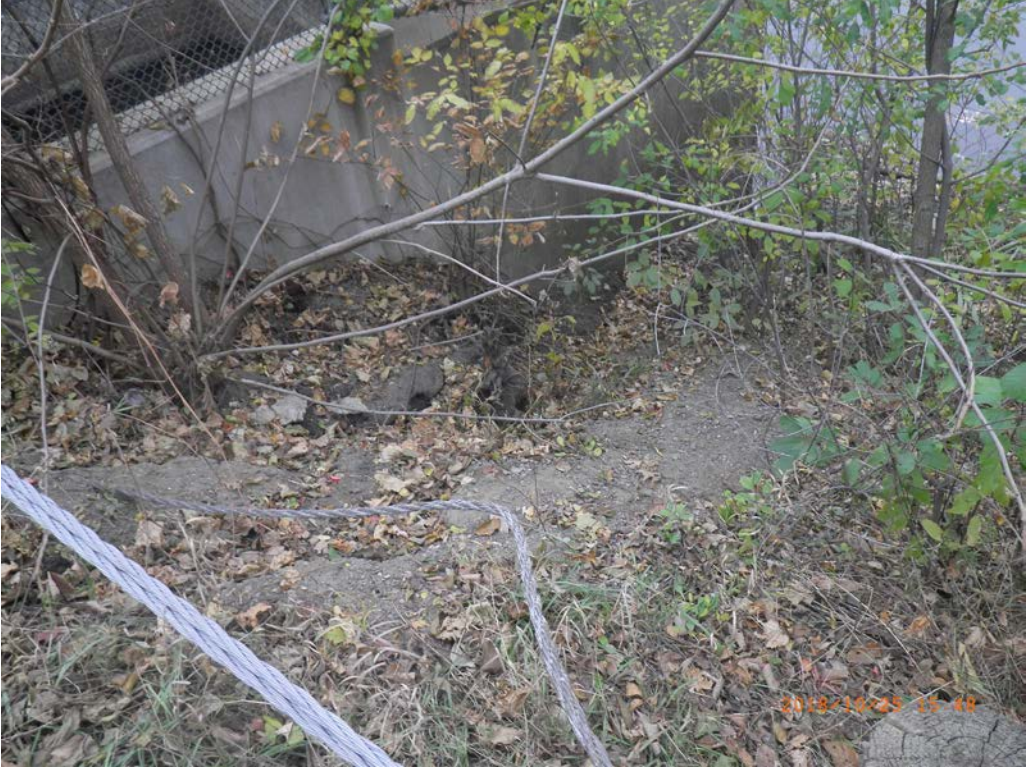
Highway 55 Control Structure (Golden Valley/Minneapolis)

- a. The concrete control structure appeared to be in satisfactory condition.
- b. A hairline crack was observed in the east (left) wall of the inlet structure. The crack is positioned in the middle of the wall extending full height. This is consistent with previous inspections and has been noted since 2002.
- c. Erosion was observed around both the east (left) and west (right) sides of the structure, likely from road runoff. This is consistent with previous inspections and has been noted since 2004. The erosion on the east (left) side is more significant and appears to be worsening.

- Armor the sides of the structure to protect against additional erosion, or divert road runoff away from the structure.
- Monitor hairline crack in the control structure.

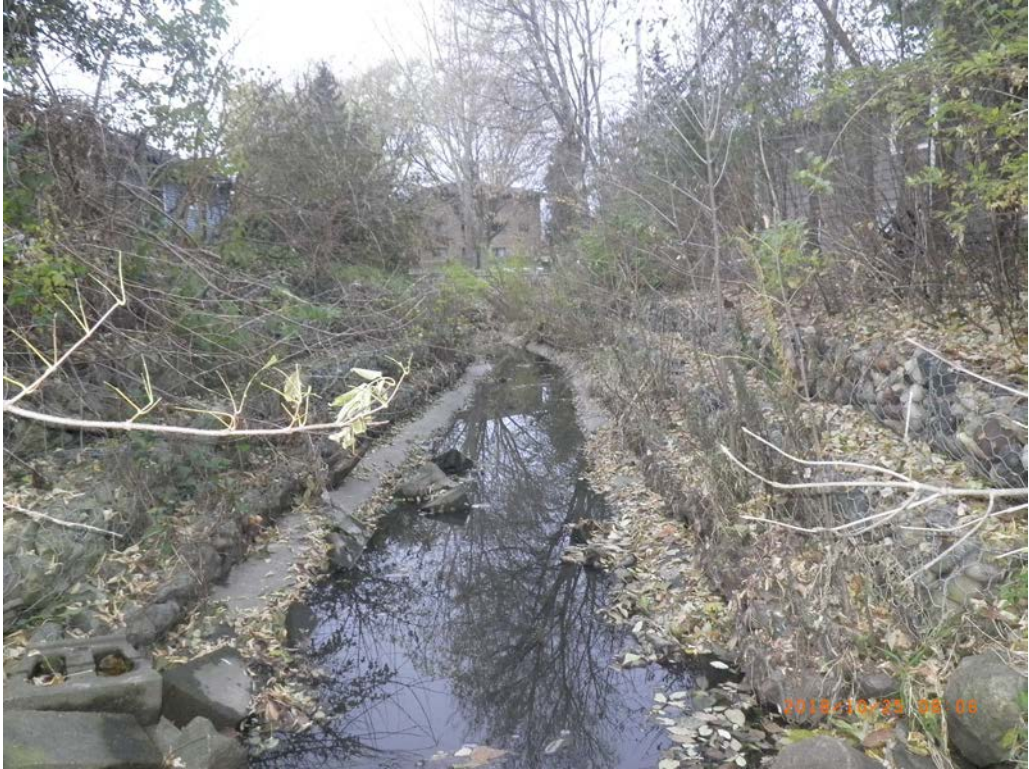
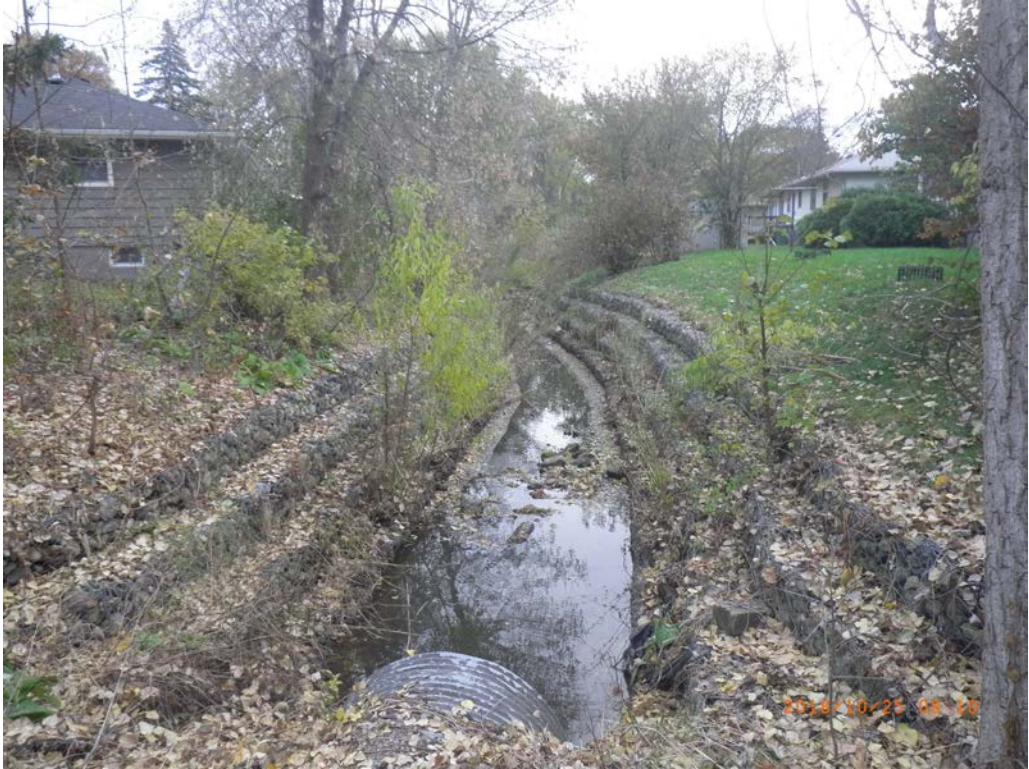
Markwood Open Channel – Gabion Section (Crystal)

- a. The channel appeared to be in satisfactory condition.

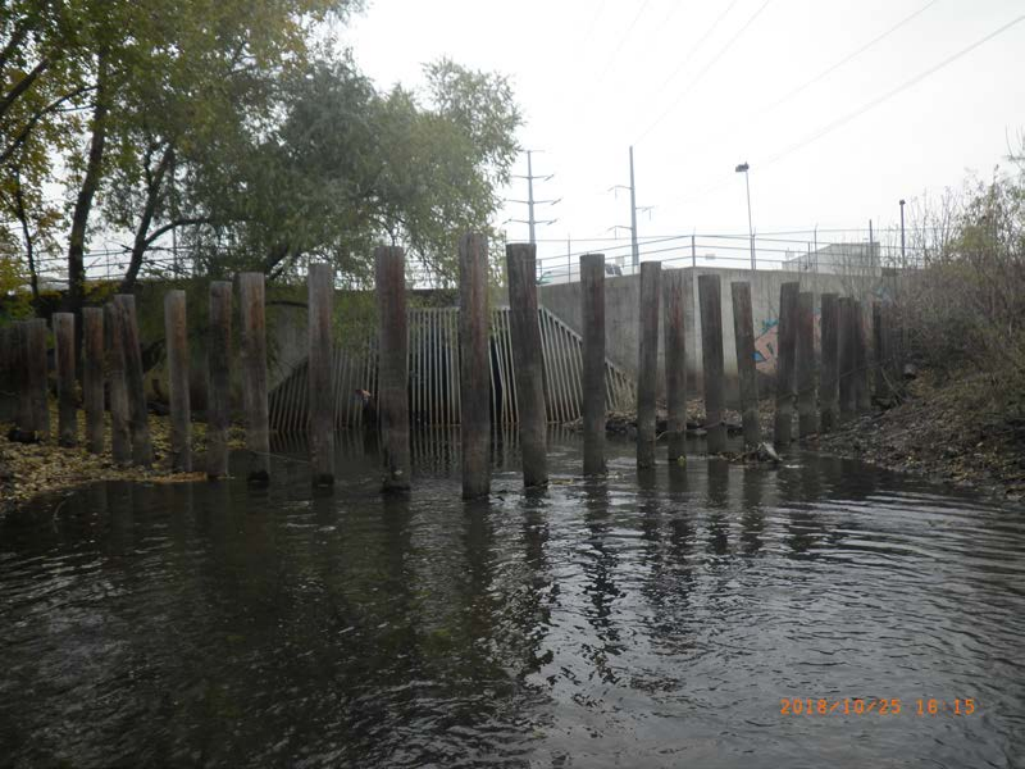
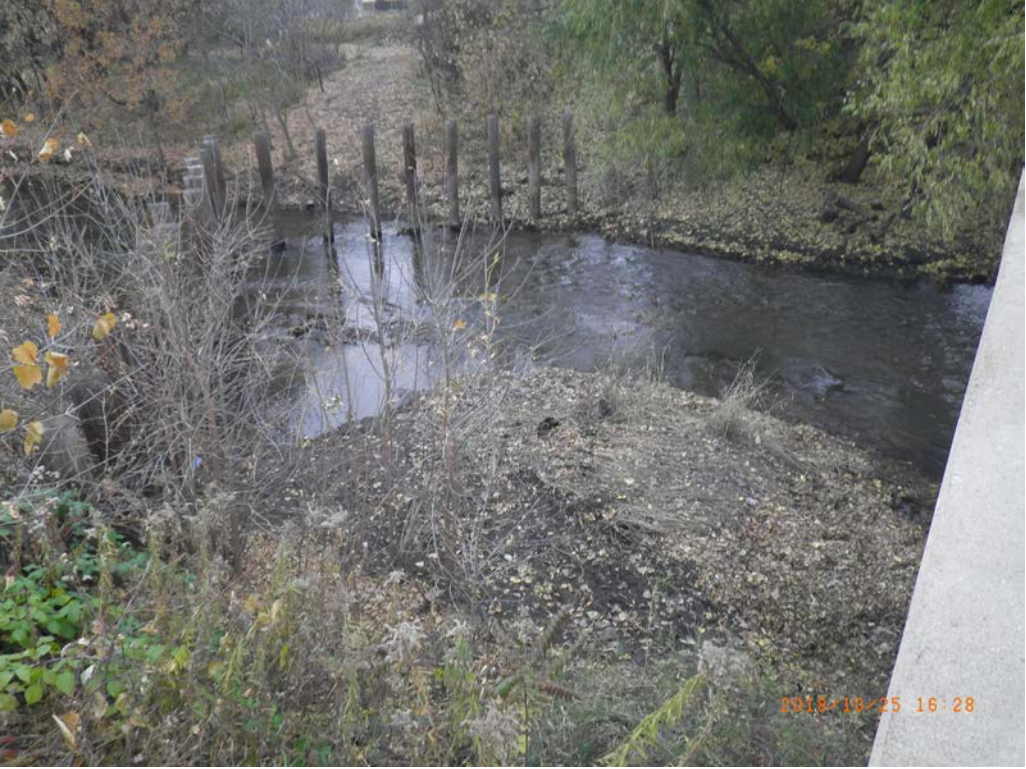
Debris Barrier (Minneapolis)

- a. The debris barrier appeared to be in satisfactory condition.
- b. The cable was missing or broken in the center portion of the channel. The cable should extend from end to end, attached at each post.

- Repair or replace the steel cable on debris barrier.

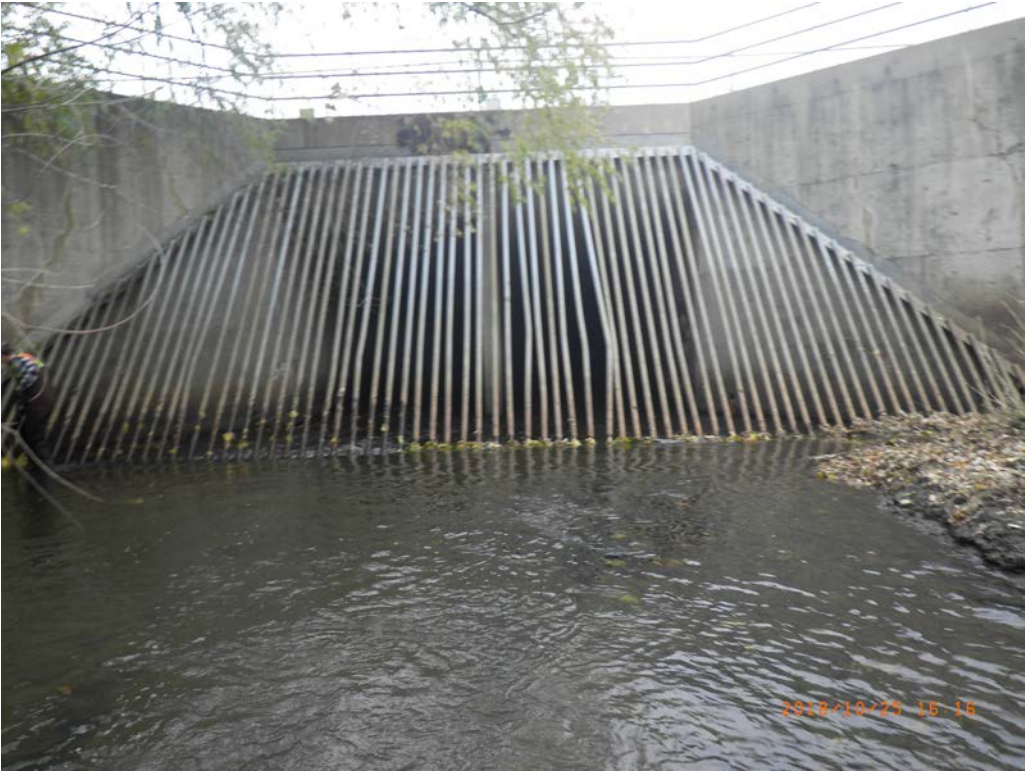
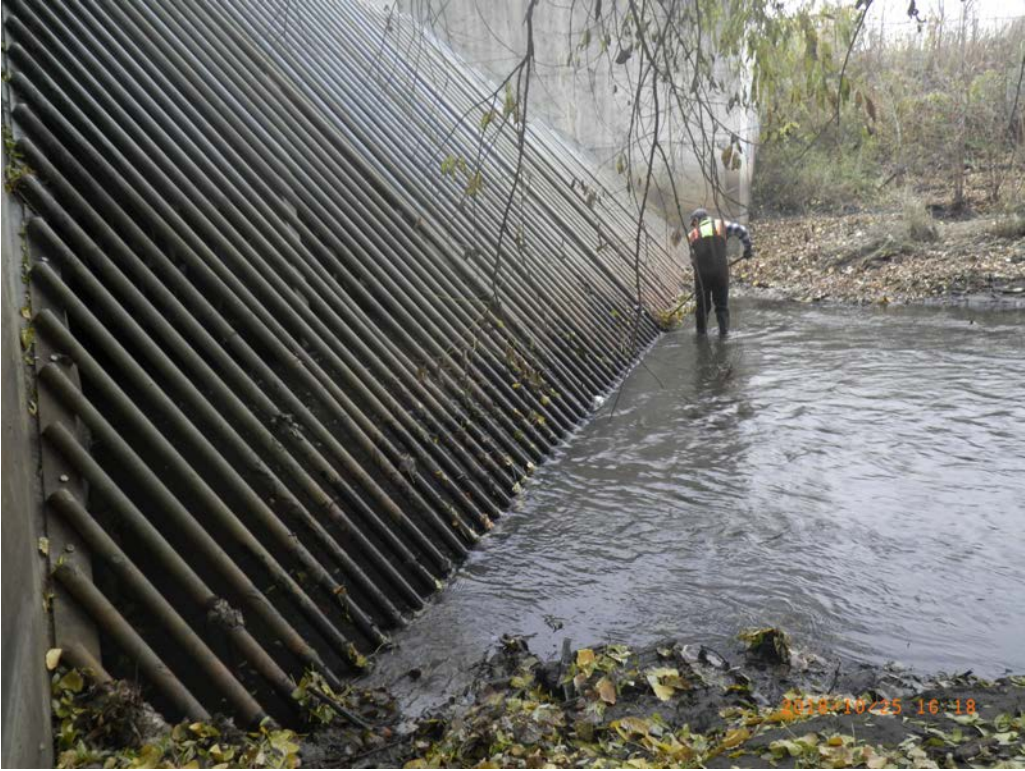
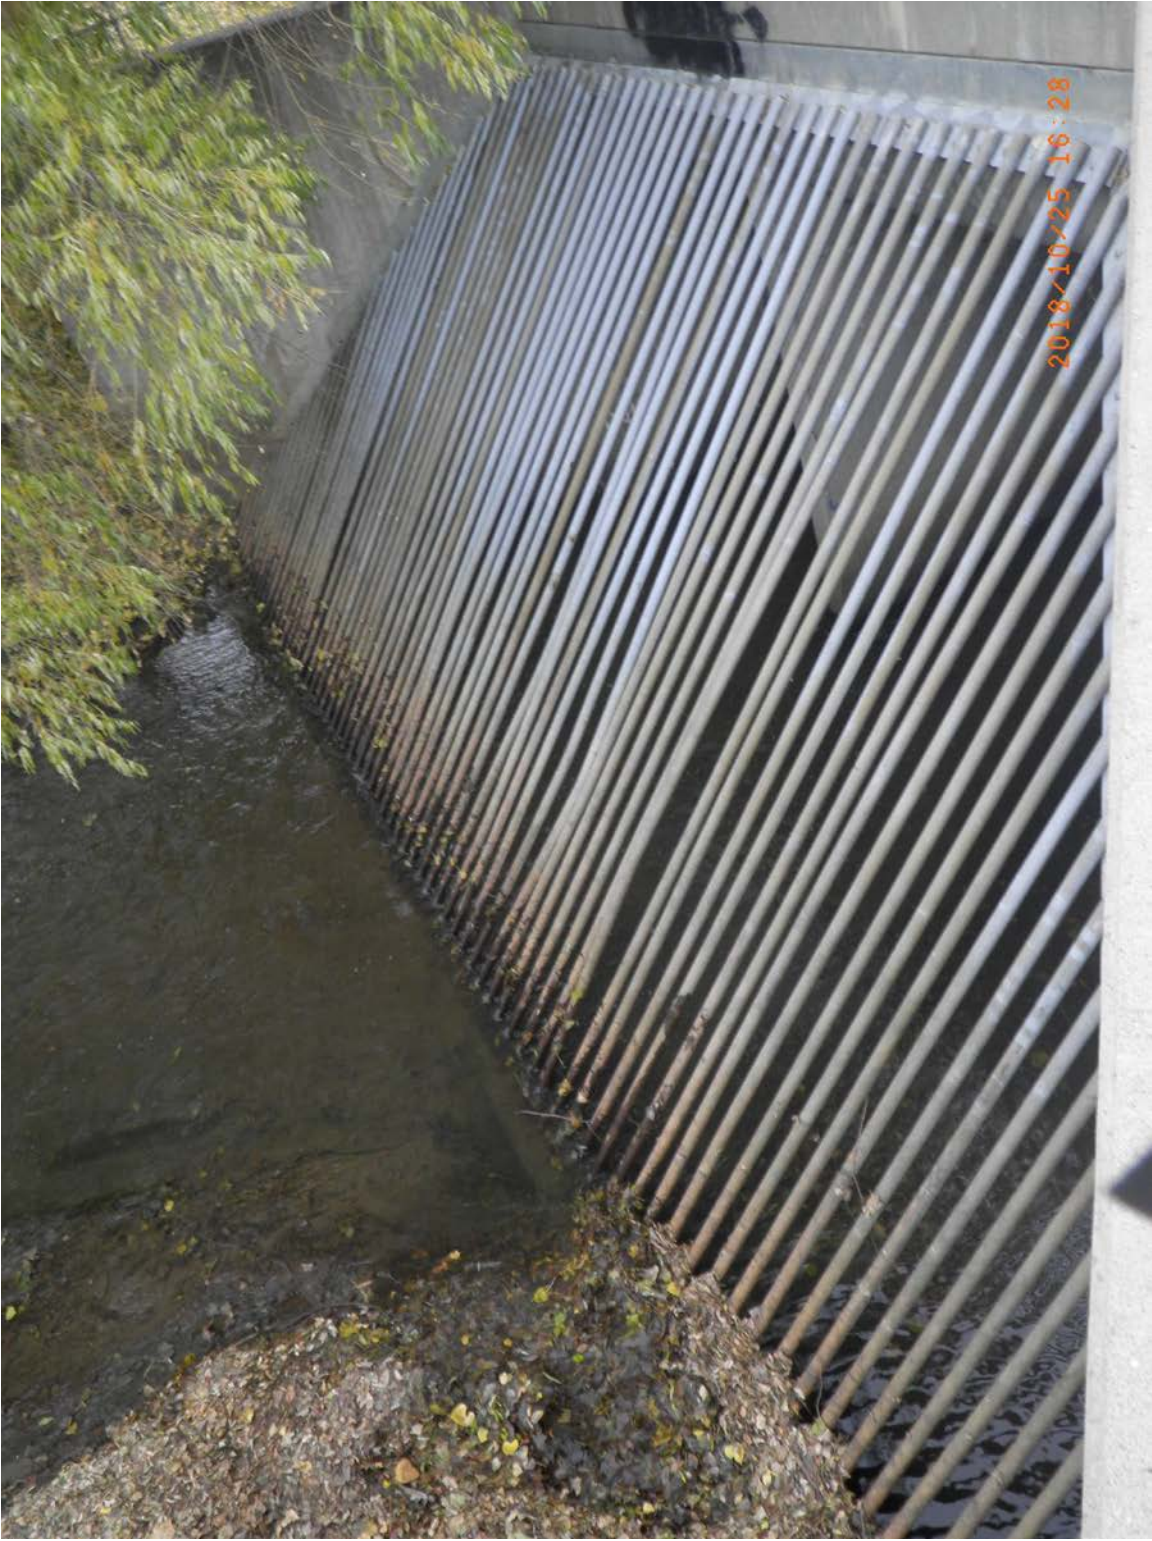
Inlet Structure (Minneapolis)

- a. The concrete inlet structure appeared to be in satisfactory condition.
- b. Vertical cracks were observed in the concrete on either side of the structure.
- c. Cracks were observed near where the handrail posts are embedded.
- d. The railings and vertical bars appeared to be in satisfactory condition.
- e. The inlet structure had recently been cleared of debris.

- Monitor for debris and clear as needed.
- Monitor cracks in the concrete inlet structure.
