Bassett Creek 3rd Avenue and 2nd Street Tunnel Inspection Report

Prepared for
Bassett Creek Watershed Management Commission

Inspection Date: October 2020

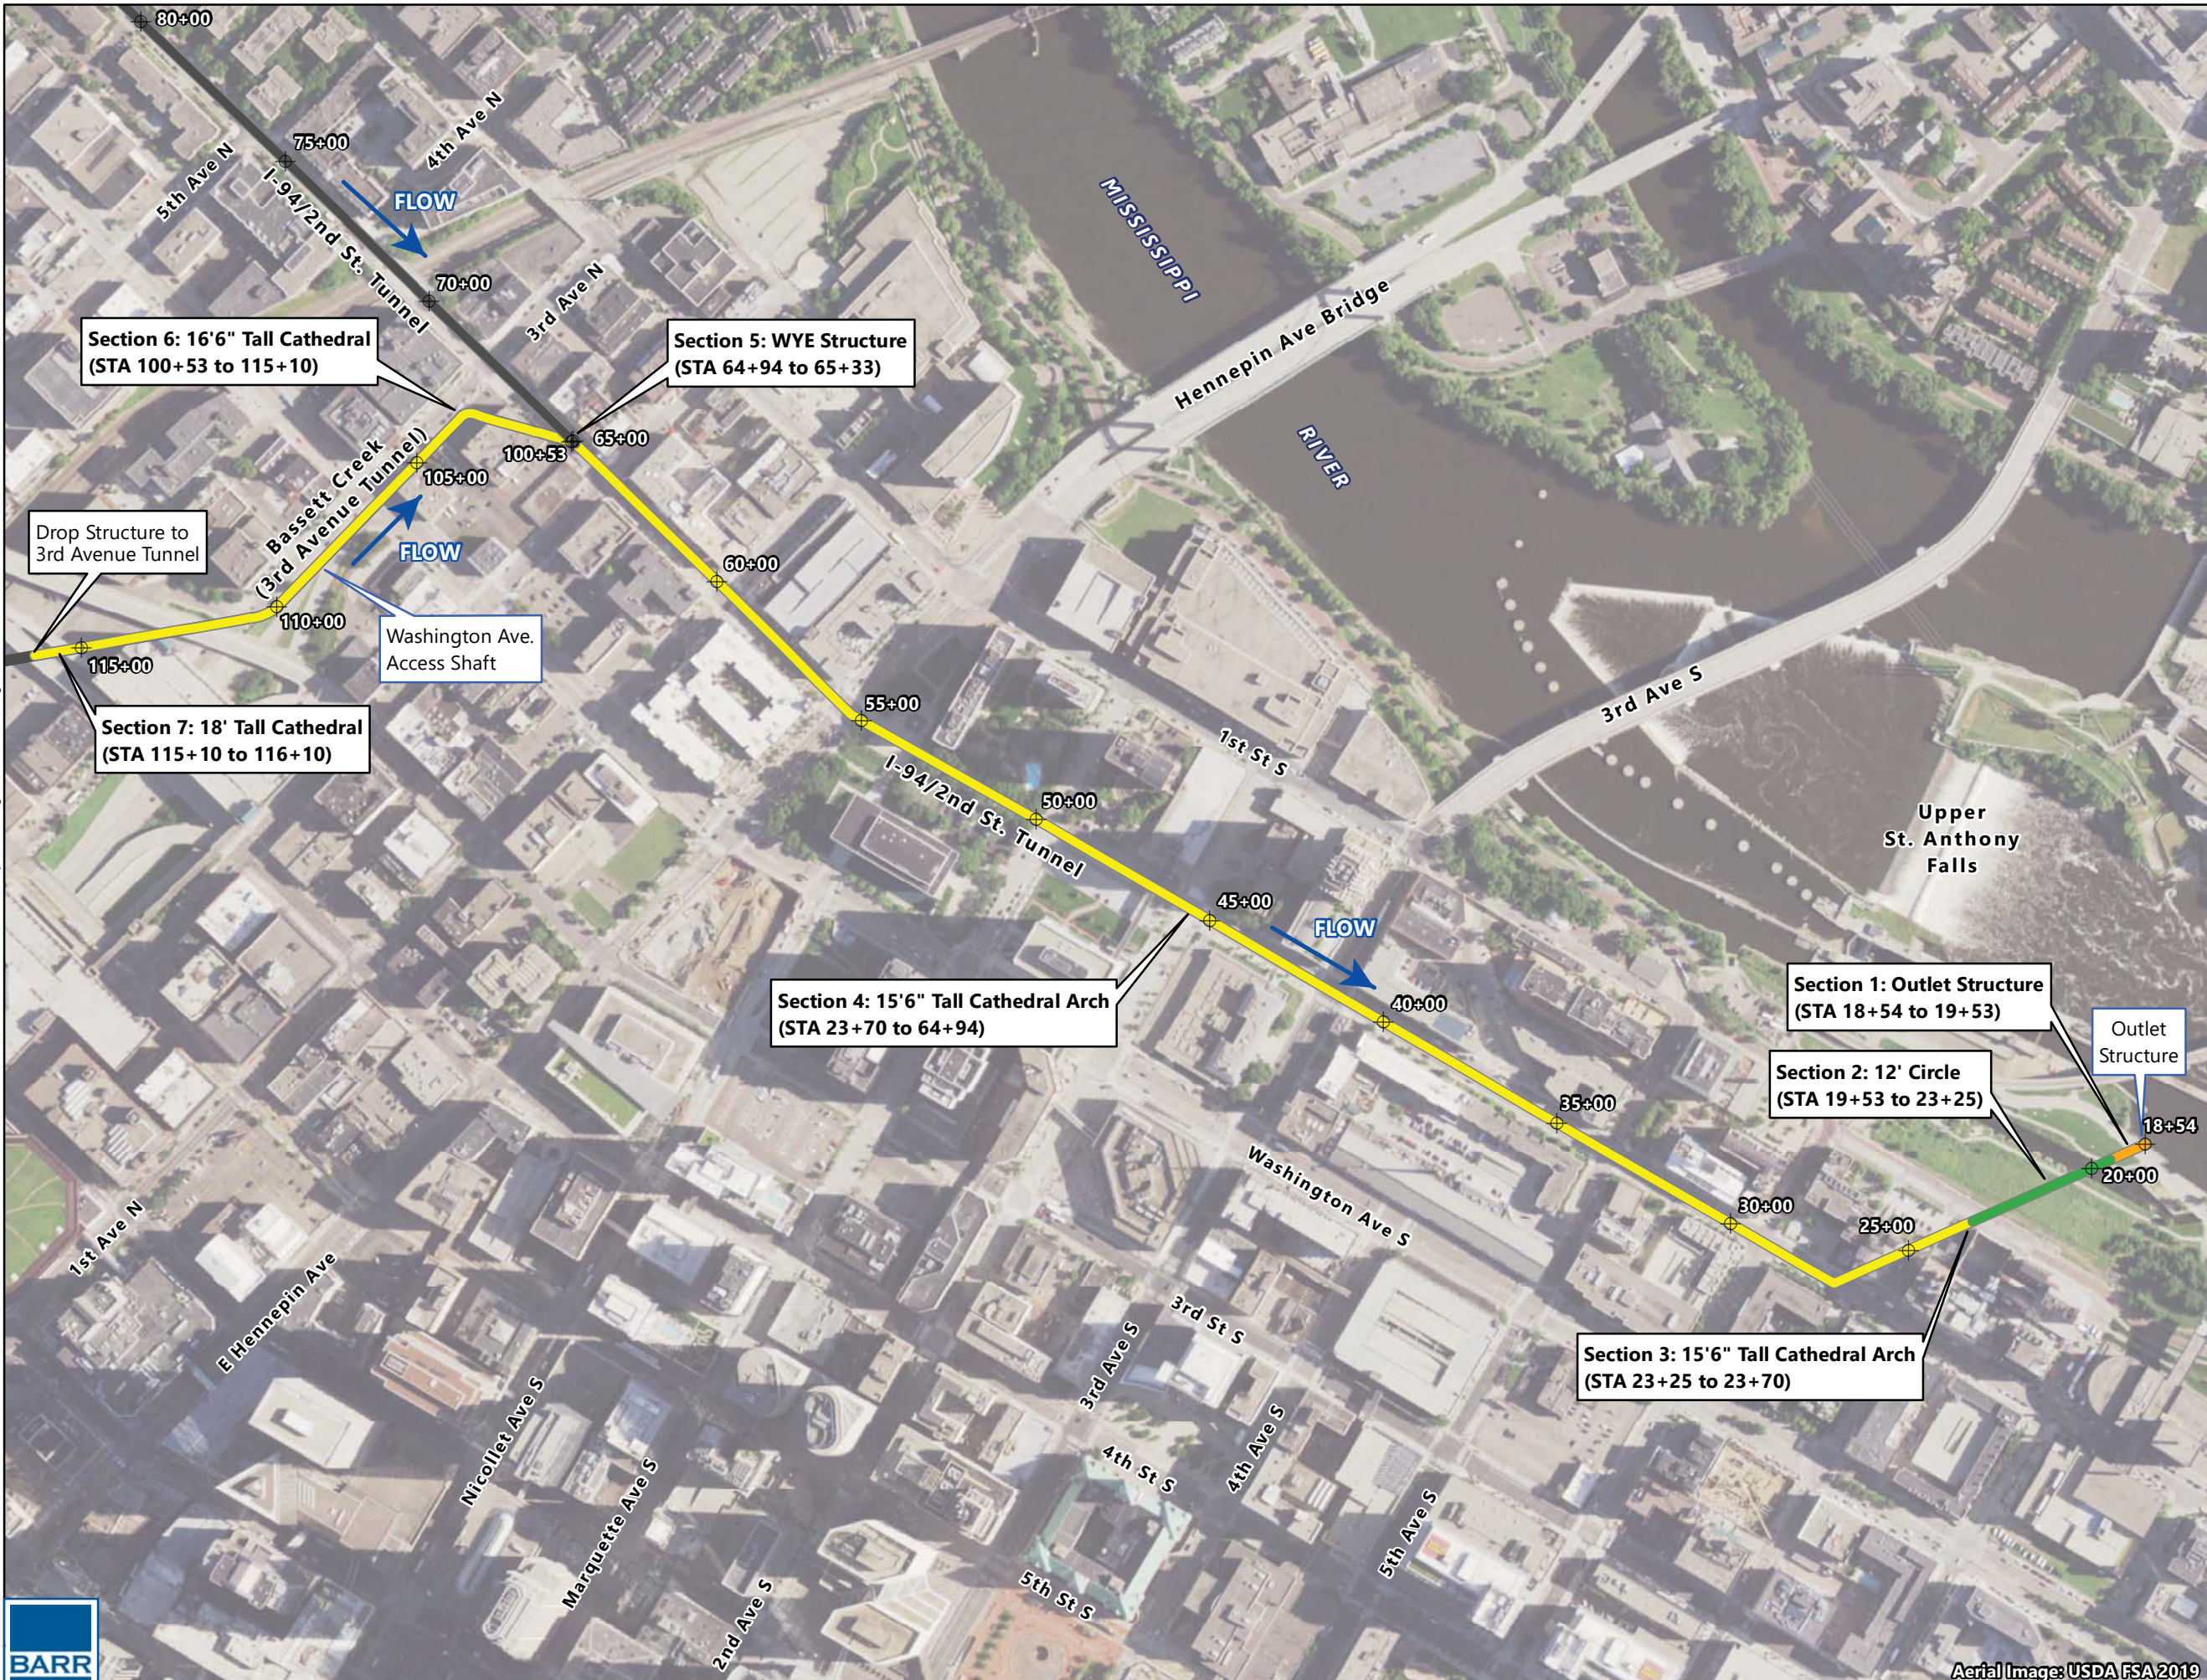
Table 5-1 provides a summary of the quantity of defects sorted by grade, as well as the O&M and Structural rating for each tunnel cross section. Figures that show the tunnel ratings graphically are included in Appendix E.

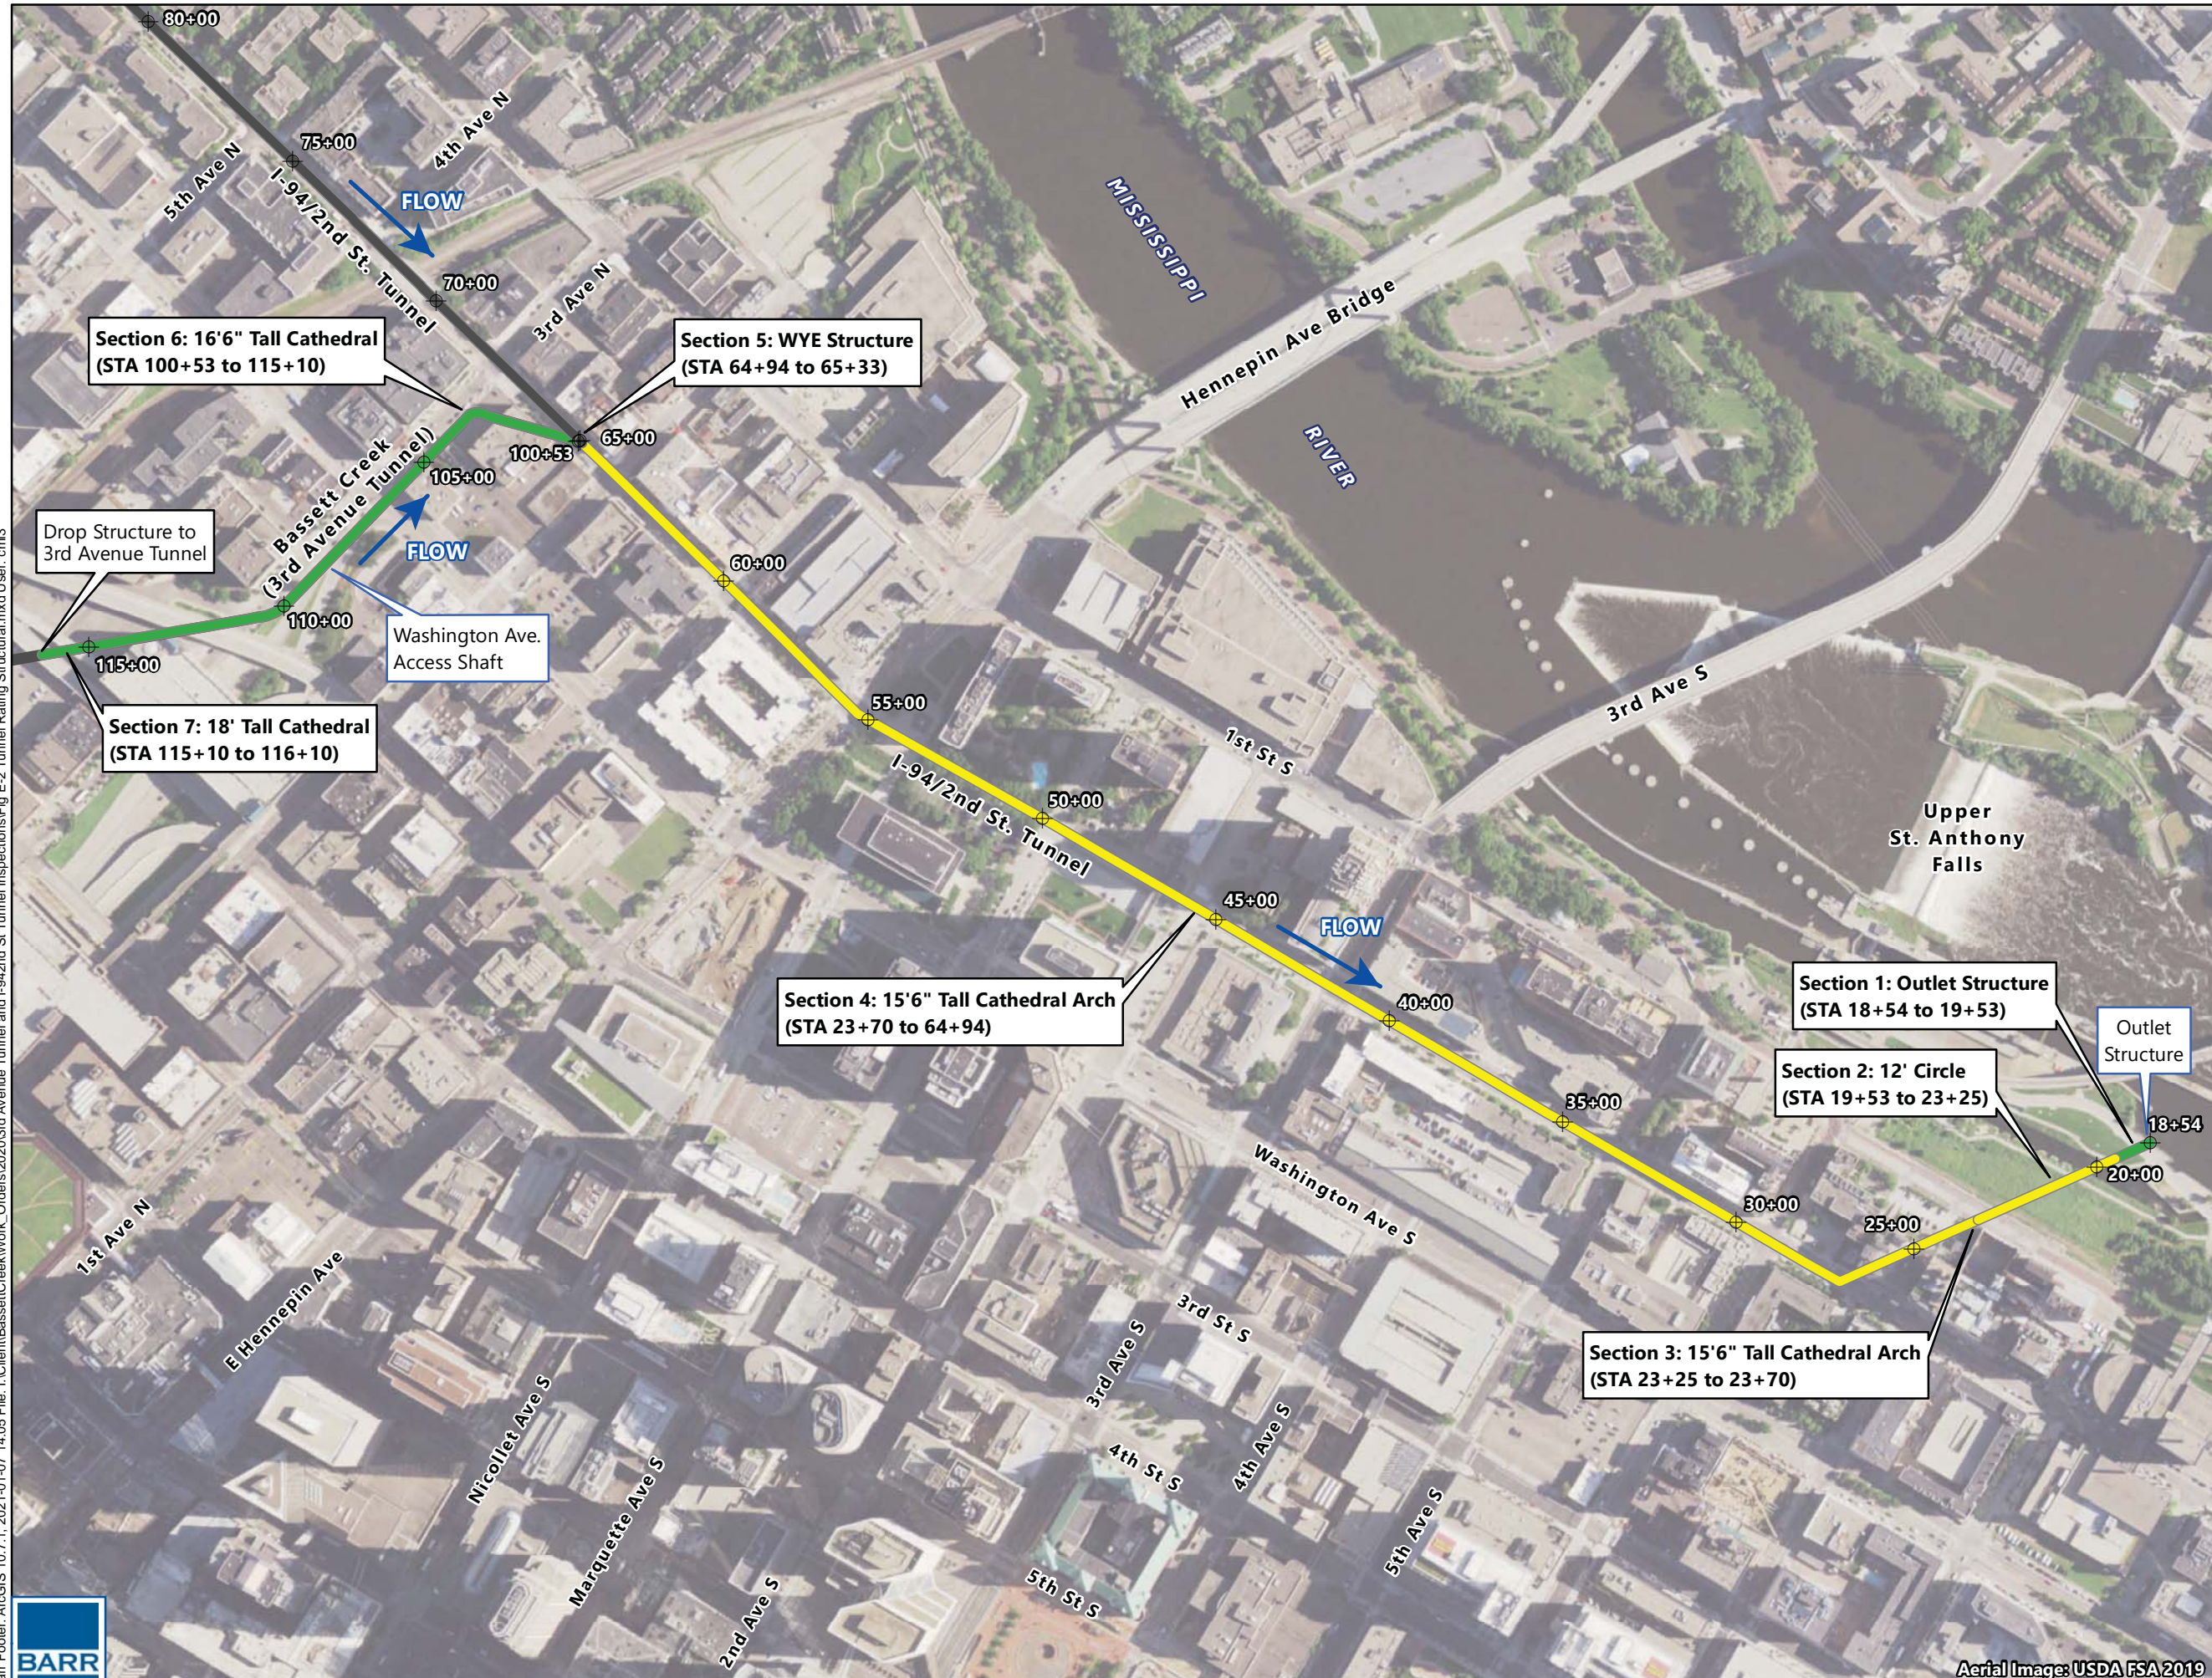
Table 5-2 provides a summary of the quantity of defects sorted by grade, as well as the O&M and Structural rating for each tunnel cross section. Figures that show the tunnel ratings graphically are included in Appendix E.
