Appendix A
Site Visit Photos

Plymouth Creek Restoration (2026 CR-P)

Plymouth Creek Restoration Project

Plymouth Creek Erosion Issues and Restoration Prioritization

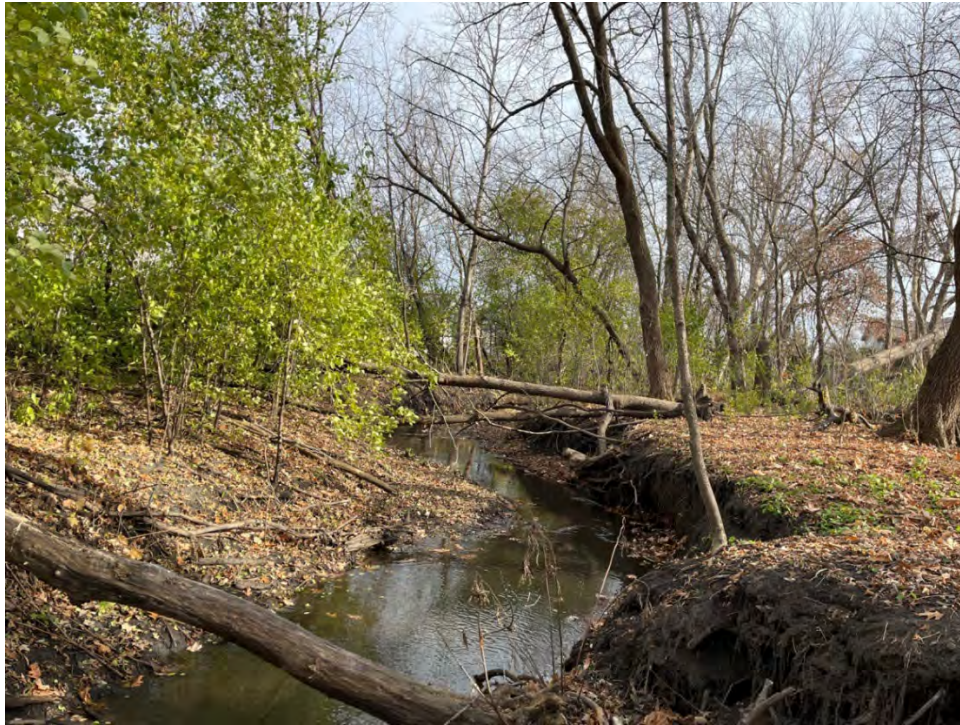
Photo 1 Site 1a. Looking downstream at the sinuous channel with bare banks with undercutting at station 1+50.

| Site Area Restoration | Severity of Existing Erosion ¹ | Creek Ownership | Riparian Ownership/Access for Stabilization ² | Riparian Ownership/Access for Vegetation Work ² | Ease of Construction Access ² | Protection of Existing Structures/ Infrastructure ² | Impact to Surrounding Areas ³ | Potential for Future Erosion (BEHI/NBS) ⁴ | Opportunity for Habitat Restoration (riparian/upland) Based on Proposes Stream Stabilization | Opportunity for Habitat Restoration (in channel) | Maintaining Healthy, Native Significant Trees ⁵ | Vegetation Establishment | Education Potential ⁶ | Count | Rank |
|--|---|---|--|--|--|--|--|--|--|--|--|---|---|---|---|
| 1a. Right and left bank stabilization with floodplain and channel realignment grading, rock toe, and vegetation establishment (Sta. 0+00 to 3+85) | 3 | 2 | 2 | 1 | 3 | 5 | 0 | 9 | 2 | 2 | 0 | 2 | 2 | 33 | High |

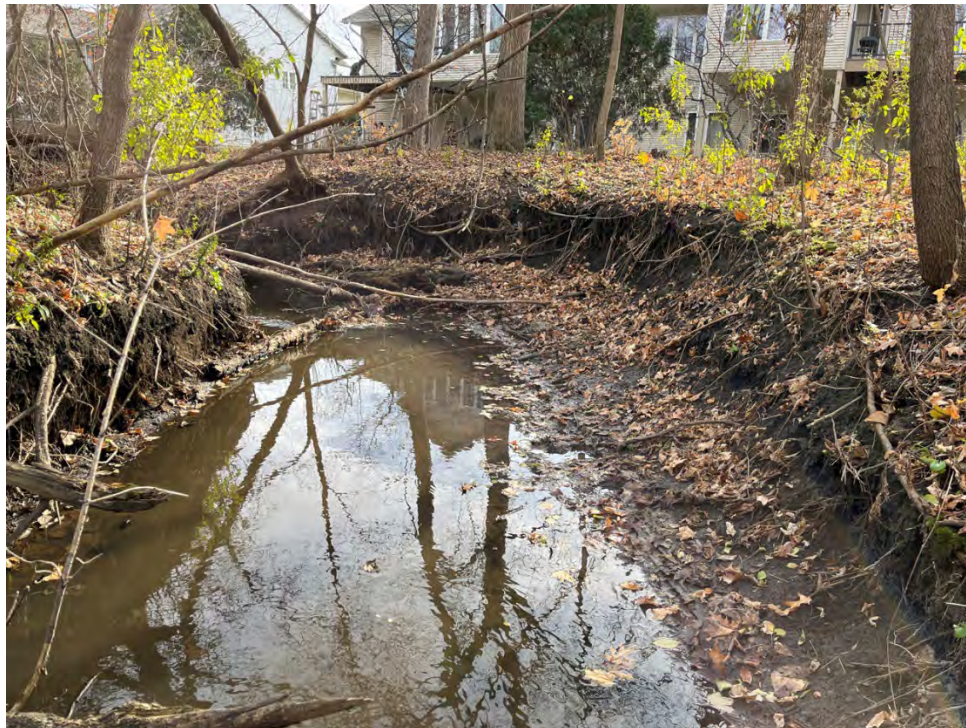
Photo 2: Site 1a. Looking downstream at station 2+75. The left bank is bare at a vertical angle, while the right bank is angled and has a soil material change at the bottom foot of the bank.

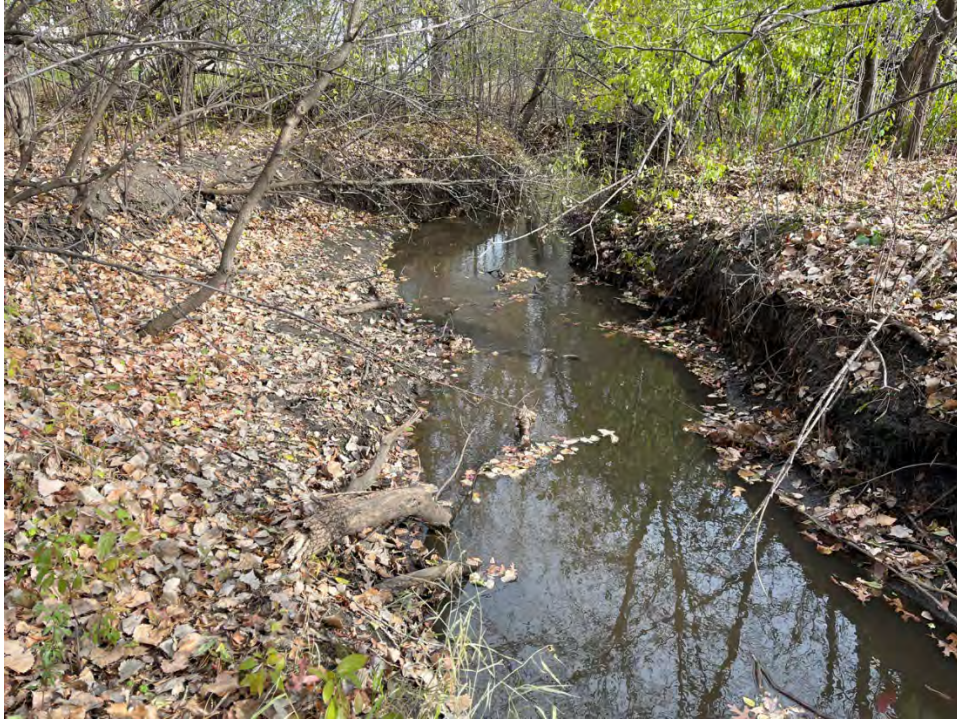
Photo 3: Site 1b. Looking downstream at sediment build up on left bank and bare right bank at station 4+60

| Site Area Restoration | Severity of Existing Erosion ¹ | Creek Ownership | Riparian Ownership/Access for Stabilization ² | Riparian Ownership/Access for Vegetation Work ² | Ease of Construction Access ² | Protection of Existing Structures/ Infrastructure ² | Impact to Surrounding Areas ³ | Potential for Future Erosion (BEHI/NBS) ⁴ | Opportunity for Habitat Restoration (riparian/upland) Based on Proposes Stream Stabilization | Opportunity for Habitat Restoration (in channel) | Maintaining Healthy, Native Significant Trees ⁵ | Vegetation Establishment | Education Potential ⁶ | Count | Rank |
|--|---|---|--|--|--|--|--|--|--|--|--|---|---|---|---|
| 1b. Right and left bank stabilization with rock toe, plantings, and VRSS (Sta. 3+85 to 6+05) | 3 | 2 | 1 | 1 | 3 | 15 | 0 | 4 | 2 | 0 | 2 | 2 | 2 | 37 | High |

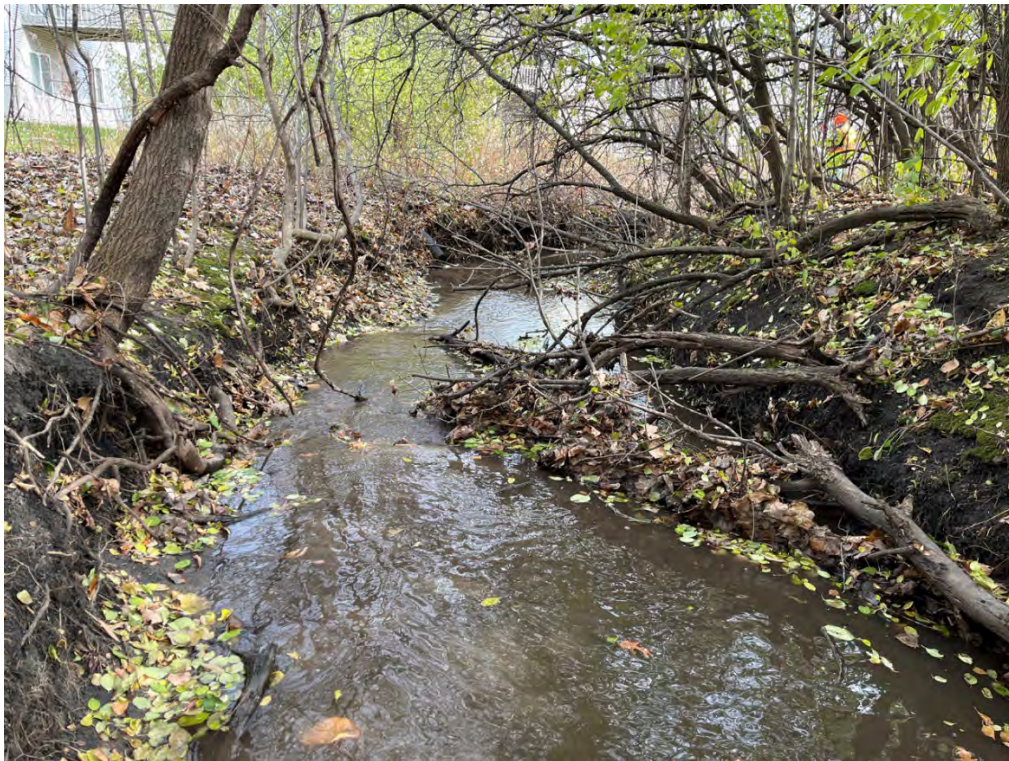
Photo 4: Site 1b. Looking downstream at station 5+00, both banks have tree roots present.

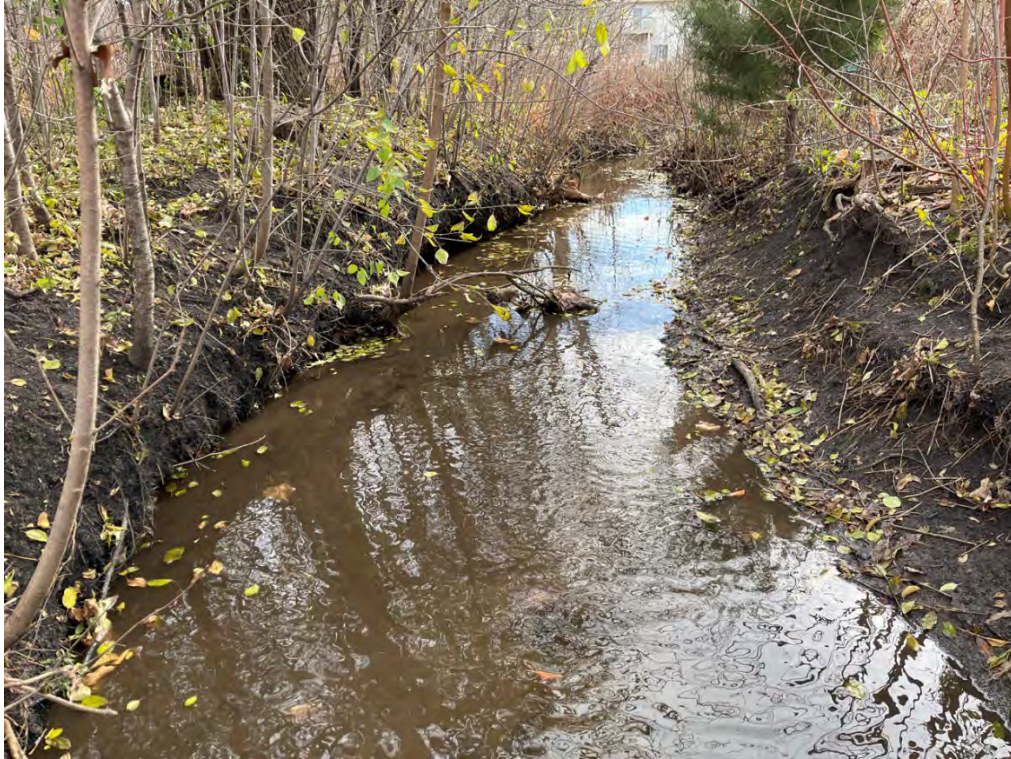
Photo 5: Site 1c. Looking downstream at station 6+40, slight undercut for left bank and slumping on the right bank.

| Site Area Restoration | Severity of Existing Erosion ¹ | Creek Ownership | Riparian Ownership/Access for Stabilization ² | Riparian Ownership/Access for Vegetation Work ² | Ease of Construction Access ² | Protection of Existing Structures/ Infrastructure ² | Impact to Surrounding Areas ³ | Potential for Future Erosion (BEHI/NBS) ⁴ | Opportunity for Habitat Restoration (riparian/upland) Based on Proposes Stream Stabilization | Opportunity for Habitat Restoration (in channel) | Maintaining Healthy, Native Significant Trees ⁵ | Vegetation Establishment | Education Potential ⁶ | Count | Rank |
|--|---|---|--|--|--|--|--|--|--|--|--|---|---|---|---|
| 1c. Right bank stabilization with grading and plantings (Sta. 6+05 to 7+05) | 2 | 3 | 2 | 1 | 3 | 5 | 0 | 3 | 2 | 0 | 2 | 2 | 2 | 27 | Medium |

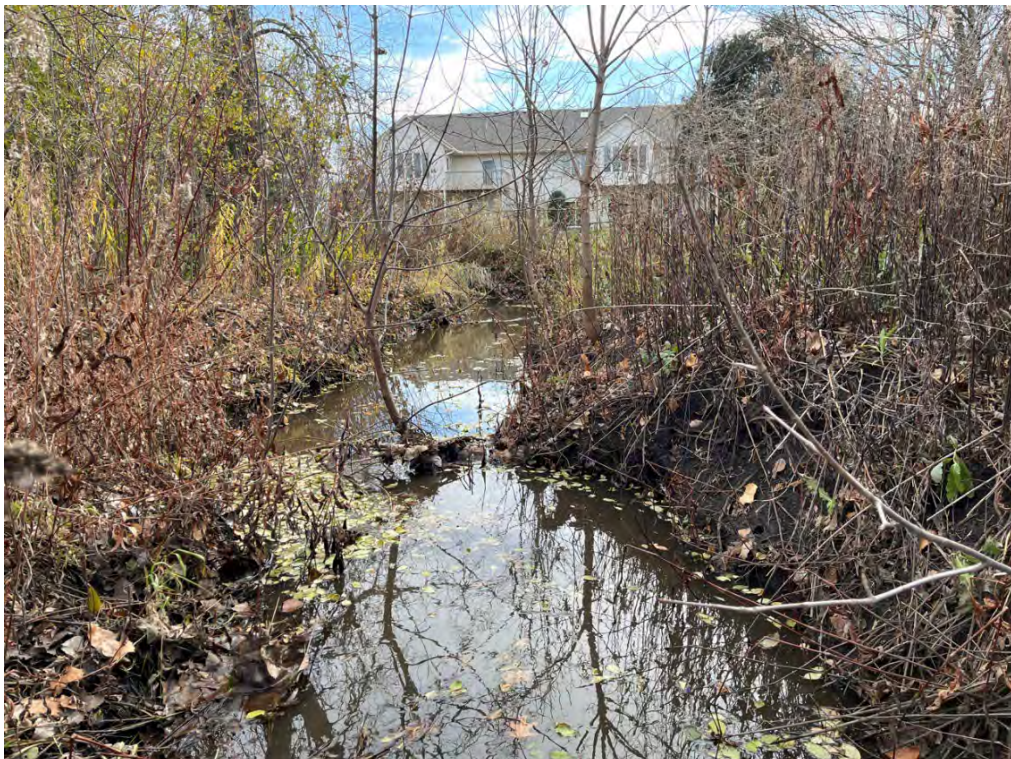
Photo 6: Site 1d. Looking downstream at the straight channel segment at station 7+20.

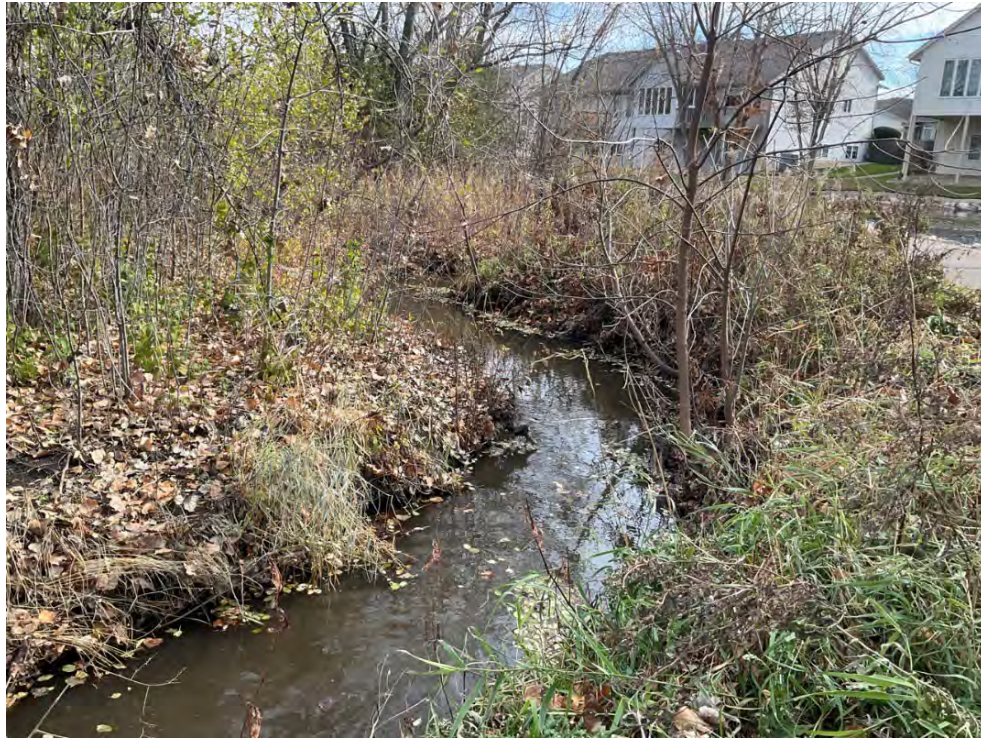
Photo 7: Site 1d. Looking downstream at station 7+75, the right bank is eroding due to a sharp turn and could encroach on the trail.

| Site Area Restoration | Severity of Existing Erosion ¹ | Creek Ownership | Riparian Ownership/Access for Stabilization ² | Riparian Ownership/Access for Vegetation Work ² | Ease of Construction Access ² | Protection of Existing Structures/ Infrastructure ² | Impact to Surrounding Areas ³ | Potential for Future Erosion (BEHI/NBS) ⁴ | Opportunity for Habitat Restoration (riparian/upland) Based on Proposes Stream Stabilization | Opportunity for Habitat Restoration (in channel) | Maintaining Healthy, Native Significant Trees ⁵ | Vegetation Establishment | Education Potential ⁶ | Count | Rank |
|--|---|---|--|--|--|--|--|--|--|--|--|---|---|---|---|
| 1d. Right bank stabilization with rock toe and VRSS (Sta. 7+05 to 8+90) | 1 | 3 | 3 | 1 | 0 | 5 | 0 | 2 | 2 | 0 | 2 | 2 | 2 | 23 | Medium |

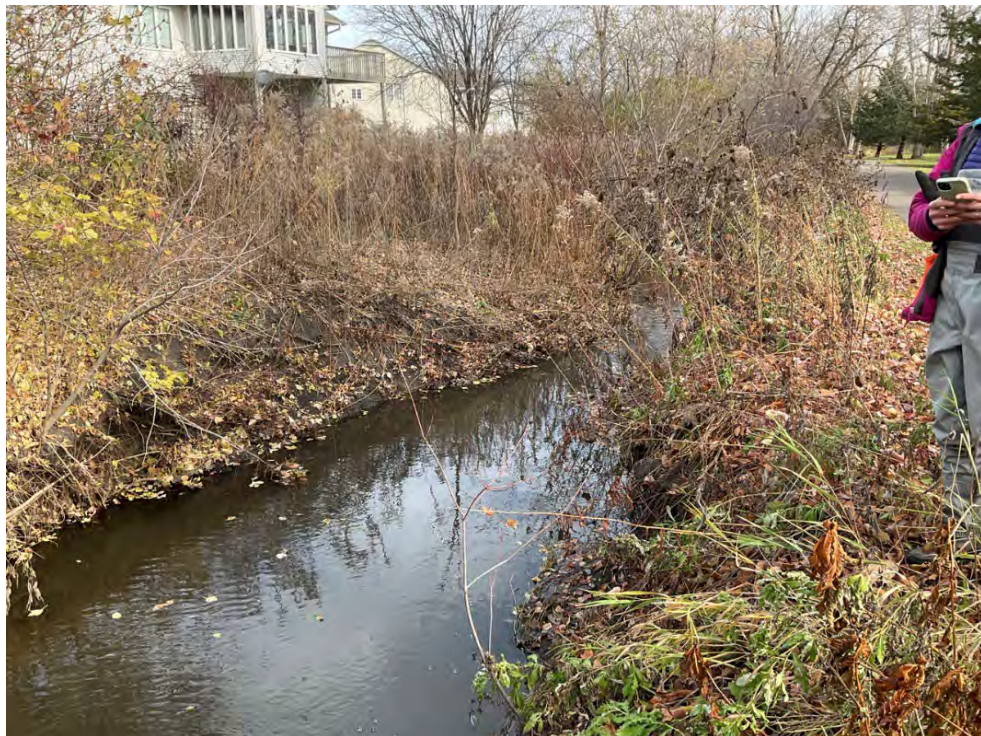
Photo 8: Site 1e. Looking downstream at station 9+25, the left bank is angled and bare while the right bank is vertical with spotty plant coverage.

| Site Area Restoration | Severity of Existing Erosion ¹ | Creek Ownership | Riparian Ownership/Access for Stabilization ² | Riparian Ownership/Access for Vegetation Work ² | Ease of Construction Access ² | Protection of Existing Structures/ Infrastructure ² | Impact to Surrounding Areas ³ | Potential for Future Erosion (BEHI/NBS) ⁴ | Opportunity for Habitat Restoration (riparian/upland) Based on Proposes Stream Stabilization | Opportunity for Habitat Restoration (in channel) | Maintaining Healthy, Native Significant Trees ⁵ | Vegetation Establishment | Education Potential ⁶ | Count | Rank |
|--|---|---|--|--|--|--|--|--|--|--|--|---|---|---|---|
| 1e. Right and left bank stabilization with rock toe, VRSS, plantings and cross vane (Sta. 9+10 to 10+20) | 2 | 3 | 2 | 1 | 0 | 5 | 0 | 3 | 2 | 2 | 2 | 2 | 2 | 26 | Medium |

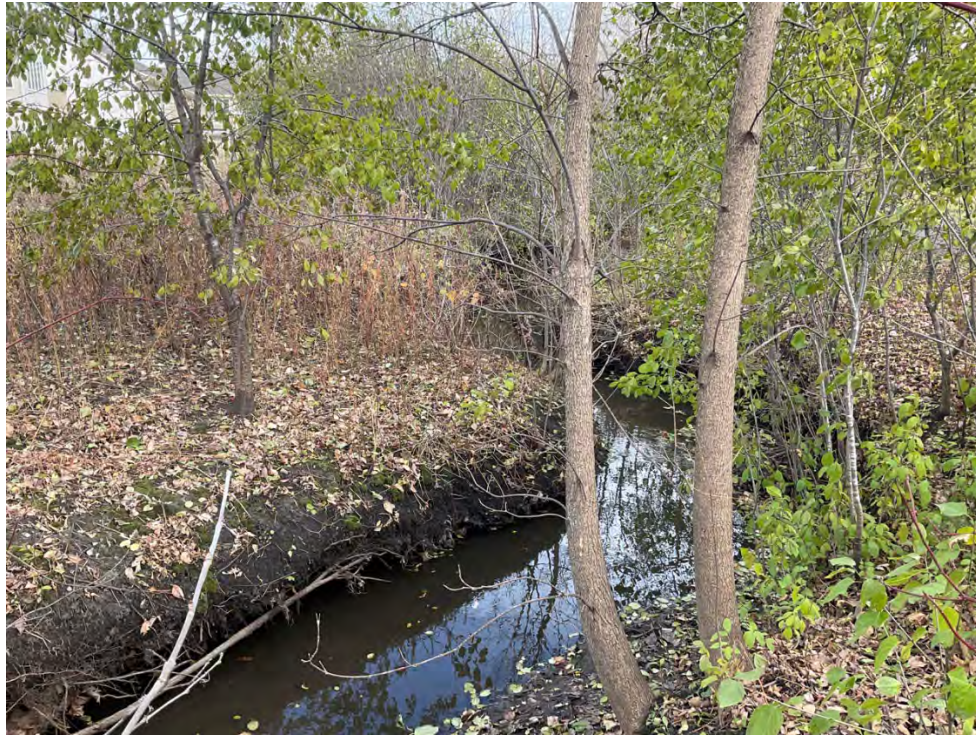
Photo 9: Site 1f. The creek begins to become more sinuous at station 11+40 and the left bank has undercut.

| Site Area Restoration | Severity of Existing Erosion ¹ | Creek Ownership | Riparian Ownership/Access for Stabilization ² | Riparian Ownership/Access for Vegetation Work ² | Ease of Construction Access ² | Protection of Existing Structures/ Infrastructure ² | Impact to Surrounding Areas ³ | Potential for Future Erosion (BEHI/NBS) ⁴ | Opportunity for Habitat Restoration (riparian/upland) Based on Proposes Stream Stabilization | Opportunity for Habitat Restoration (in channel) | Maintaining Healthy, Native Significant Trees ⁵ | Vegetation Establishment | Education Potential ⁶ | Count | Rank |
|--|---|---|--|--|--|--|--|--|--|--|--|---|---|---|---|
| 1f. Right and left bank stabilization with coir logs, grading, and plantings (Sta. 10+20 to 13+55) | 3 | 3 | 2 | 1 | 0 | 5 | 0 | 7 | 2 | 0 | 0 | 2 | 2 | 27 | Medium |

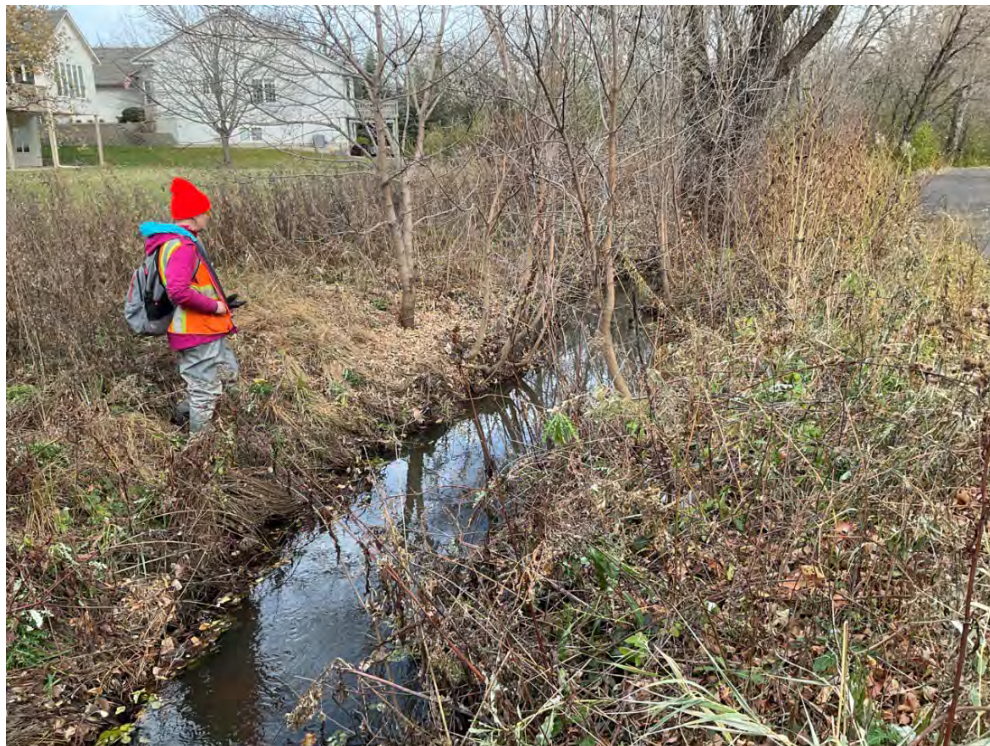
Photo 10: Site 1f. Looking downstream at station 12+50, low bank on left side, higher bank on right side, plant cover is intermittent.

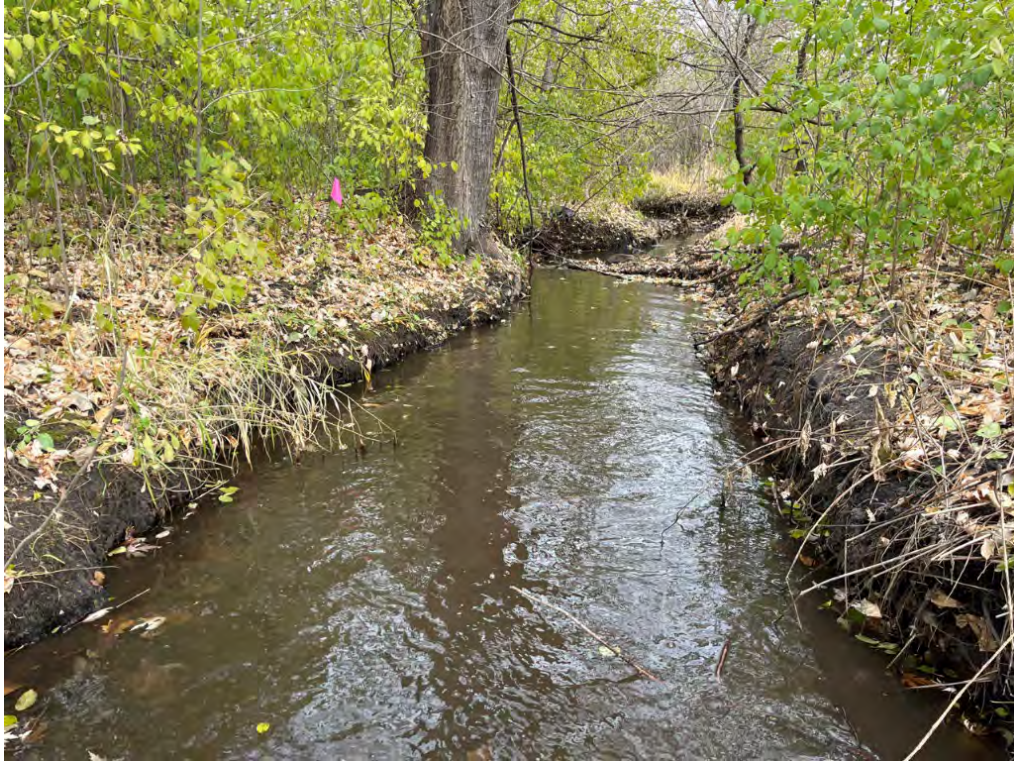
Photo 11: Site 1g. Looking downstream at station 14+00, both banks are low with some undercutting.

| Site Area Restoration | Severity of Existing Erosion ¹ | Creek Ownership | Riparian Ownership/Access for Stabilization ² | Riparian Ownership/Access for Vegetation Work ² | Ease of Construction Access ² | Protection of Existing Structures/ Infrastructure ² | Impact to Surrounding Areas ³ | Potential for Future Erosion (BEHI/NBS) ⁴ | Opportunity for Habitat Restoration (riparian/upland) Based on Proposes Stream Stabilization | Opportunity for Habitat Restoration (in channel) | Maintaining Healthy, Native Significant Trees ⁵ | Vegetation Establishment | Education Potential ⁶ | Count | Rank |
|--|---|---|--|--|--|--|--|--|--|--|--|---|---|---|---|
| 1g. Right and left bank stabilization with channel realignment, cross vanes, and plantings (Sta. 13+55 to 15+35) | 3 | 3 | 2 | 3 | 3 | 15 | 0 | 9 | 2 | 2 | 2 | 2 | 2 | 48 | High |

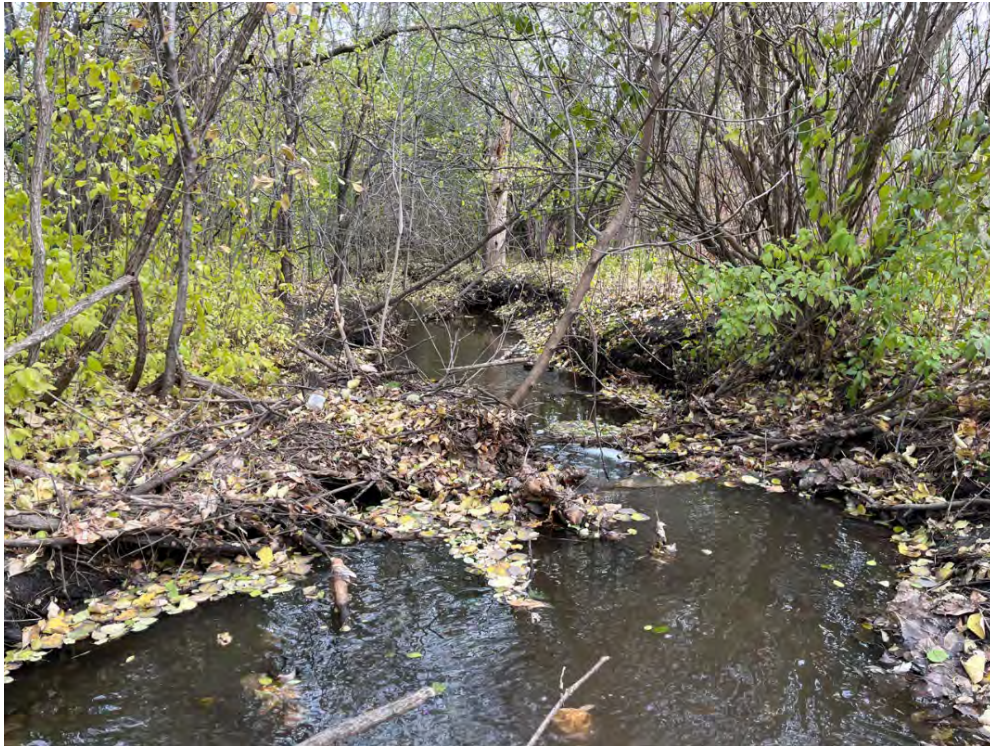
Photo 12: Site 1g. Looking downstream at station 15+10, multiple outlets enter this location and could contribute to the eroding banks.

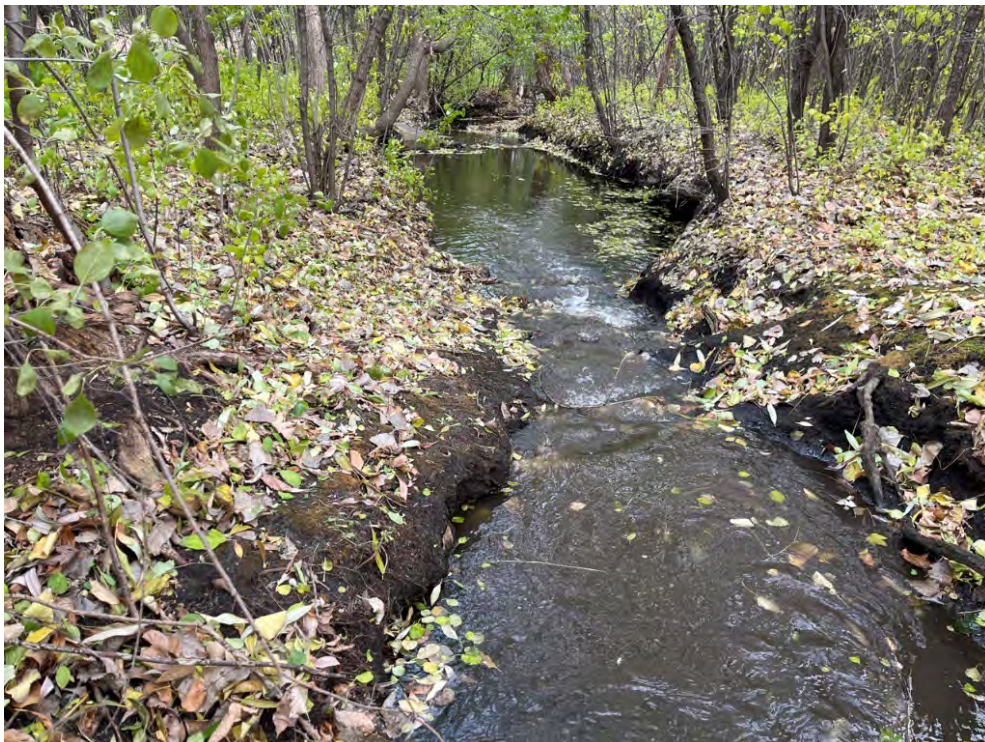
Photo 13: Site 1h. Looking downstream at station 16+00, upstream of a large pool that is at least 6 feet deep.

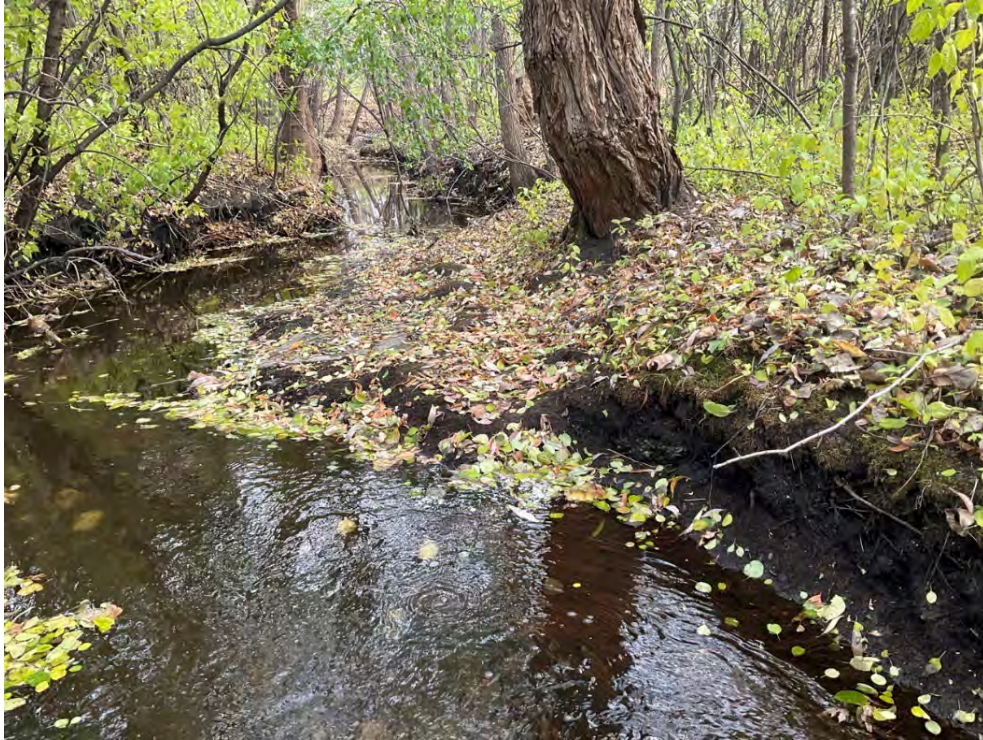
Photo 14: Site 1h. Looking downstream at station 16+80, the channel becomes sinuous and sediment deposition has occurred on the right bank.

| Site Area Restoration | Severity of Existing Erosion ¹ | Creek Ownership | Riparian Ownership/Access for Stabilization ² | Riparian Ownership/Access for Vegetation Work ² | Ease of Construction Access ² | Protection of Existing Structures/ Infrastructure ² | Impact to Surrounding Areas ³ | Potential for Future Erosion (BEHI/NBS) ⁴ | Opportunity for Habitat Restoration (riparian/upland) Based on Proposes Stream Stabilization | Opportunity for Habitat Restoration (in channel) | Maintaining Healthy, Native Significant Trees ⁵ | Vegetation Establishment | Education Potential ⁶ | Count | Rank |
|--|---|---|--|--|--|--|--|--|--|--|--|---|---|---|---|
| 1h. Right and left bank stabilization with rock toe, vegetation, and j-hooks (Sta. 15+35 to 18+30) | 3 | 2 | 2 | 2 | 3 | 0 | 0 | 4 | 2 | 2 | 0 | 2 | 0 | 22 | Medium |

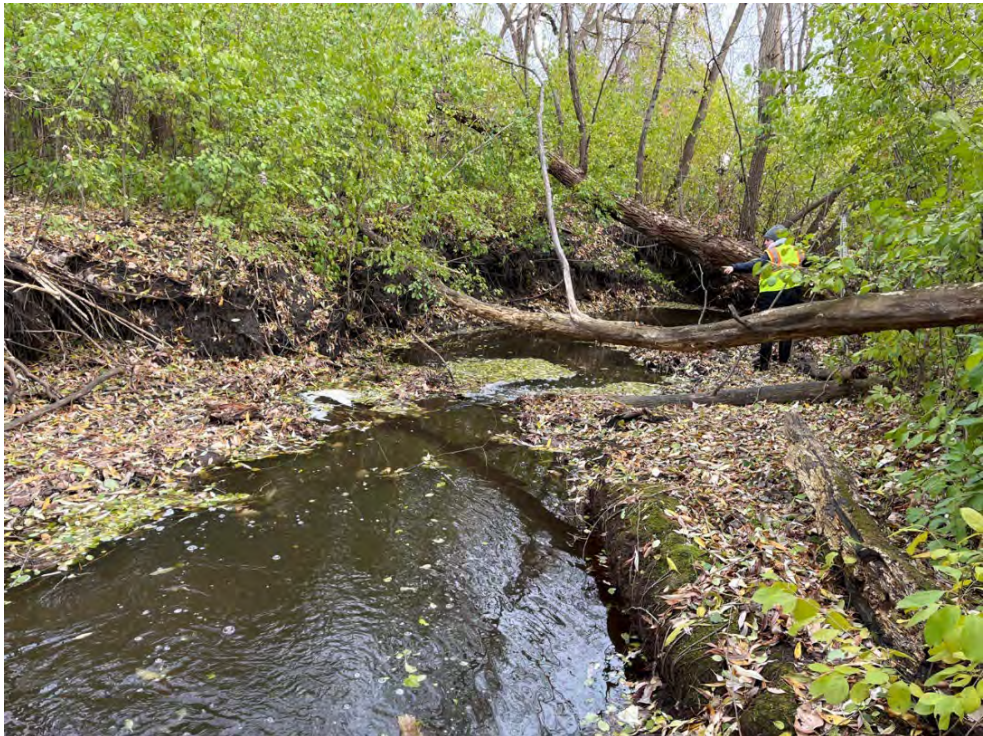
Photo 15: Site 2a. Looking downstream at station 19+20, this location is downstream of an outlet; flows with high exit velocities are eroding the left bank.

| Site Area Restoration | Severity of Existing Erosion ¹ | Creek Ownership | Riparian Ownership/Access for Stabilization ² | Riparian Ownership/Access for Vegetation Work ² | Ease of Construction Access ² | Protection of Existing Structures/ Infrastructure ² | Impact to Surrounding Areas ³ | Potential for Future Erosion (BEHI/NBS) ⁴ | Opportunity for Habitat Restoration (riparian/upland) Based on Proposes Stream Stabilization | Opportunity for Habitat Restoration (in channel) | Maintaining Healthy, Native Significant Trees ⁵ | Vegetation Establishment | Education Potential ⁶ | Count | Rank |
|--|---|---|--|--|--|--|--|--|--|--|--|---|---|---|---|
| 2a. Right and left bank stabilization with rock toe, cross vanes, j-hook, and vegetation establishment (Sta. 18+70 to 21+00) | 3 | 2 | 2 | 2 | 3 | 0 | 0 | 4 | 2 | 2 | 0 | 2 | 0 | 22 | Medium |

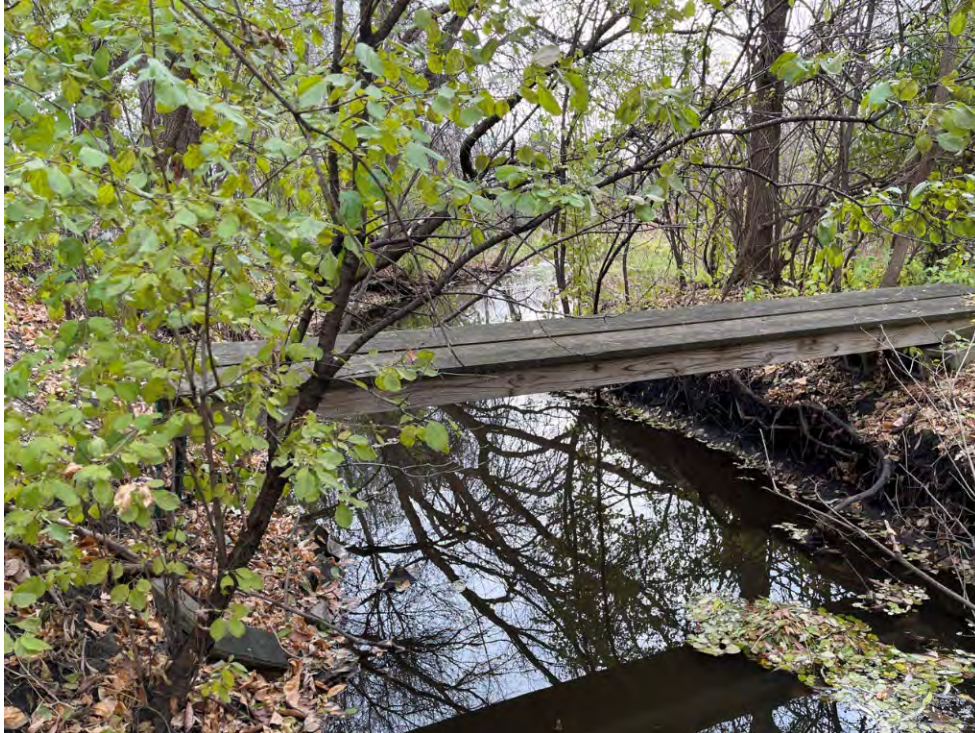
Photo 16: Site 2a. Looking downstream at station 20+30, the right bank is bare and vertical. There are two footbridges in this vicinity.

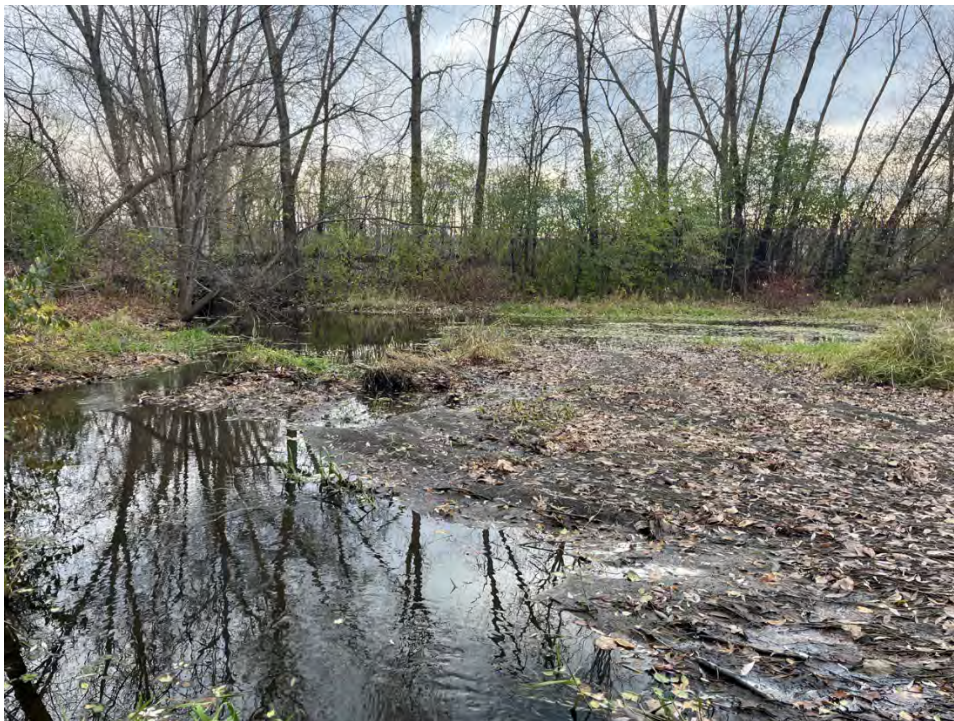
Photo 17: Site 2b. Looking downstream at station at 22+00, there is a buildup of sediment in the channel that is approximately 40 feet by 100 feet in area.

| Site Area Restoration | Severity of Existing Erosion ¹ | Creek Ownership | Riparian Ownership/Access for Stabilization ² | Riparian Ownership/Access for Vegetation Work ² | Ease of Construction Access ² | Protection of Existing Structures/ Infrastructure ² | Impact to Surrounding Areas ³ | Potential for Future Erosion (BEHI/NBS) ⁴ | Opportunity for Habitat Restoration (riparian/upland) Based on Proposes Stream Stabilization | Opportunity for Habitat Restoration (in channel) | Maintaining Healthy, Native Significant Trees ⁵ | Vegetation Establishment | Education Potential ⁶ | Count | Rank |
|--|---|---|--|--|--|--|--|--|--|--|--|---|---|---|---|
| 2b. Grading to improve channel definition and improve settling capacity of basin (Sta. 21+00 to 23+30) | 0 | 2 | 2 | 2 | 0 | 0 | 0 | 1 | 0 | 0 | 2 | 0 | 0 | 9 | Low |

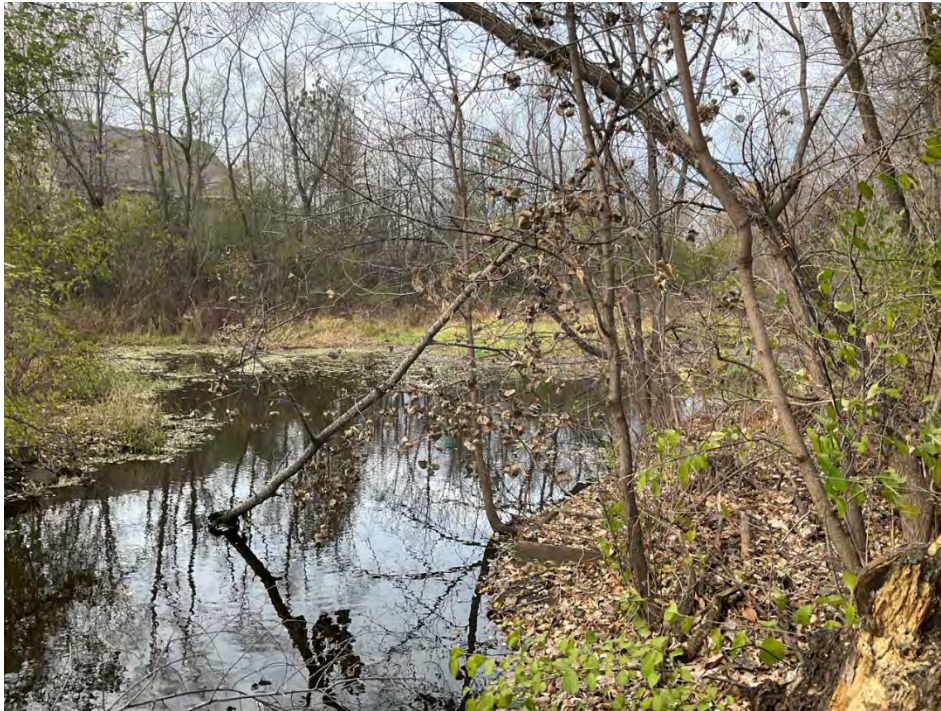
Photo 18: Site 2b. Looking upstream at 23+20. Roughly 40% of the channel width is filled in. Most of the sediment buildup is 1 foot above the water surface level, with a few locations reaching 2 feet higher than the water surface.

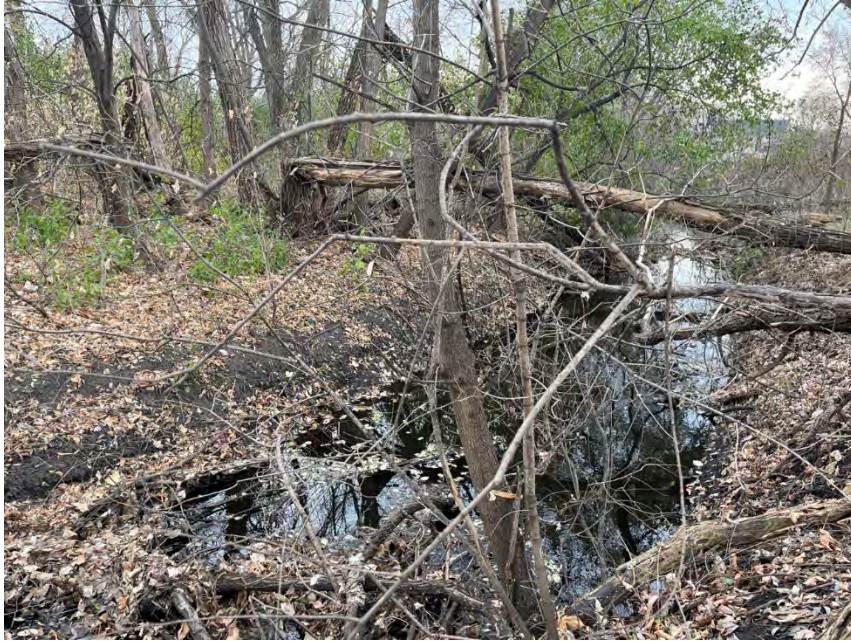
Photo 20: Site 2c. Looking downstream at station 24+80 with steep eroding banks and woody debris in the channel.

| Site Area Restoration | Severity of Existing Erosion ¹ | Creek Ownership | Riparian Ownership/Access for Stabilization ² | Riparian Ownership/Access for Vegetation Work ² | Ease of Construction Access ² | Protection of Existing Structures/ Infrastructure ² | Impact to Surrounding Areas ³ | Potential for Future Erosion (BEHI/NBS) ⁴ | Opportunity for Habitat Restoration (riparian/upland) Based on Proposes Stream Stabilization | Opportunity for Habitat Restoration (in channel) | Maintaining Healthy, Native Significant Trees ⁵ | Vegetation Establishment | Education Potential ⁶ | Count | Rank |
|--|---|---|--|--|--|--|--|--|--|--|--|---|---|---|---|
| 2c. Right and left bank stabilization with grading, rock toe, root wads, log vanes, and vegetation establishment (Sta. 23+40 to 25+40) | 3 | 3 | 3 | 3 | 3 | 15 | 0 | 4 | 2 | 2 | 0 | 2 | 1 | 41 | High |

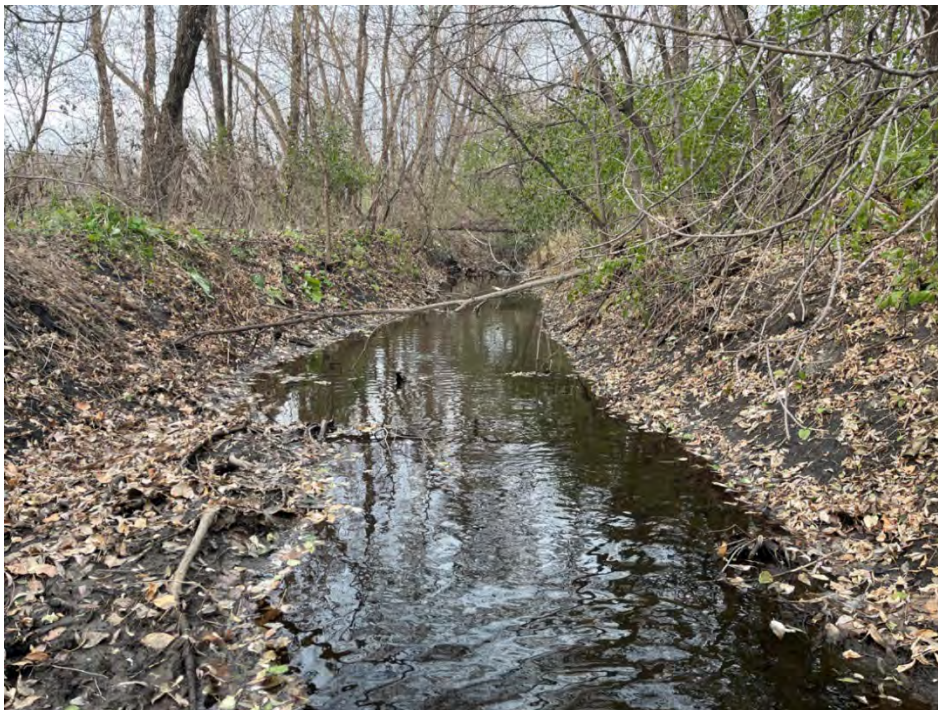
Photo 21: Site 2d. Looking upstream at station 26+50, both banks are angled at approximately 60 degrees and are bare.

| Site Area Restoration | Severity of Existing Erosion ¹ | Creek Ownership | Riparian Ownership/Access for Stabilization ² | Riparian Ownership/Access for Vegetation Work ² | Ease of Construction Access ² | Protection of Existing Structures/ Infrastructure ² | Impact to Surrounding Areas ³ | Potential for Future Erosion (BEHI/NBS) ⁴ | Opportunity for Habitat Restoration (riparian/upland) Based on Proposes Stream Stabilization | Opportunity for Habitat Restoration (in channel) | Maintaining Healthy, Native Significant Trees ⁵ | Vegetation Establishment | Education Potential ⁶ | Count | Rank |
|--|---|---|--|--|--|--|--|--|--|--|--|---|---|---|---|
| 2d. Right and left bank stabilization with grading, root wads, log vanes, woody debris removal, and vegetation establishment (Sta. 25+40 to 29+30) | 3 | 3 | 3 | 3 | 3 | 0 | 0 | 4 | 2 | 2 | 0 | 2 | 1 | 26 | Medium |

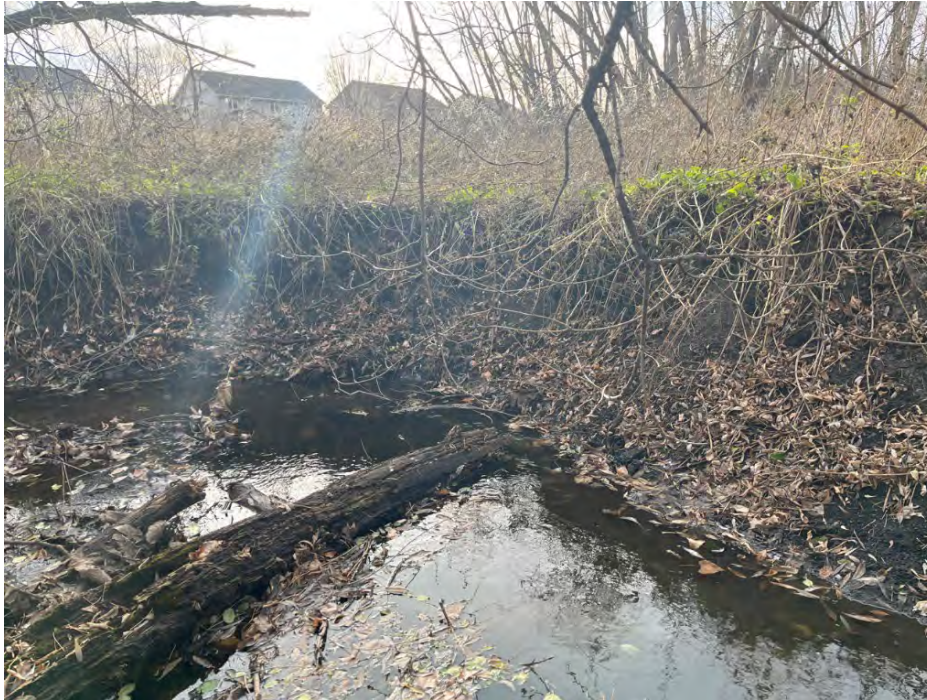
Photo 22: Site 2d. Looking at the right bank at station 27+90, the bank is mostly exposed.

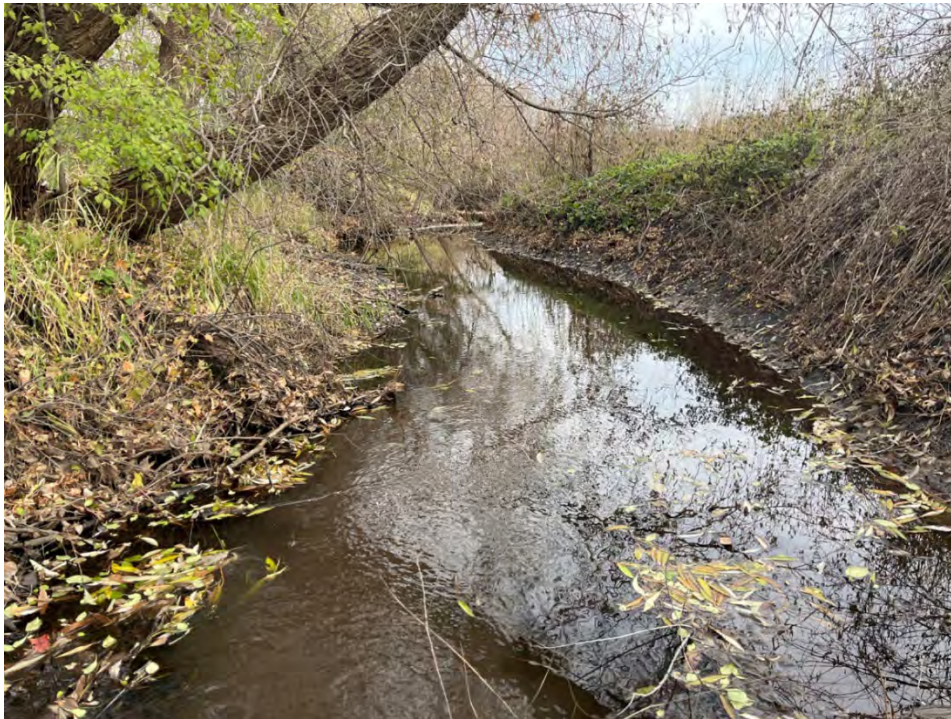
Photo 23: Site 2e. Looking downstream at station 30+30, the right bank is bare while the left bank had moderate cover.

| Site Area Restoration | Severity of Existing Erosion ¹ | Creek Ownership | Riparian Ownership/Access for Stabilization ² | Riparian Ownership/Access for Vegetation Work ² | Ease of Construction Access ² | Protection of Existing Structures/ Infrastructure ² | Impact to Surrounding Areas ³ | Potential for Future Erosion (BEHI/NBS) ⁴ | Opportunity for Habitat Restoration (riparian/upland) Based on Proposes Stream Stabilization | Opportunity for Habitat Restoration (in channel) | Maintaining Healthy, Native Significant Trees ⁵ | Vegetation Establishment | Education Potential ⁶ | Count | Rank |
|--|---|---|--|--|--|--|--|--|--|--|--|---|---|---|---|
| 2e. Right and left bank stabilization with grading banks and side channels, log vanes, woody debris removal, and vegetation establishment (Sta. 29+30 to 33+90) | 2 | 1 | 1 | 1 | 3 | 0 | 0 | 8 | 2 | 2 | 0 | 2 | 1 | 23 | Medium |

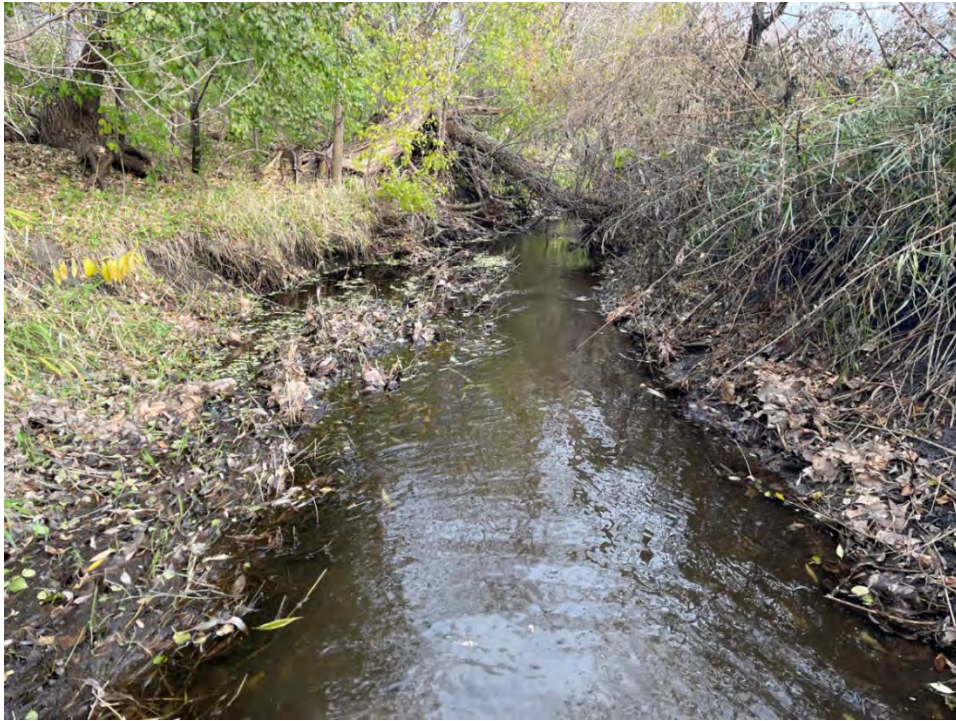
Photo 24: Site 2e. Looking downstream at station 31+10, woody debris has fallen into the channel and there is slight sediment accumulation at the bottom of the banks.

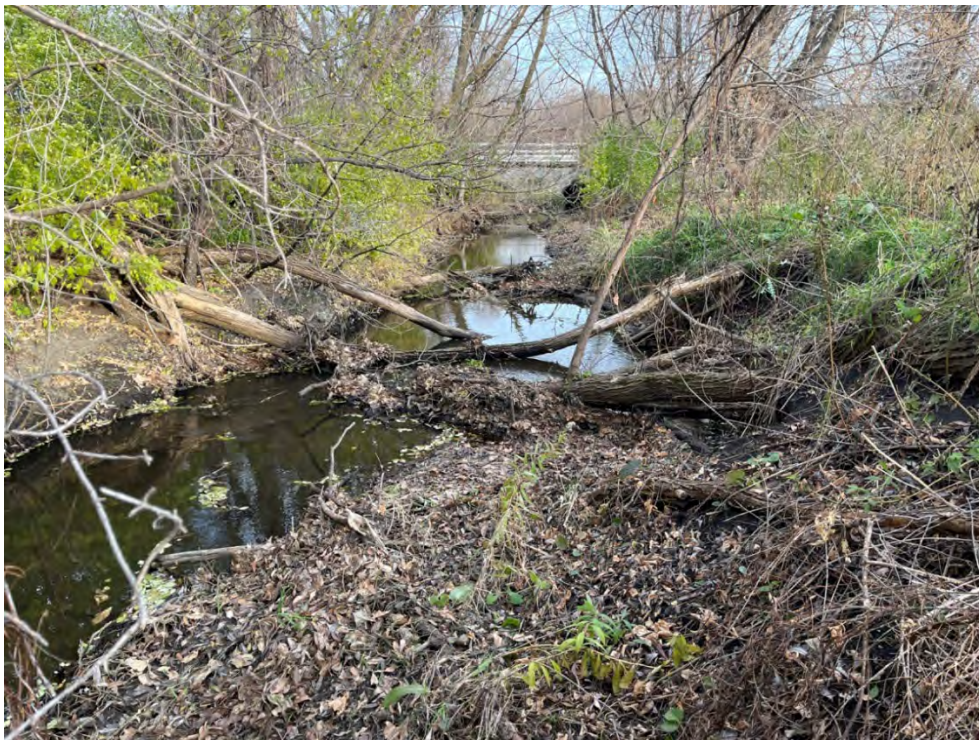
Photo 25: Site 2f. Looking downstream at station 34+40, multiple fallen trees in the channel creating woody debris and potential channel blockages.

| Site Area Restoration | Severity of Existing Erosion ¹ | Creek Ownership | Riparian Ownership/Access for Stabilization ² | Riparian Ownership/Access for Vegetation Work ² | Ease of Construction Access ² | Protection of Existing Structures/ Infrastructure ² | Impact to Surrounding Areas ³ | Potential for Future Erosion (BEHI/NBS) ⁴ | Opportunity for Habitat Restoration (riparian/upland) Based on Proposes Stream Stabilization | Opportunity for Habitat Restoration (in channel) | Maintaining Healthy, Native Significant Trees ⁵ | Vegetation Establishment | Education Potential ⁶ | Count | Rank |
|--|---|---|--|--|--|--|--|--|--|--|--|---|---|---|---|
| 2f. Right and left bank stabilization with grading, woody debris removal, log vanes, and vegetation establishment (Sta. 33+90 to 36+00) | 1 | 1 | 1 | 1 | 3 | 0 | 0 | 3 | 2 | 2 | 2 | 2 | 1 | 19 | Medium |

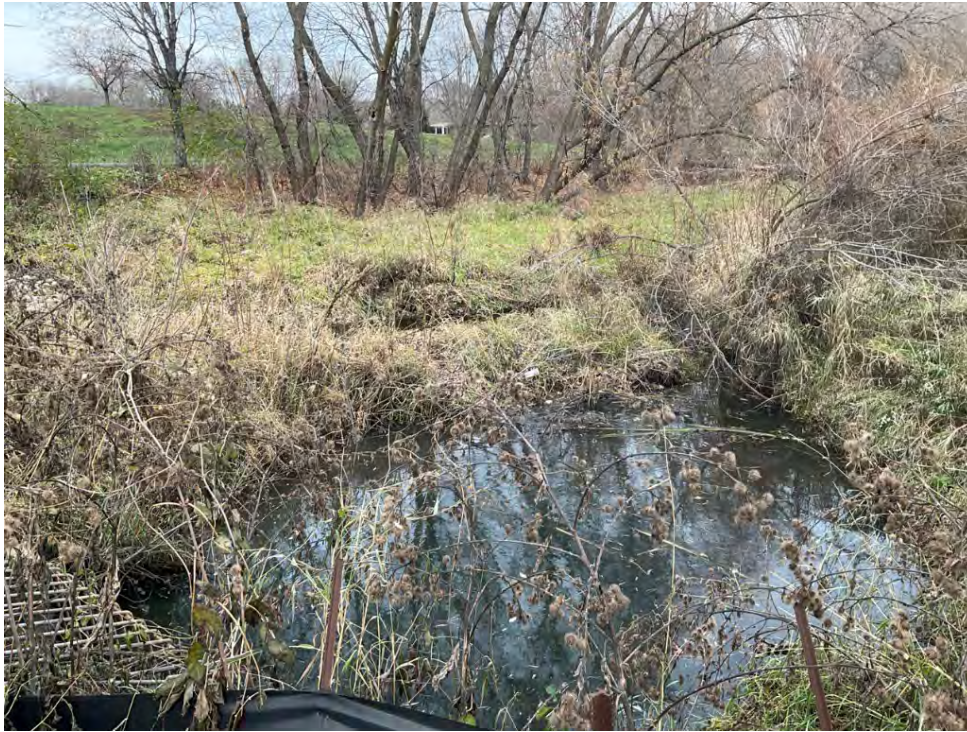
Photo 26: Site 3a. Looking downstream at the sediment island formed at station 37+00 due to the pipe crossing at Vicksburg Road. The island width ranges from 1 to 10 feet wide, is 30-feet long, and roughly 1 foot above the water surface level.

| Site Area Restoration | Severity of Existing Erosion ¹ | Creek Ownership | Riparian Ownership/Access for Stabilization ² | Riparian Ownership/Access for Vegetation Work ² | Ease of Construction Access ² | Protection of Existing Structures/ Infrastructure ² | Impact to Surrounding Areas ³ | Potential for Future Erosion (BEHI/NBS) ⁴ | Opportunity for Habitat Restoration (riparian/upland) Based on Proposes Stream Stabilization | Opportunity for Habitat Restoration (in channel) | Maintaining Healthy, Native Significant Trees ⁵ | Vegetation Establishment | Education Potential ⁶ | Count | Rank |
|--|---|---|--|--|--|--|--|--|--|--|--|---|---|---|---|
| 3a. Grading to improve channel definition and remove accumulated sediment (Sta. 37+00 to 38+00) | 0 | 3 | 1 | 1 | 3 | 0 | 0 | 1 | 0 | 0 | 2 | 0 | 2 | 13 | Low |

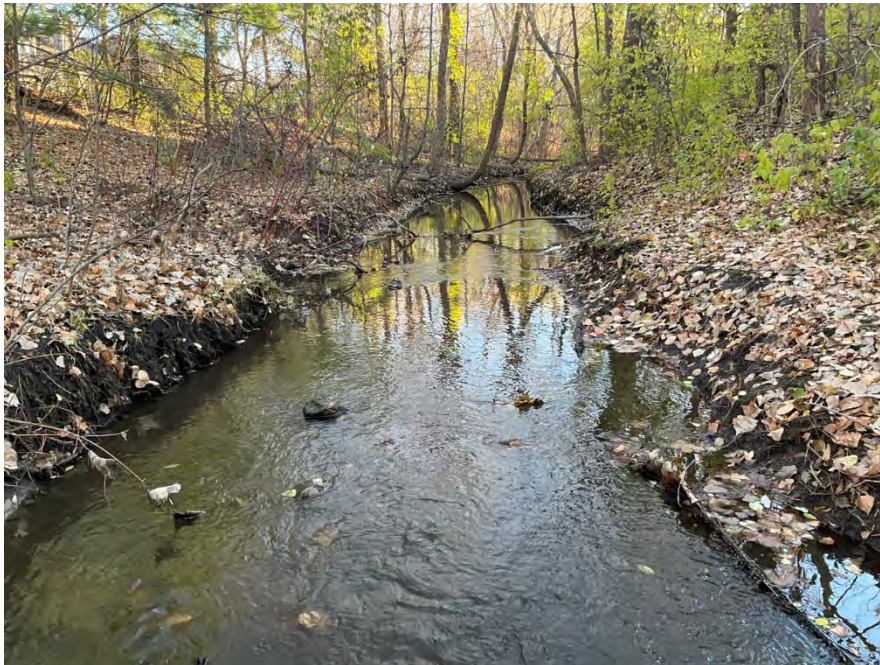
Photo 27: Site 3c. Looking downstream at station 42+90, both banks have minimal vegetative surface protection.
