Appendix A
Site Visit Photos

Plymouth Creek Restoration (2026 CR-P)

Plymouth Creek Restoration Project

Plymouth Creek Erosion Issues and Restoration Prioritization

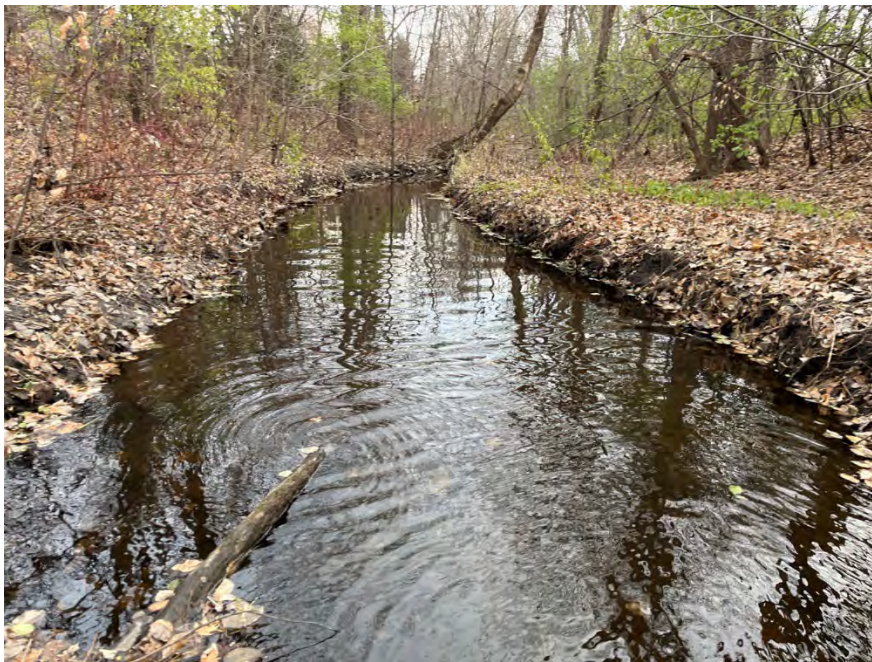
Photo 29: Site 3d. Looking downstream at station 46+70 where the channel widens.

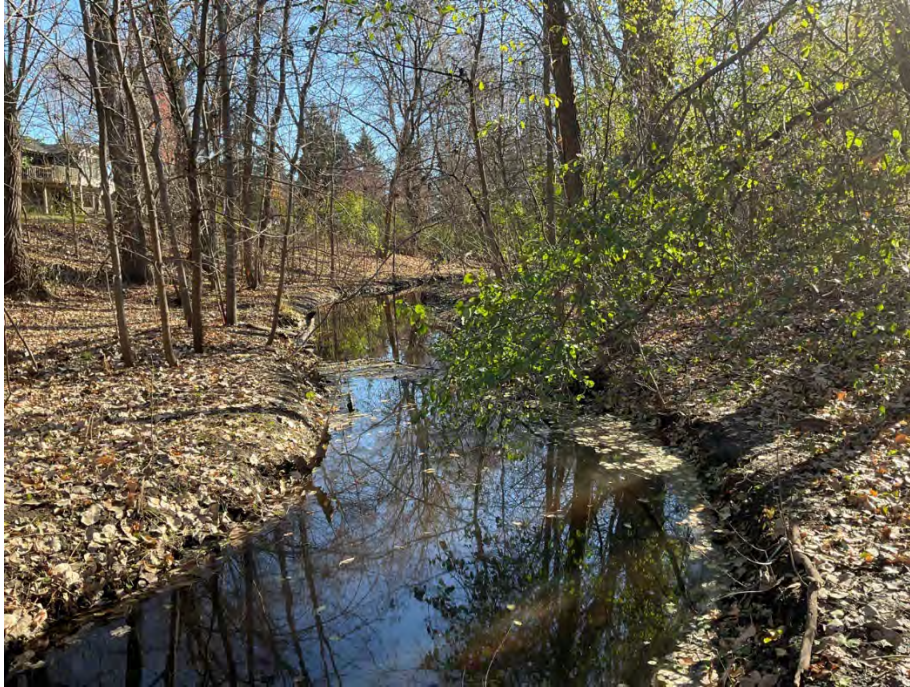
Photo 30: Site 3d. Looking downstream at station 47+50, the channel has bare banks and minor meandering and good floodplain connection.

| Site Area Restoration | Severity of Existing Erosion ¹ | Creek Ownership | Riparian Ownership/Access for Stabilization ² | Riparian Ownership/Access for Vegetation Work ² | Ease of Construction Access ² | Protection of Existing Structures/ Infrastructure ² | Impact to Surrounding Areas ³ | Potential for Future Erosion (BEHI/NBS) ⁴ | Opportunity for Habitat Restoration (riparian/upland) Based on Proposes Stream Stabilization | Opportunity for Habitat Restoration (in channel) | Maintaining Healthy, Native Significant Trees ⁵ | Vegetation Establishment | Education Potential ⁶ | Count | Rank |
|--|---|---|--|--|--|--|--|--|--|--|--|---|---|---|---|
| 3d. Right and left bank stabilization with log vanes, plantings, and installation of riprap (Sta. 46+40 to 49+00) | 2 | 3 | 1 | 1 | 3 | 0 | 0 | 3 | 0 | 2 | 2 | 2 | 0 | 19 | Medium |

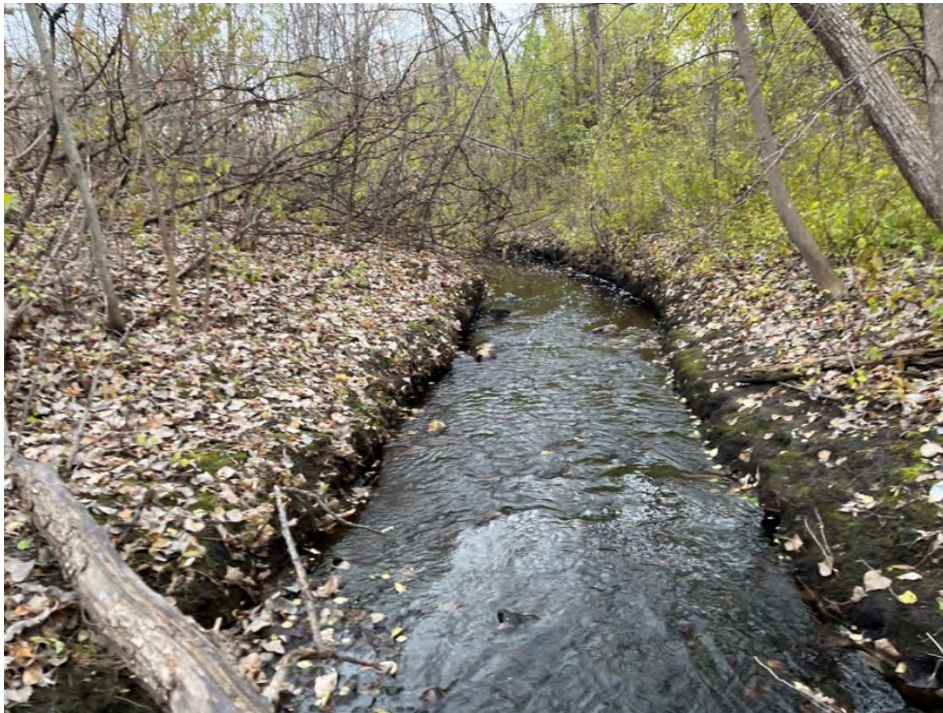
Photo 31: Site 4a. Looking downstream at station 54+00, downstream of the Rockford Road crossing. Undercut bank (six inches or less).

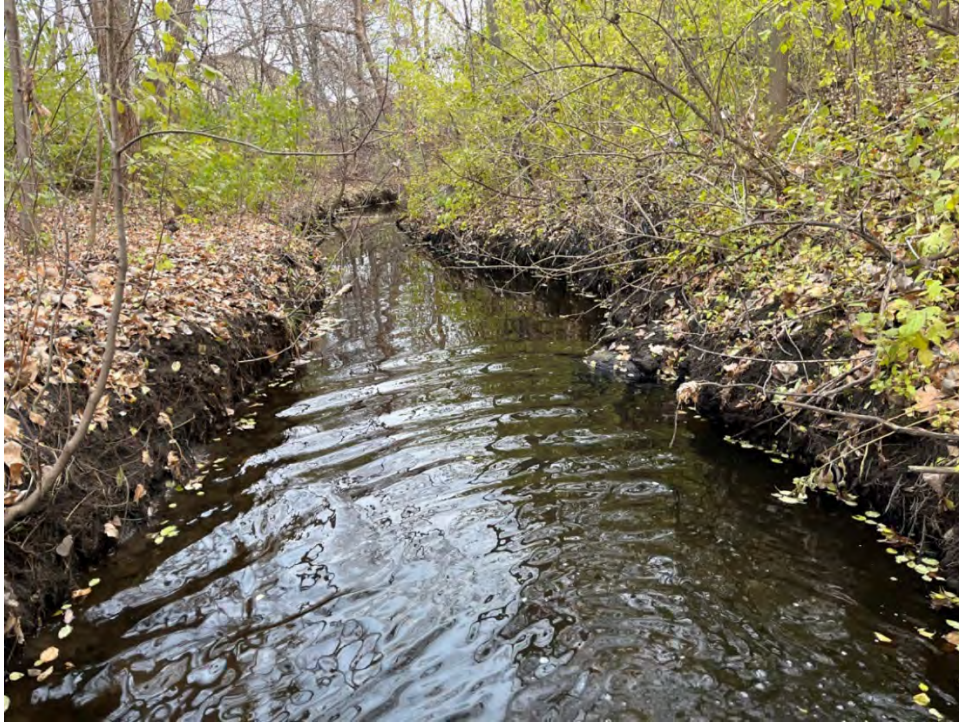
Photo 32: Site 4a. Looking downstream at station 55+00, both banks have slight undercutting at the water line.

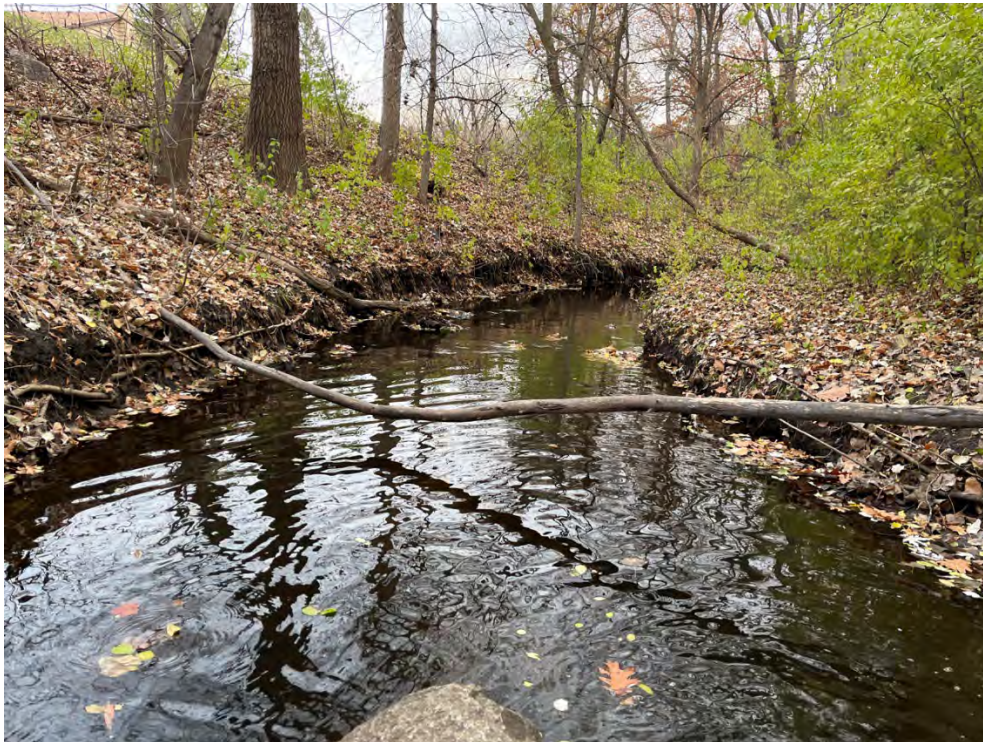
Photo 33: Site 4b. Looking downstream at station 57+00, the banks are vertical and bare.

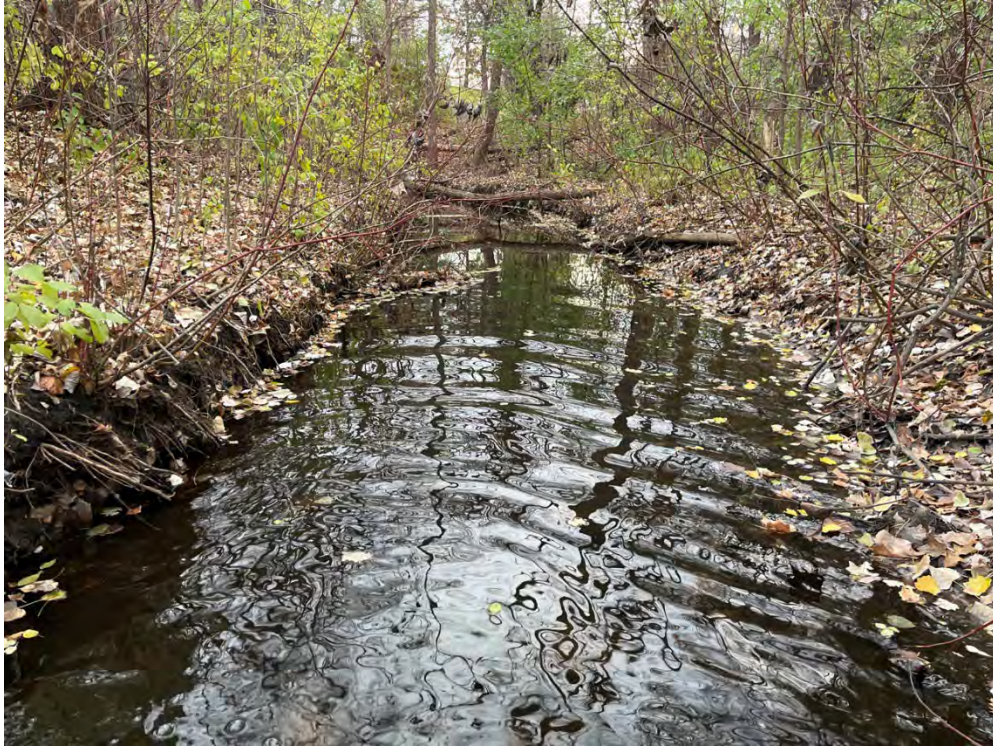
Photo 34: Site 4b. Looking downstream at station 57+80, woody debris has fallen into the channel.

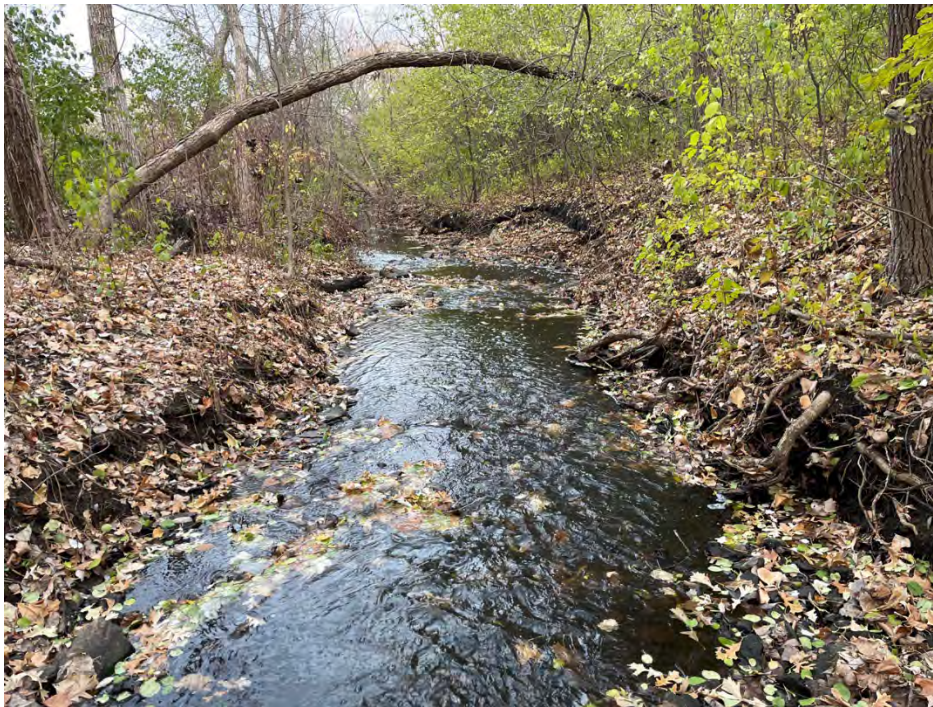
Photo 35: Site 4c. Looking downstream at station 59+00, the right bank is undercut below the tree roots.

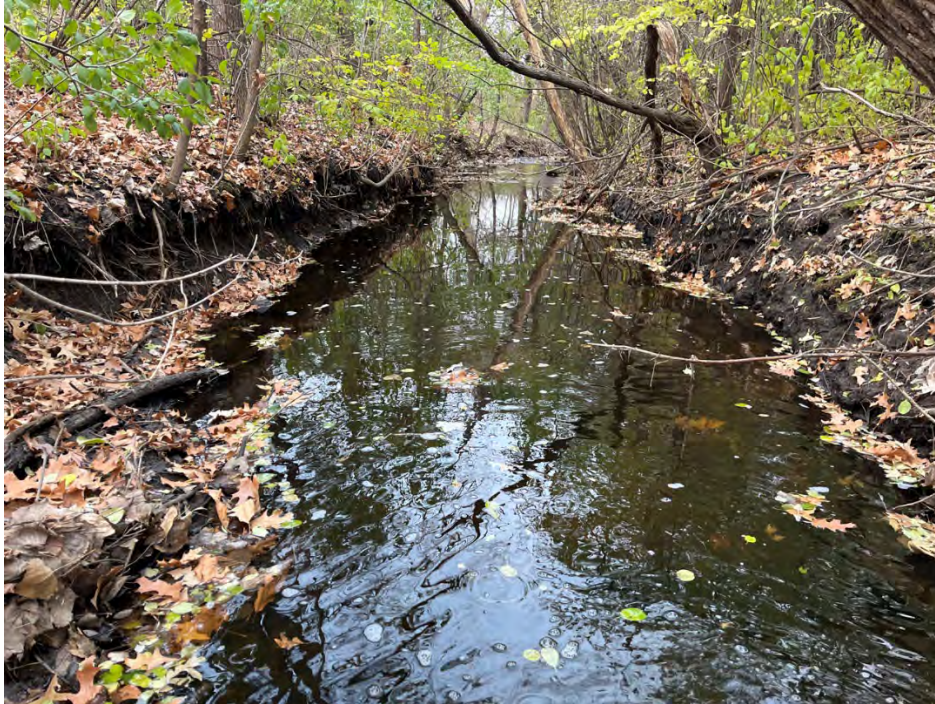
Photo 36: Site 4c. Looking downstream at station 60+00, the left bank is undercut.

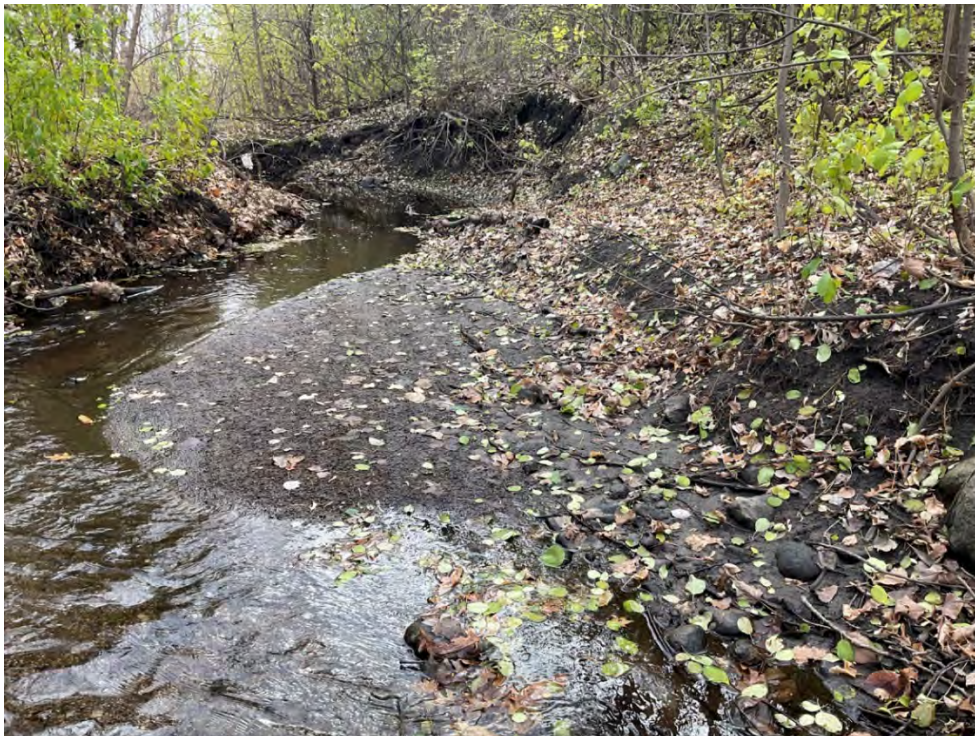
Photo 37: Site 4d. Looking downstream at station 62+30, sediment accumulation on the right bank.

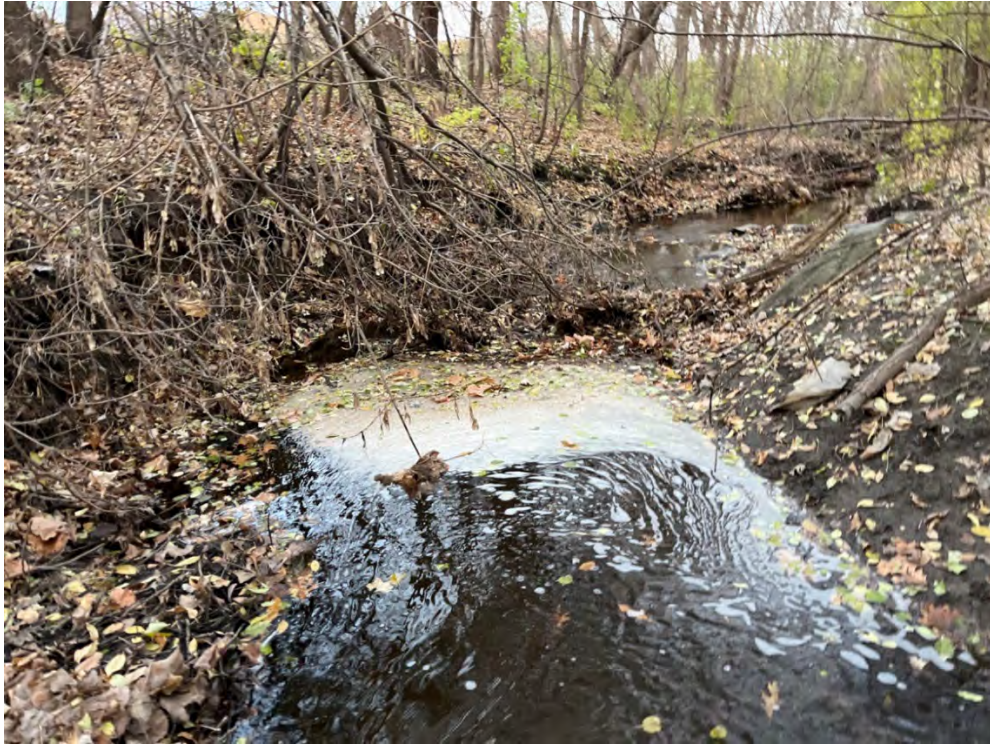
Photo 38: Site 4e. Looking downstream at station 63+00, mild channel blockage.

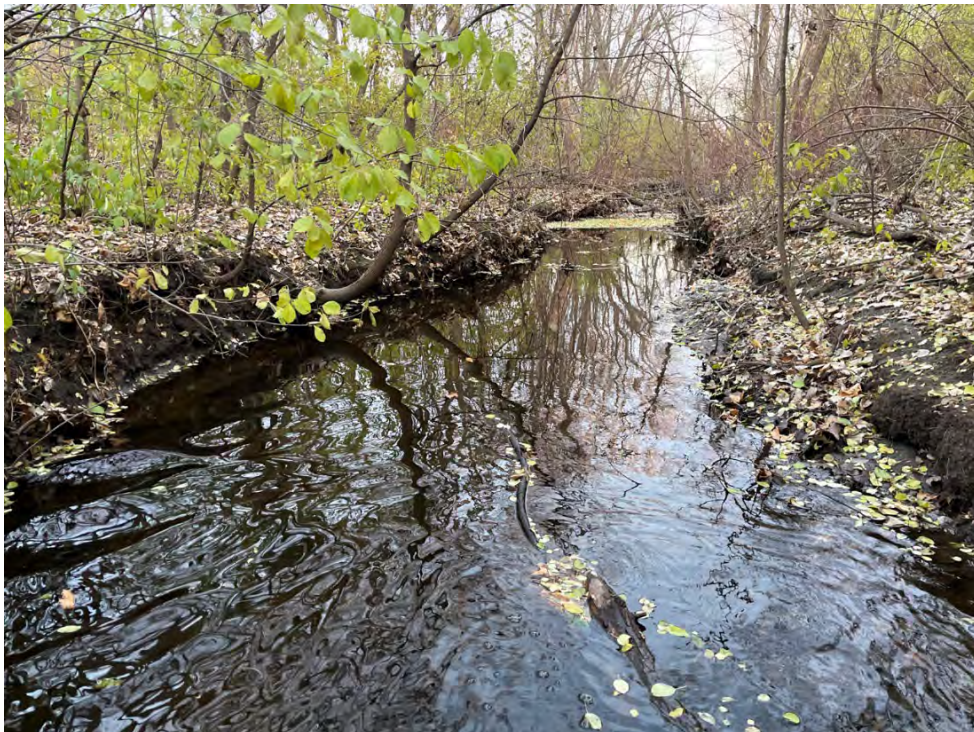
Photo 39: Site 4e. Looking downstream at station 64+20, upstream of a larger deep pool.

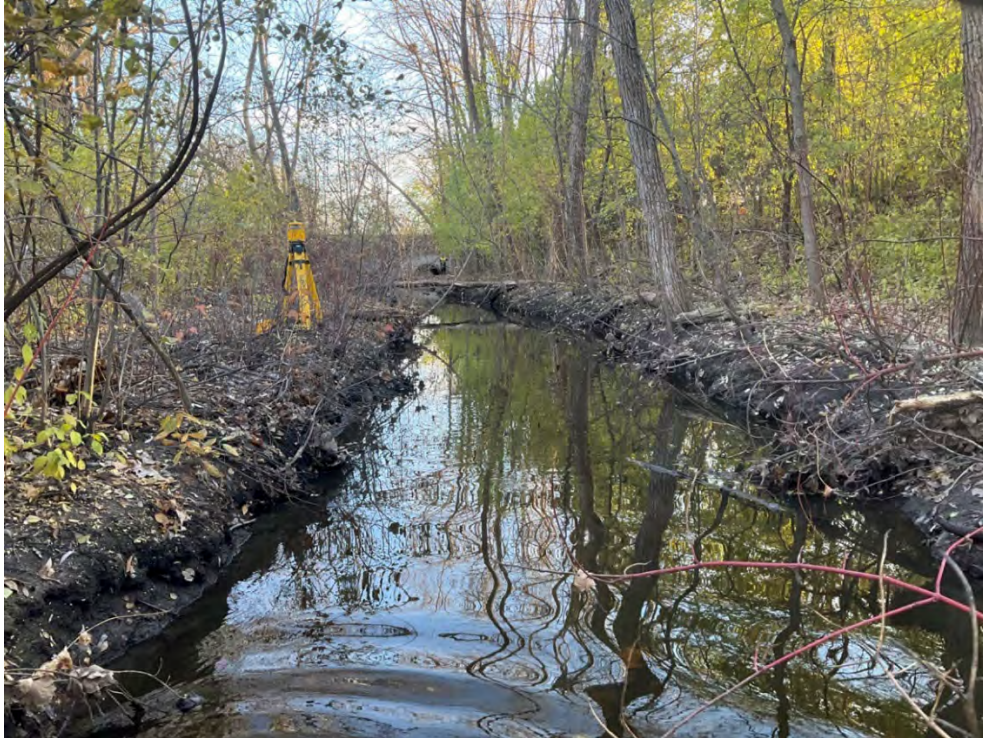
Photo 40: Site 4f. Looking downstream at station 65+60, the banks are bare but have good floodplain connection

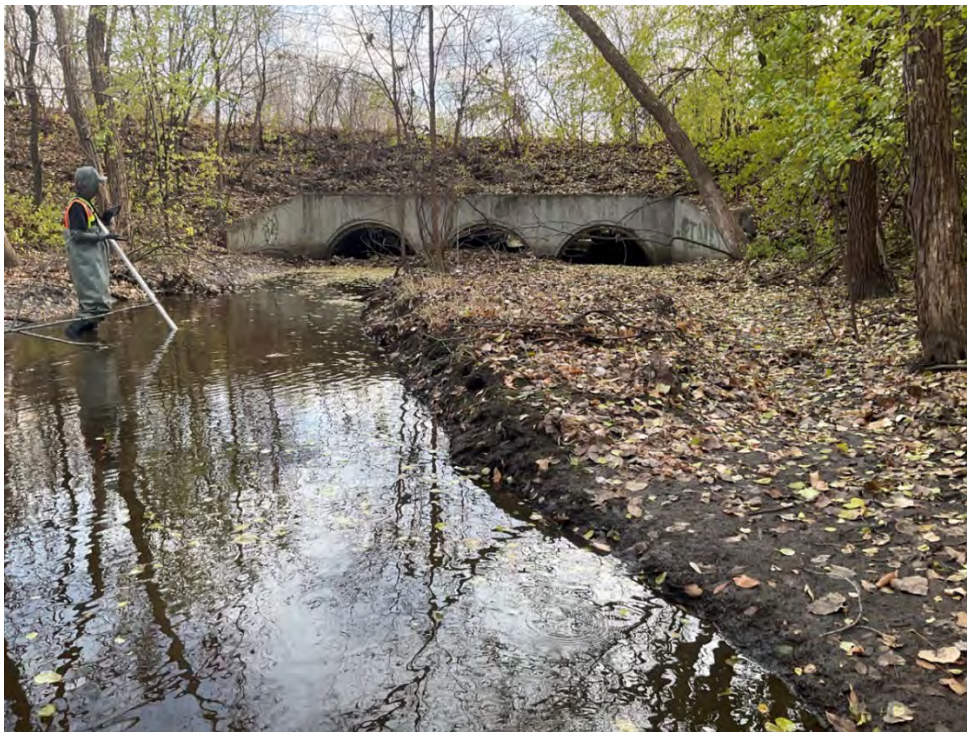
Photo 41: Site 4f. Looking downstream at station 66+90 towards the 38th Avenue crossing. The center and right culvert are partially blocked by sediment deposition.

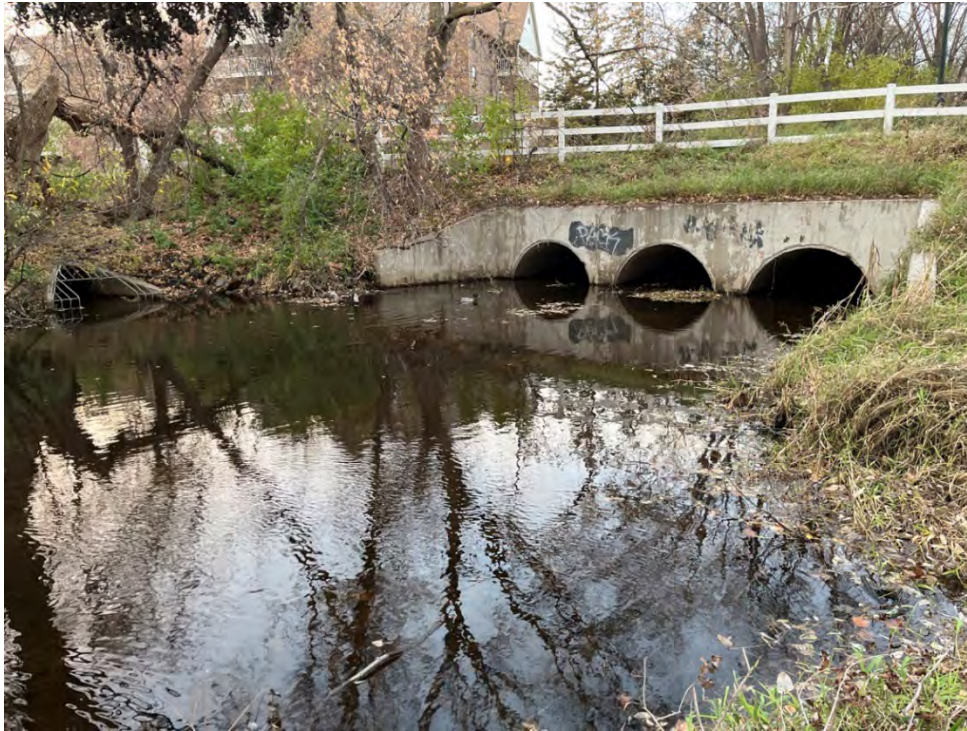
Photo 42: Site 4g. Looking upstream at station 69+00 towards the 38th Avenue crossing. Slight sediment build up in center of channel near the culverts.
