# Memorandum

**To:** Bassett Creek Watershed Management Commission (BCWMC)  
**From:** Barr Engineering Co. (Barr) (Josh Phillips, Gabby Campagnola, Jim Herbert)  
**Subject:** Item 4F: Bassett Creek 2024 Flood Control Project Inspection - BCWMC December 19, 2024 Meeting Agenda  
**Date:** December 12, 2024  
**Project:** 23270051.62 1080 001

## 4F Bassett Creek 2024 Flood Control Project Inspection

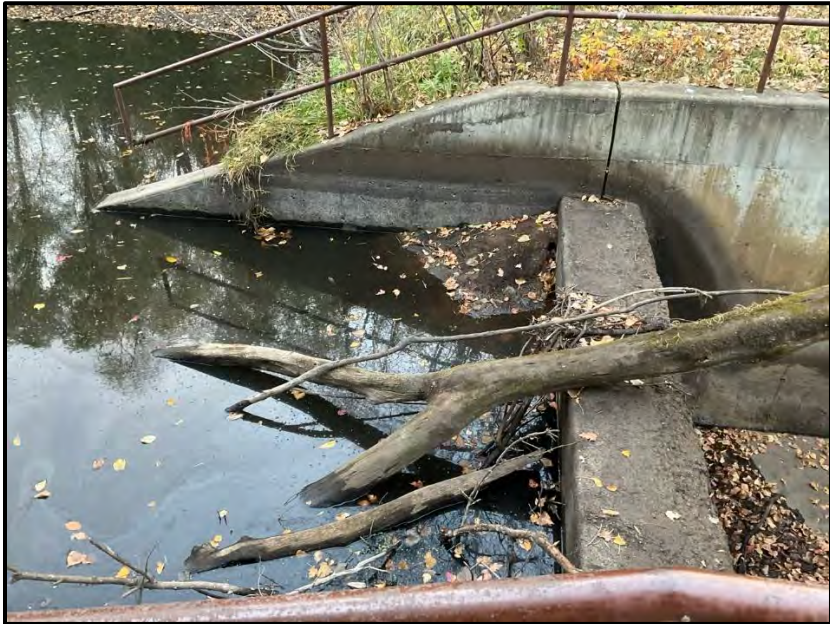
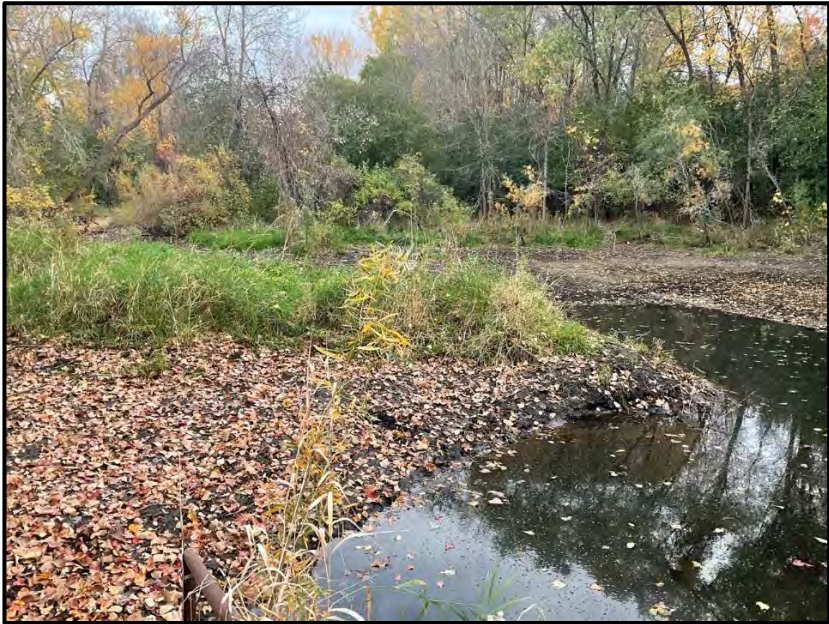
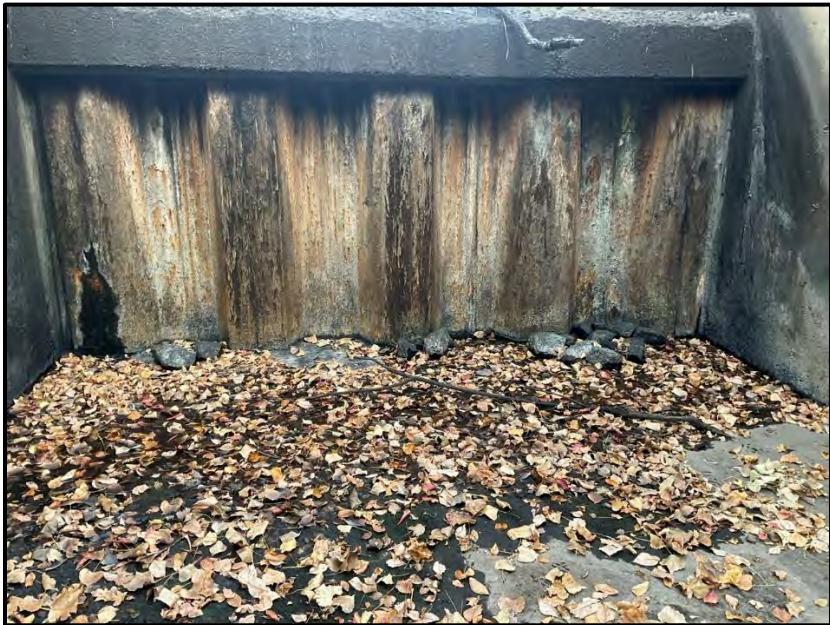
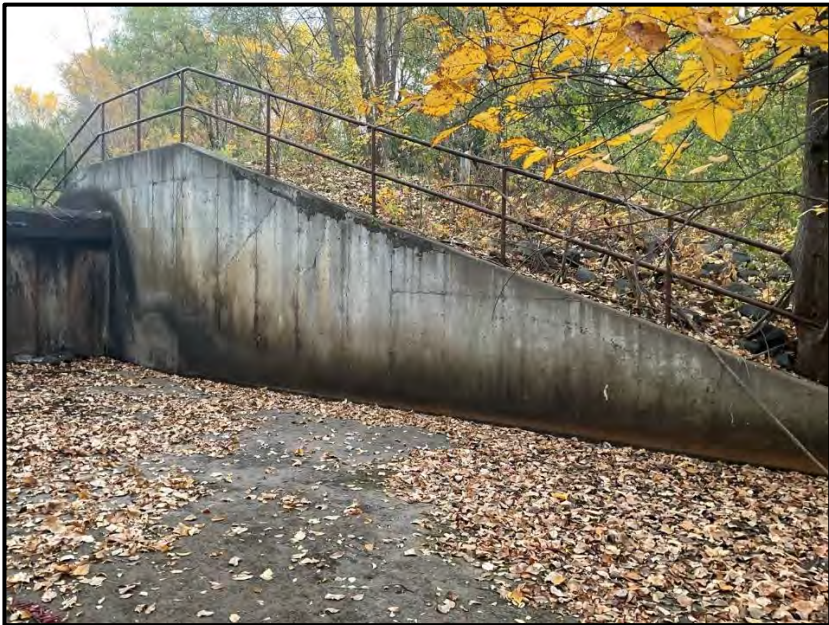
Plymouth Creek Fish Barrier (Plymouth)

- a. The structure appeared to be in satisfactory condition.
- b. The water level was below the staff gage and the water was 1.35 feet below the weir at the time of the inspection.

- c. Woody debris has accumulated on the weir and should be removed.
- d. Sediment has accumulated in the pool upstream of the structure and formed a delta, which was overgrown with vegetation. The deposited sediment was generally creating a meander in the creek toward the east (left) bank. Deposited sediment in the upstream pool has been noted since 2005.

- e. Minor seeping was observed through the sheet pile.
- f. The railings at the upstream end of the structure, on the east (left) and west (right) sides, have rusted off below the weir level. This is consistent with previous inspections and has been noted since 2015.

- h. The top downstream edge of the concrete pile cap forming the weir has deteriorated along its entire length. Deterioration includes loss of cement paste and fines resulting in exposed aggregate. The weir appears to be functioning properly and controlling water to the design elevation.

- i. Three cracks were observed on the downstream west (right) wing wall. This is consistent with previous inspections and has been noted since 2004.
- j. Seven diagonal cracks were observed on the downstream east (left) wing wall. Three of the cracks are more prominently defined, closed cracks. Observation of the three prominent cracks is consistent with previous inspections and has been noted since 2002. The other four cracks are generally closed hairline cracks and less noticeable.

- k. A 15-inch diameter tree was observed growing adjacent to the downstream east (left) wing wall and through the railing.
- l. Small trees and shrubs were observed growing on the embankment and downstream channel banks, including some near the wing walls and railings.

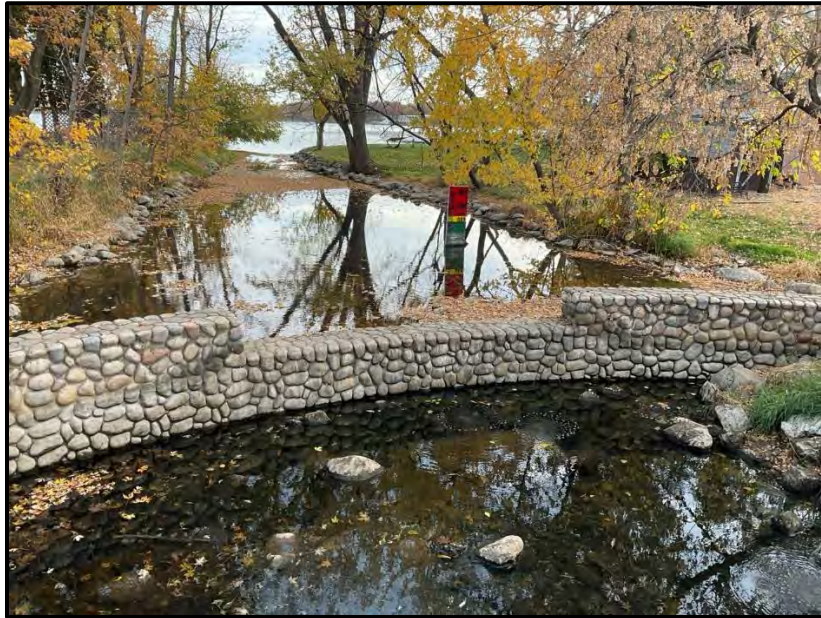
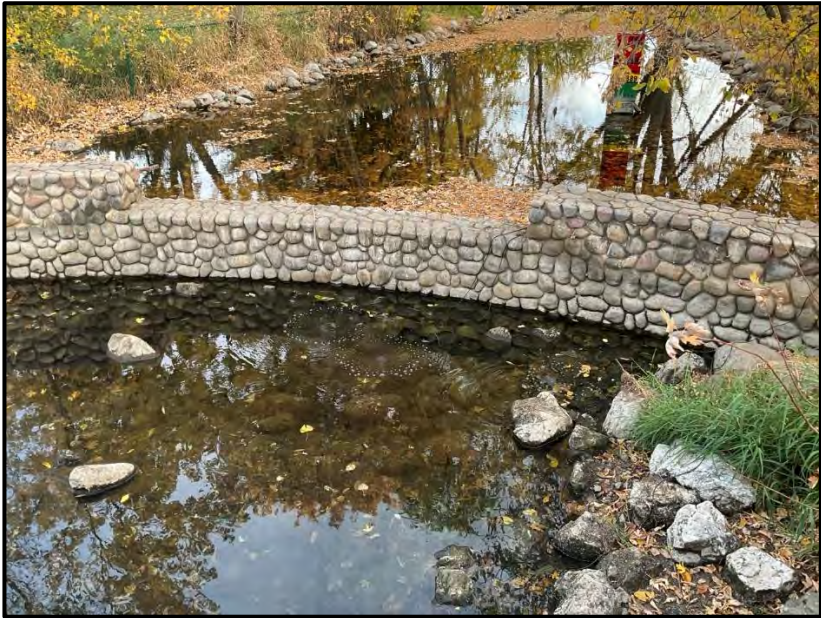
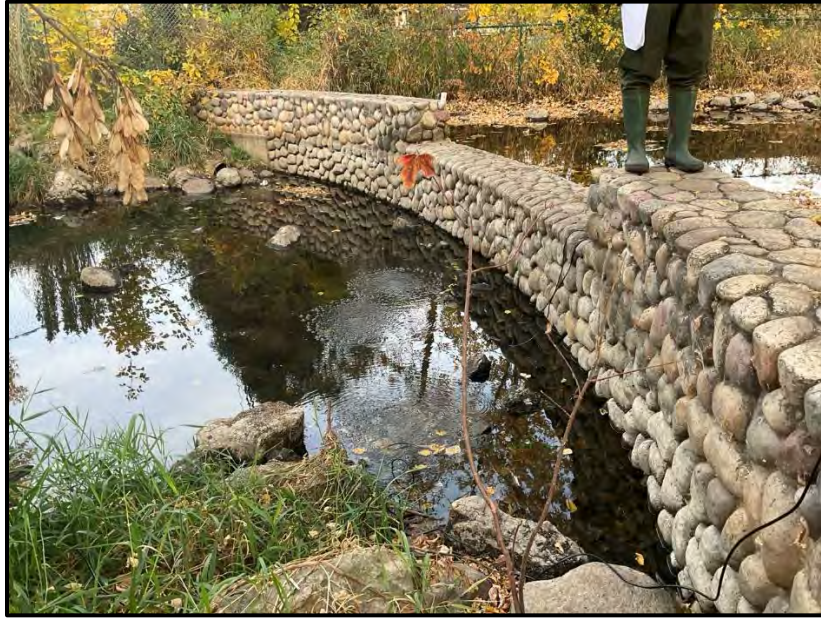
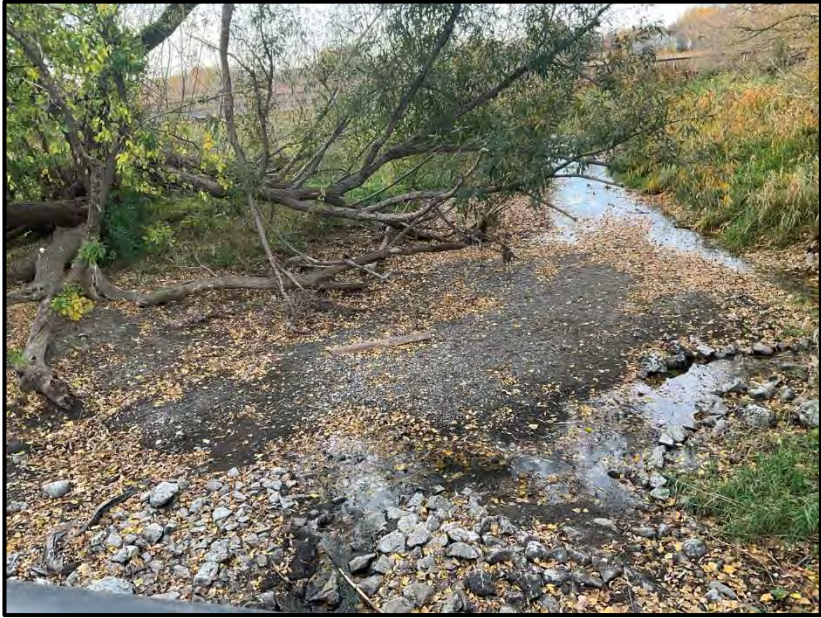
Medicine Lake Outlet (Plymouth)

- a. The channel between Medicine Lake and the outlet structure was clear of debris.
- b. The water level was below the weir at the time of the inspection and the staff gauge was measured at 887.25 feet
- c. The outlet structure appeared to be in satisfactory condition.
- d. Although not part of the flood control project, the storm sewer outfall for local drainage from South Shore Drive in the west (right) bank was partially full of sediment.
- e. Woody vegetation was observed at each end of the dam where it ties into the banks.
- f. In late May 2019, City of Plymouth staff observed water flowing over the east side, but not the west side, of the Medicine Lake Outlet Structure. The city performed a baseline survey of the dam in the summer of 2019 and found that the east side of the dam was 0.15 feet lower than the west side. Future surveys can be performed to compare against the baseline.

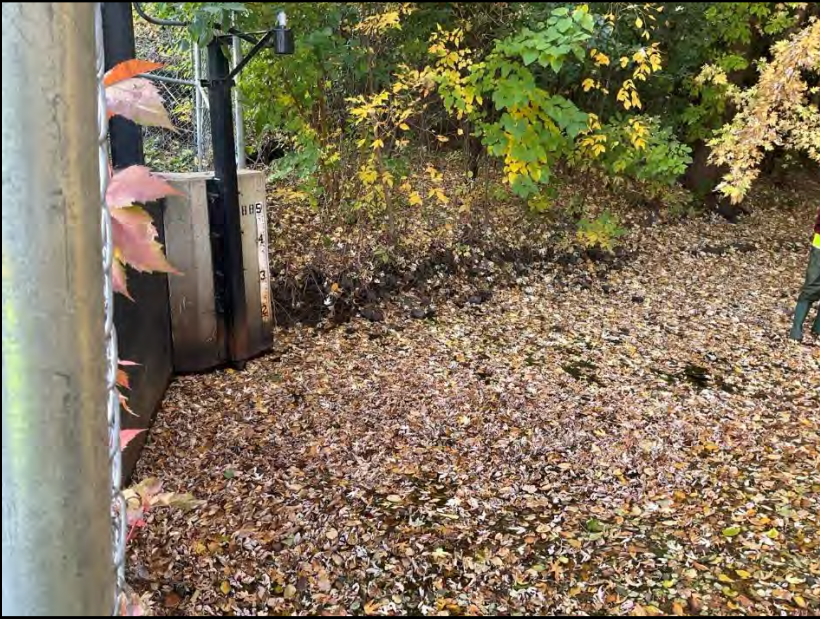
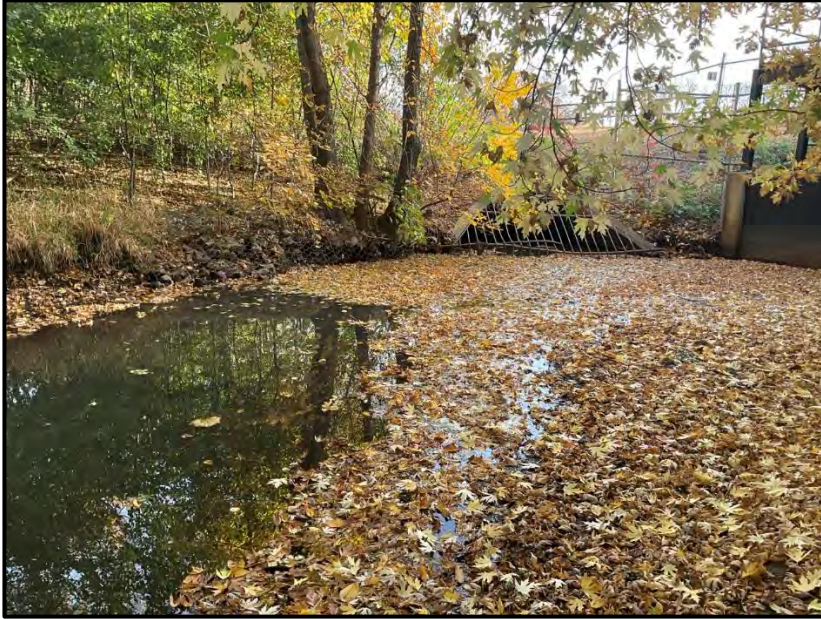
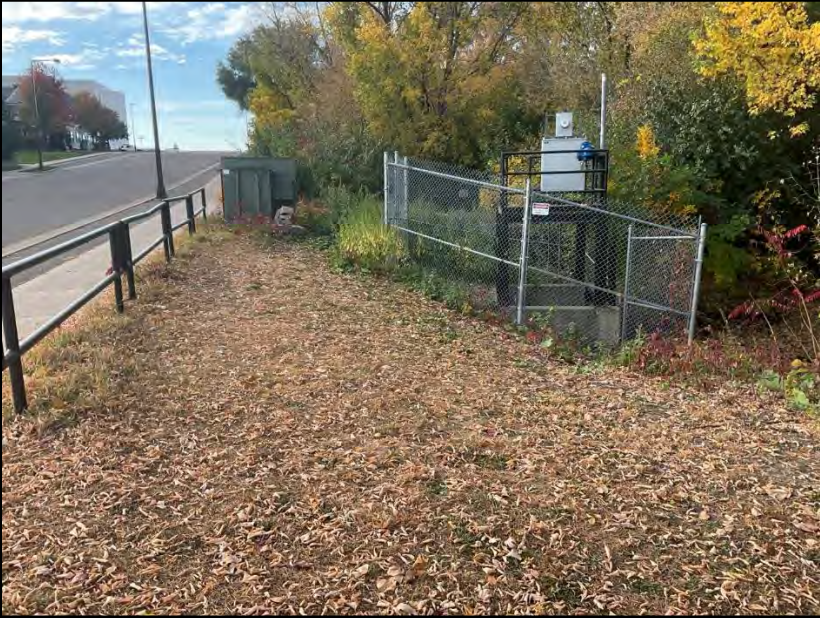
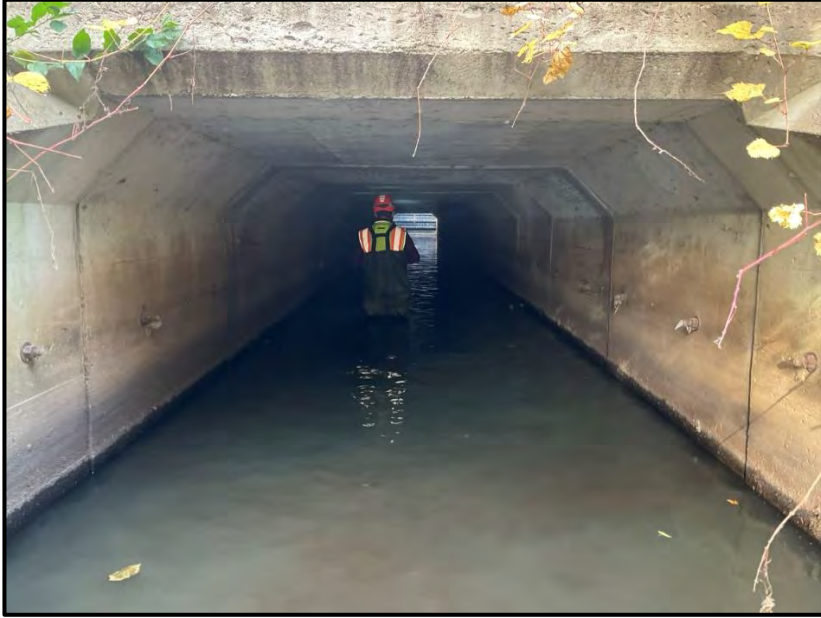
Wisconsin Avenue Control Structure (Golden Valley)

- a. The water level was below the lowest staff gauge reading upstream and downstream of the culvert.
- b. The flood gate was closed (down) at the time of the inspection and appeared to be in satisfactory condition.

- c. Deposited sediment was observed in the bottom of the culvert, ranging from 2-6 inches deep. The deposited sediment is consistent with previous inspections and has been noted since 2006.

- d. Some of the gabion baskets upstream and downstream of the culvert have deteriorated or broken and riprap had fallen out of the baskets at some locations. Although the gabion baskets are no longer functioning as installed, no significant erosion was observed. There is evidence of some minor erosion near the staff gauge and left bank upstream of large culvert.

- e. Cracks were observed along the crown of the culvert.
- f. Upstream of the gate, the left bank has begun to scour, and deposition is occurring on the right bank.

- g. Scour of the creek bed was observed downstream of culvert. The scour appeared to start at the end of the culvert and continued for roughly 40 feet.

- h. The railings at the upstream and downstream ends of the culvert were in satisfactory condition.
- i. City of Golden Valley staff had recently cleared brush upstream of the culvert.

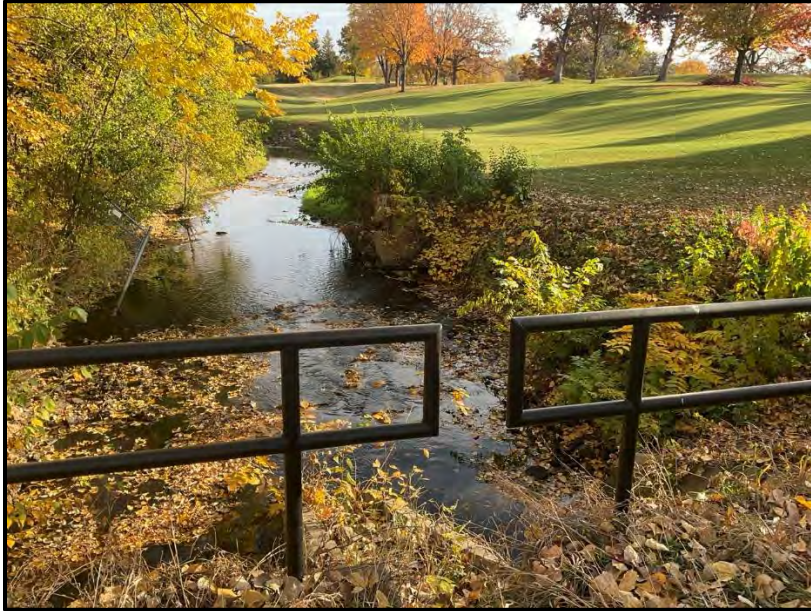
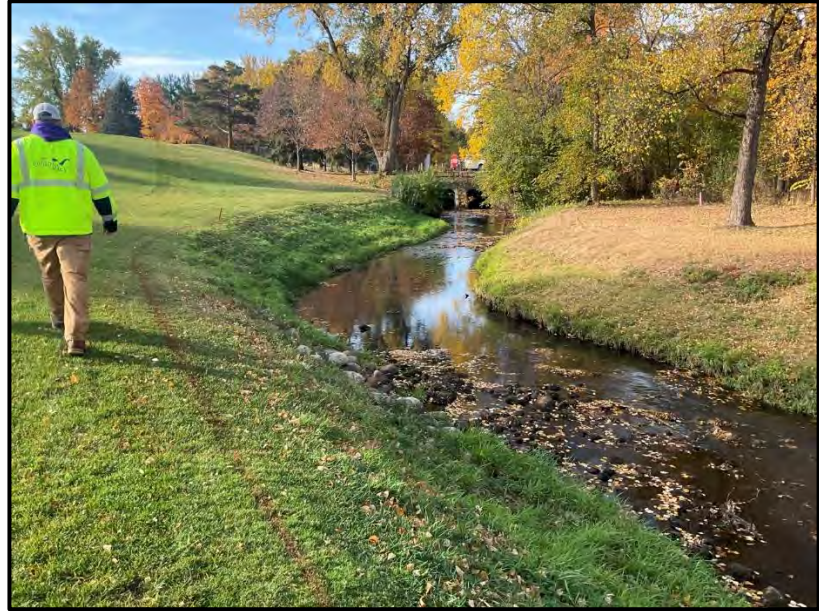
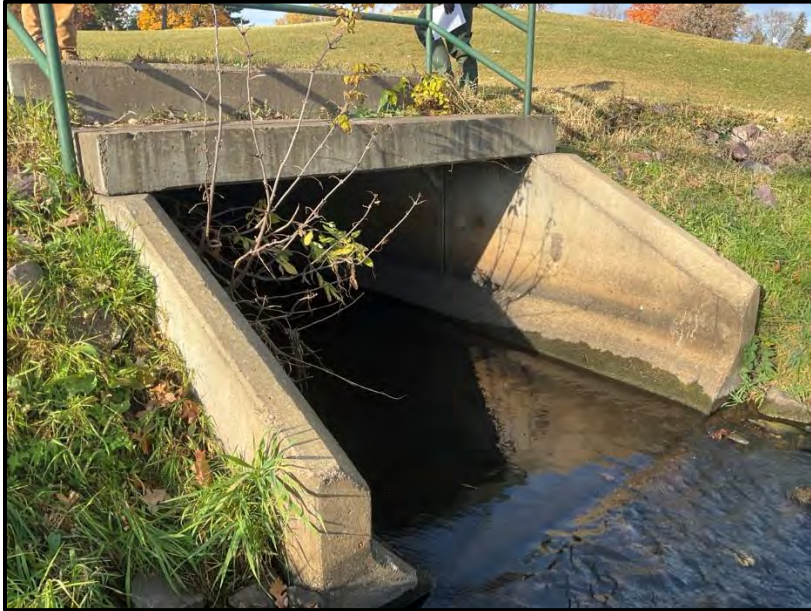
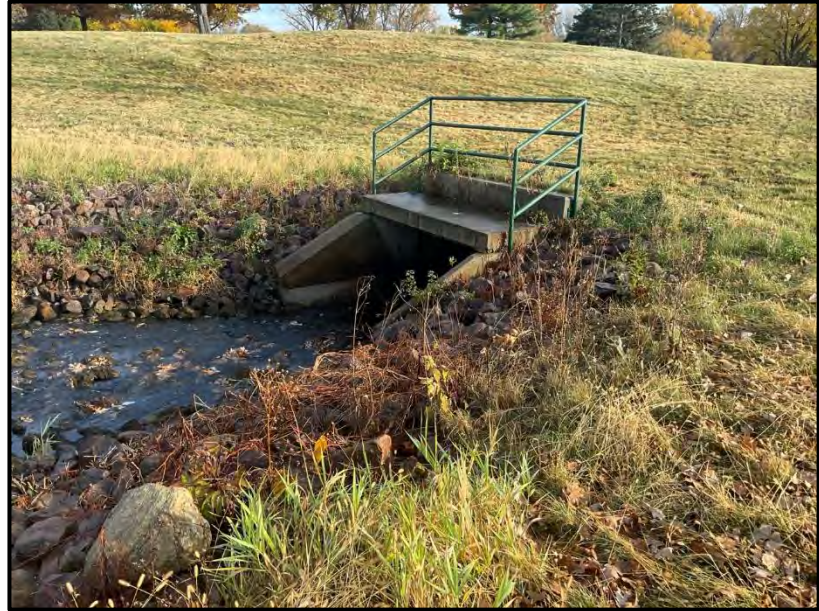
Golden Valley Country Club (Golden Valley)

- a. The channel and riprap armoring from Pennsylvania Avenue to the box culvert appeared to be in satisfactory condition.
- b. The box culvert, joints, and railings appeared to be in satisfactory condition.

- c. The overflow weir (earth berm) appeared to be in satisfactory condition and has been maintained by the Golden Valley Country Club staff as manicured fairway turf.

- d. Some sediment deposition was observed on the north (left) bank just upstream of the box culvert on top of the riprap, consistent with previous years.

- e. Some sediment deposition in other upstream areas was observed. This may have been due to low water levels.
- f. A tree is growing into the downstream side of the box culvert. The tree is growing through the last joint on the top right of the culvert.

- g. Near Pennsylvania avenue, a large chunk of concrete was observed in the channel near the right bank. At roughly the same cross section of the creek, a fence was observed on the left bank. The fence starts on the hill of the right bank and extends to be partially in the creek.

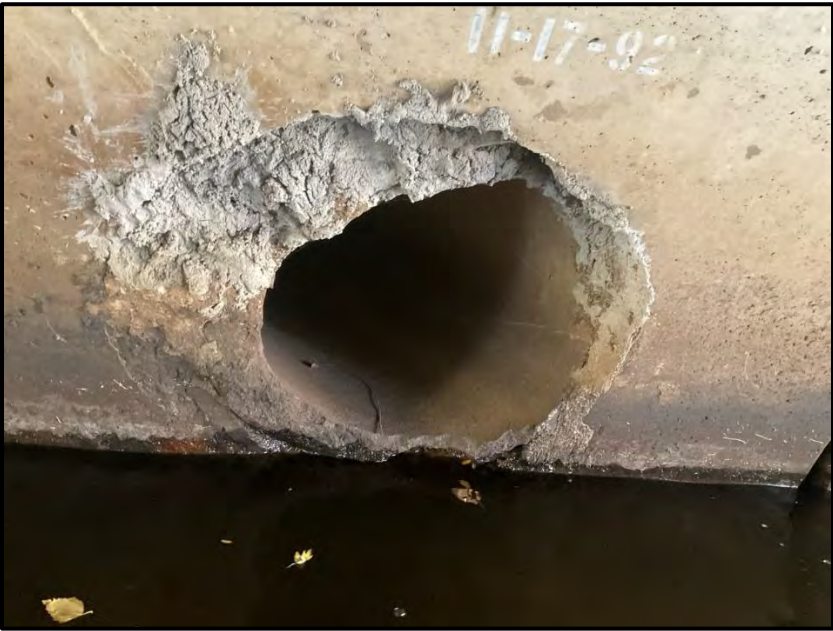
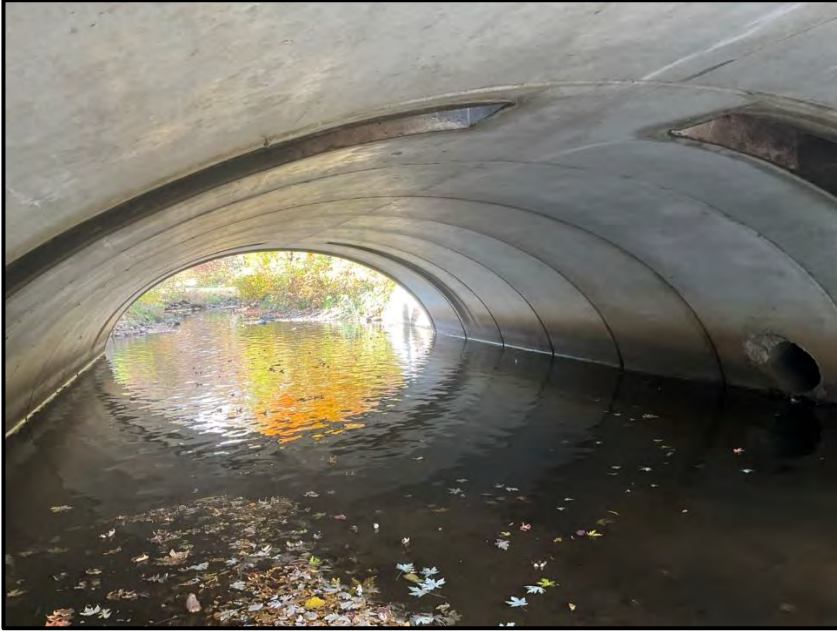
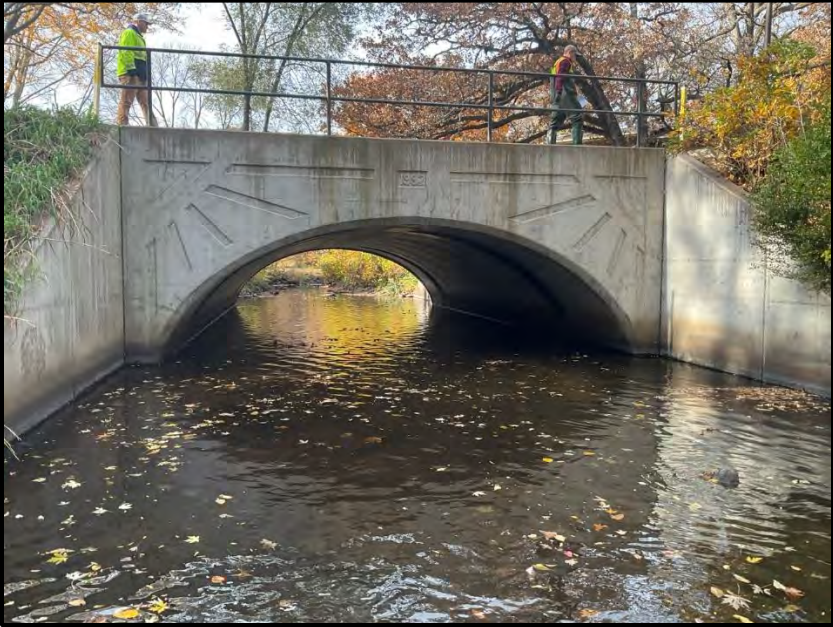
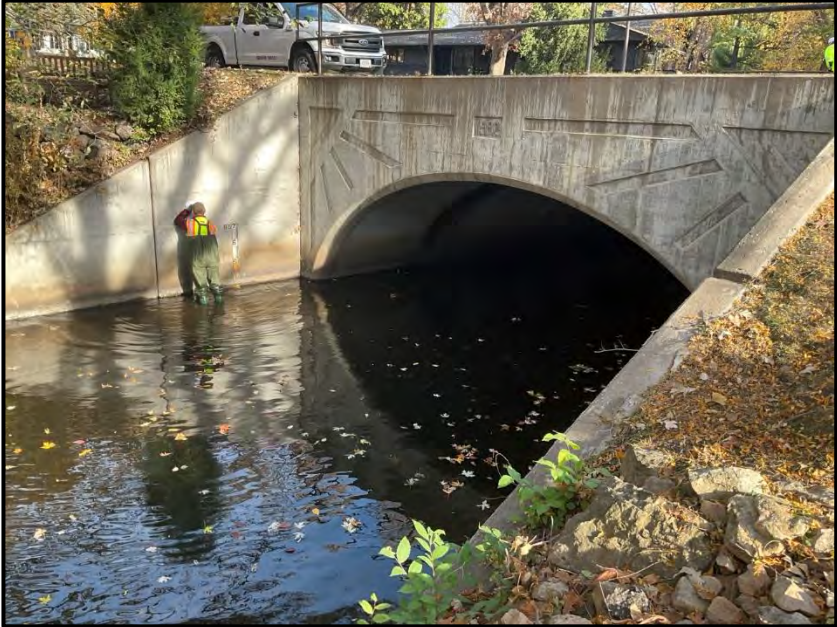
Westbrook Road Crossing (Golden Valley)

- a. The concrete Bebo arch culvert appeared to be in satisfactory condition.
- b. The water level at the staff gauge was measured at 853.65 feet.
- c. A scour hole was observed by the inlet pipe.
- d. Longitudinal hairline cracks were observed on the top of sections of the Bebo culvert, extending across the entire section (pre-cast section) width. The cracks are approximately 2 feet off-center of the structure. These cracks are consistent with previous inspections and have been noted since 2002.
- e. Spalled concrete was observed at multiple locations upstream and downstream of the culvert at the top of the wing walls and head wall. This is consistent with previous inspections and has been noted since 2007.
- f. The railings appeared to be in satisfactory condition.

- Monitor cracks in the culvert.
- Monitor joint gap at pressure points.
- Monitor spalled concrete at wing walls, head walls, and catch basin.

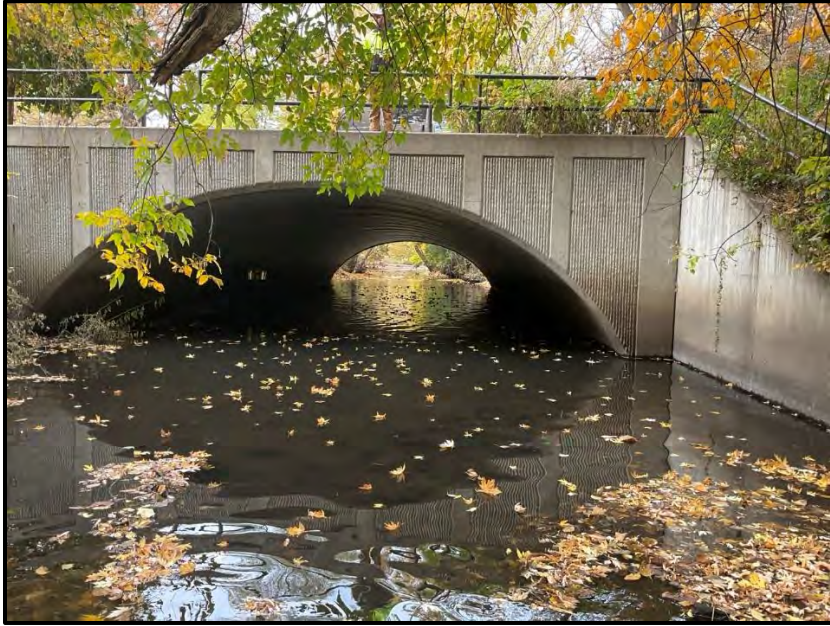
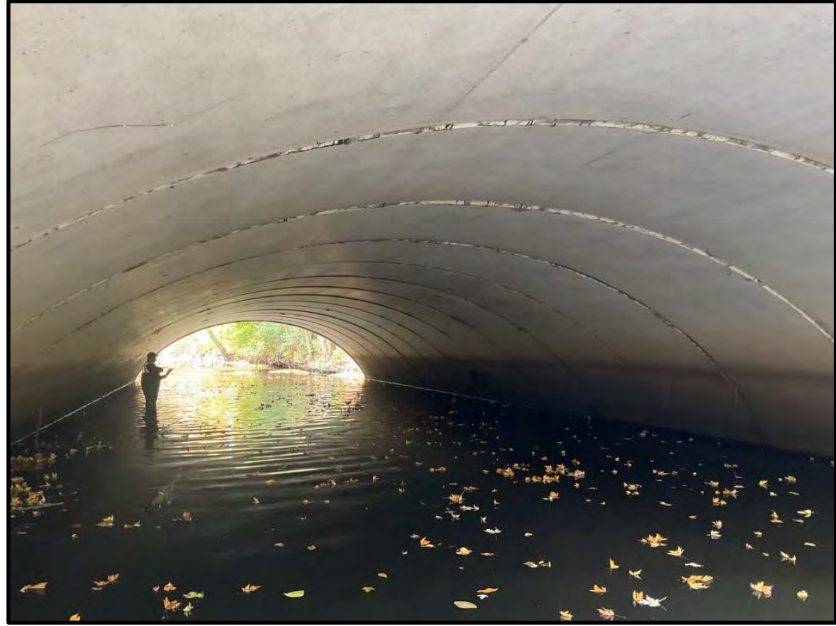
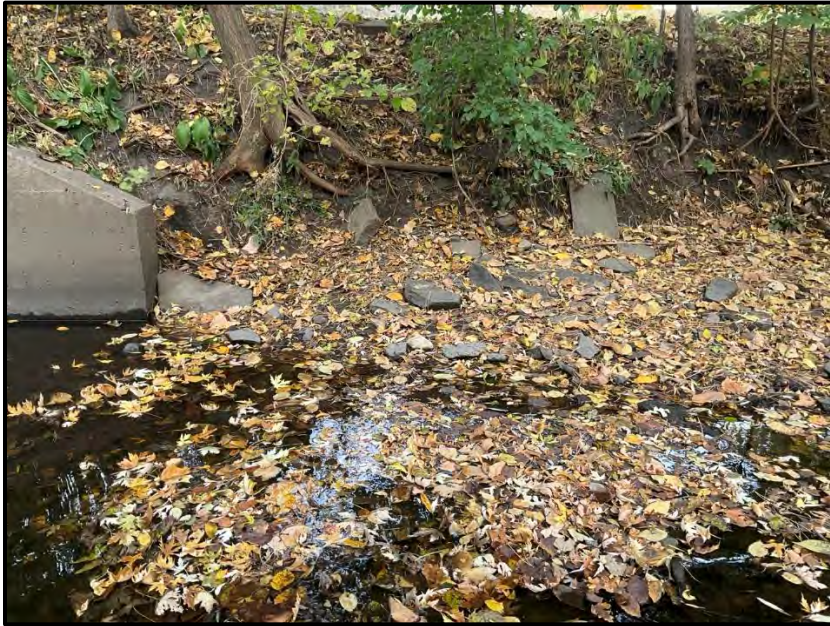
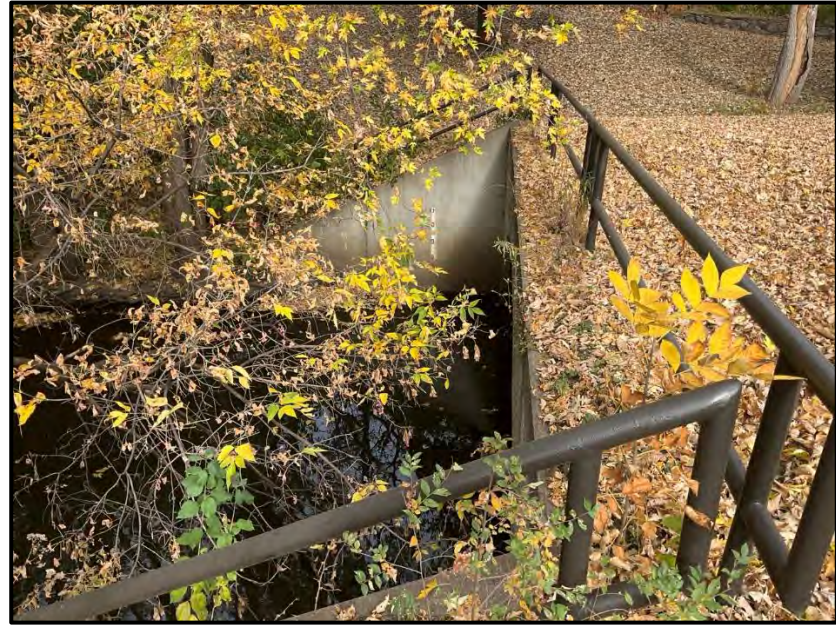
Regent Avenue Crossing (Golden Valley)

- a. The concrete Bebo arch culvert appeared to be in satisfactory condition.
- b. The channel bottom was soft and mucky, and the water level was below the bottom of the staff gauge and not measured.

- c. Spalled concrete was observed at the middle joint of the upstream north (left) wing wall. This is consistent with previous inspections and has been noted since 2002.

- d. A crack was observed at the upstream north (left) wing wall. The crack was near the top of the wing wall and travels at a 45-degree angle down to the headwall. This is consistent with previous inspections and has been noted since 2002.

- e. A crack was observed at the downstream south (right) wing wall. The crack was near the top of the wing wall and travels at a 45-degree angle down to the headwall. This is consistent with previous inspections and has been noted since 2002.

- f. Minor erosion was observed on the upstream side of the left bank and downstream side of the north (left) wing wall. This area is included in the project extents for the BCWMC's Main Stem Restoration Project from Reagent Avenue to Golden Valley Road as part of the 5-year Capital Improvement Program.

- g. Flows appeared to have scoured the north (left) side of the creek bottom and deposited sediment on the south (right) side of the creek bottom.
- h. The railings appeared to be in satisfactory condition.

- Monitor spalled concrete at the upstream north (left) wing wall.
- Monitor cracks at the upstream north (left) wing wall, upstream south (right) wing wall, and downstream south (right) wing wall.
- Monitor creek bottom for scour and deposition.

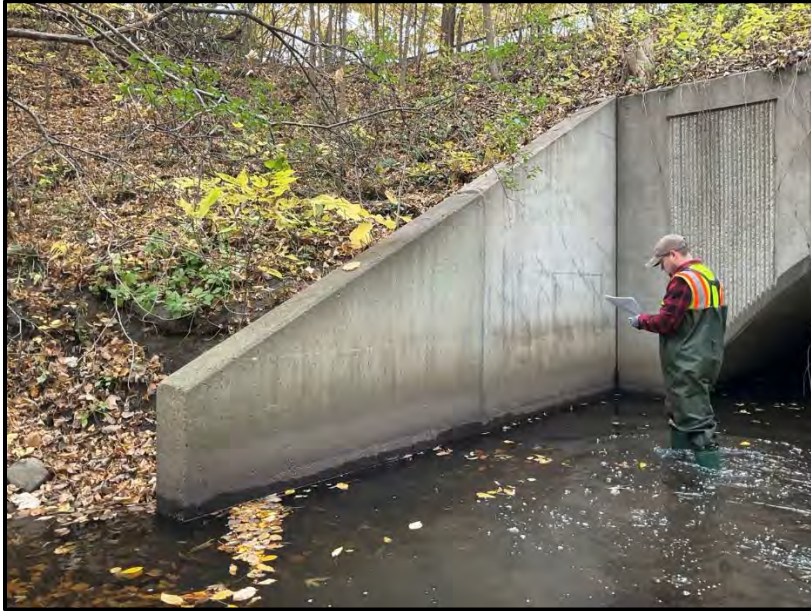
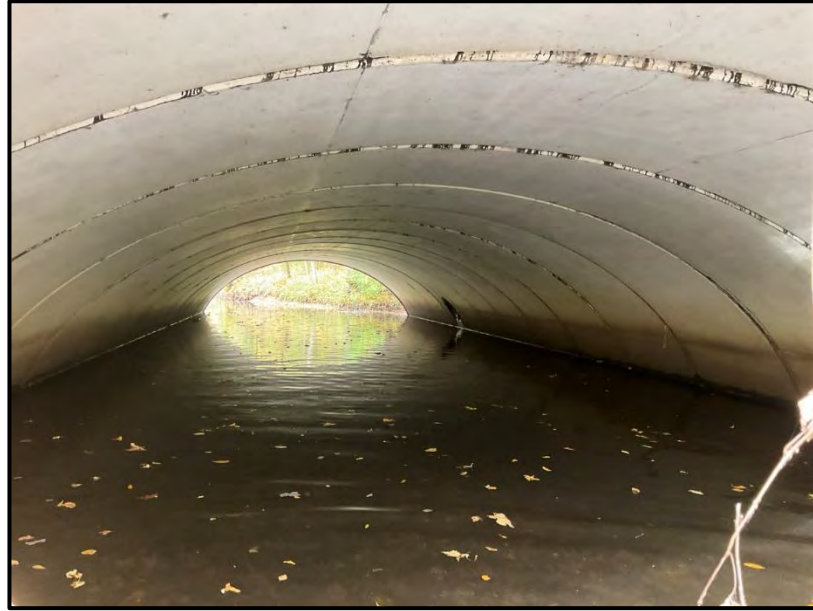
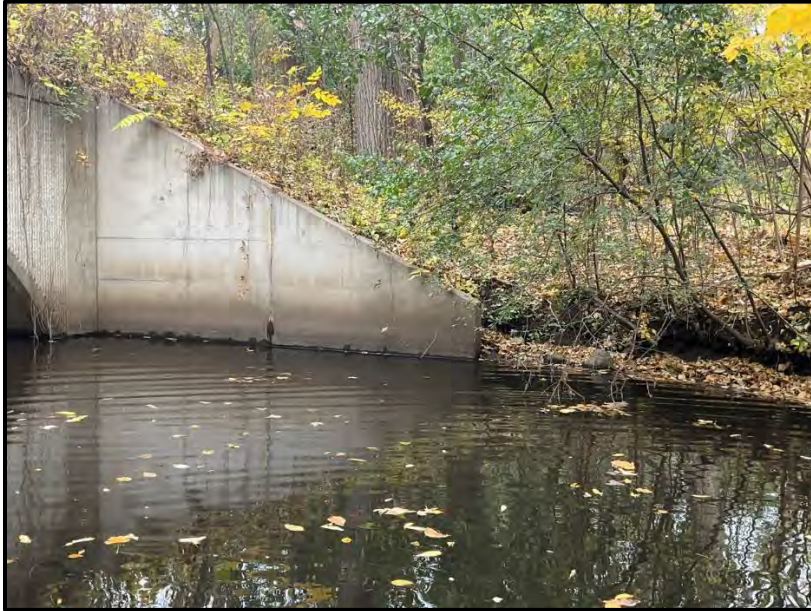
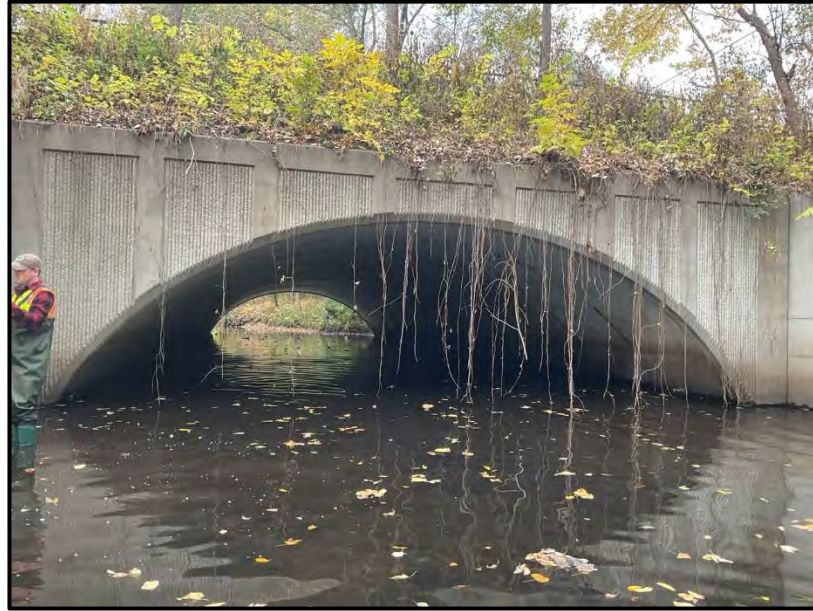
Noble Avenue Crossing (Golden Valley)

- a. The concrete Bebo arch culvert appeared to be in satisfactory condition.
- b. Longitudinal hairline cracks were observed throughout the length of the top of the culvert, extending across the entire (pre-cast) section width. The cracks were either in the center of the

structure or approximately 2 feet off-center of the structure. This is consistent with previous inspections and has been noted since 2002.

- c. Spalled concrete and exposed plastic joint material were observed approximately 2 feet either side of center throughout the length of the top of the culvert. The cement paste covering the plastic joint material has separated and exposed the plastic. This is consistent with previous inspections and has been noted since 2002.

- d. Fractured and spalled concrete was observed at the downstream north (left) wing wall. This is consistent with previous inspections and has been noted since 2002.

- e. Multiple cracks and spalling were observed at the top of downstream north (left) wing wall. The cracking is consistent with previous inspections and has been noted since 2007.

- g. Minor bank erosion and scour was observed on both sides of the downstream wing walls. This is consistent with previous inspections and has been noted since 2002.
- h. Flows appeared to be scouring the north (left) side of the creek bottom.
- i. The paint on the railings is peeling.
- j. The City of Golden Valley installed riprap in 2018 to reinforce the bank and minimize continued erosion at the outside edge of the upstream south (right) wing wall, however some erosion has perpetuated upstream.

- Monitor cracks and spalled concrete in the culvert and wing walls.
- Monitor bank erosion at downstream wing walls and upstream of installed riprap at upstream south (right) wing wall.
- Monitor creek bottom for scour and deposition.

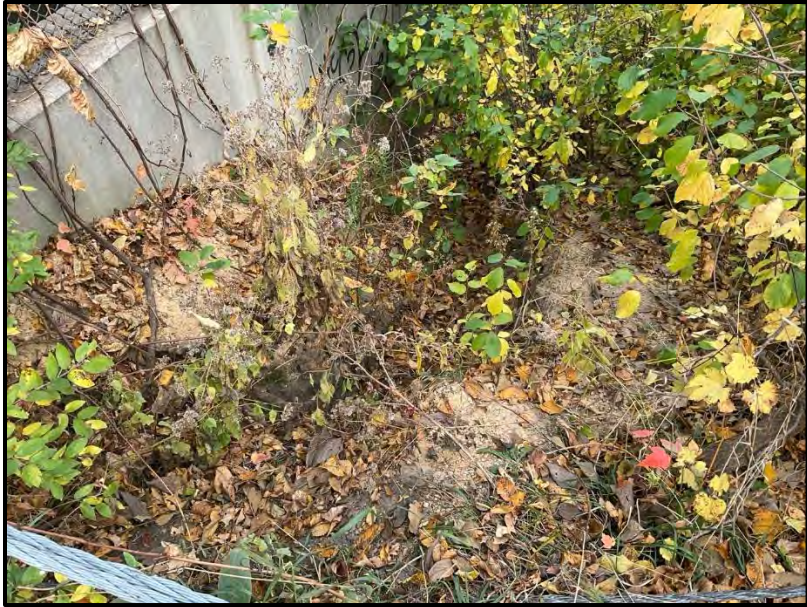
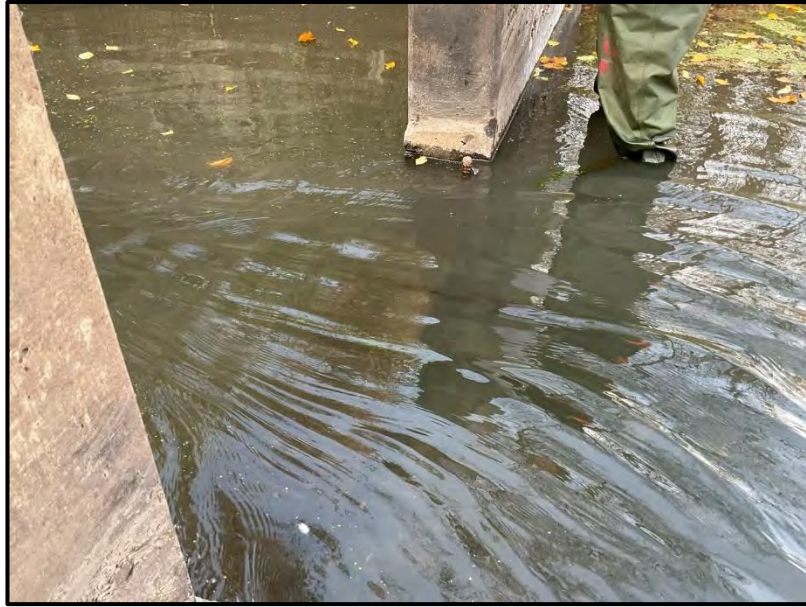
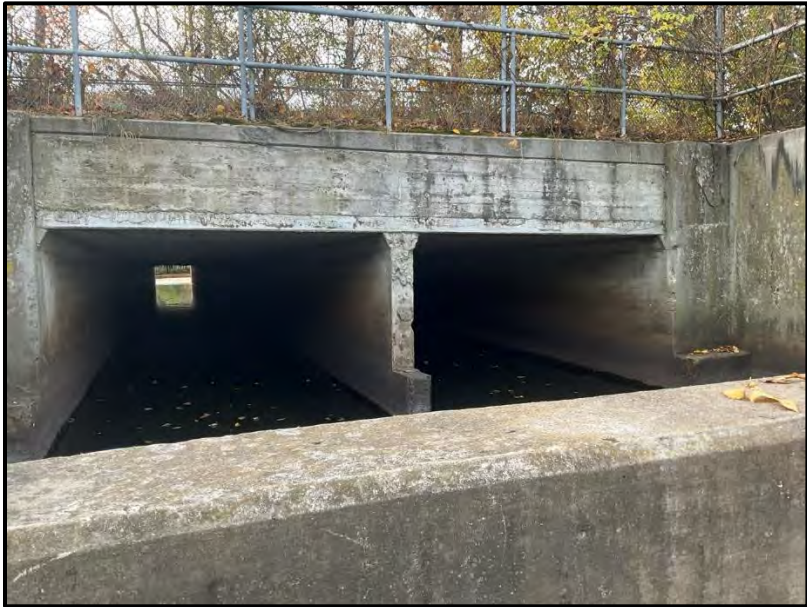
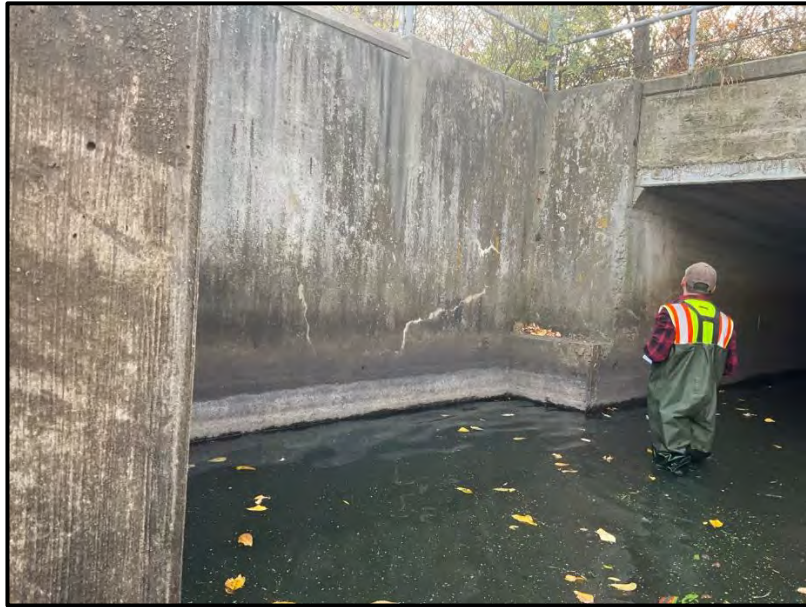
Highway 55 Control Structure (Golden Valley)

- a. The concrete control structure appeared to be in satisfactory condition.
- b. A hairline crack was observed in the east (left) wall of the inlet structure, although it appears that the crack may have been previously sealed with caulk. The crack is positioned in the middle of the wall extending full height. This is consistent with previous inspections and has been noted since 2002.

- c. Erosion was observed around the east (left) side of the structure, likely from road runoff. In the summer of 2021, Minnesota Department of Transportation (MnDOT) crews placed class 5 aggregate on the east (left) side of the structure to access the upstream end of the structure to perform repairs of the double box culvert below Highway 55. The new class 5 aggregate is actively eroding. The erosion appears to have continued to worsen since previous years.

- d. MnDOT crews also drilled holes into the structure to install brackets and a temporary plate to block flows through the structure so they could perform repairs. MnDOT removed the plate, brackets, and bolts, but did not fill or repair the bolt holes.

- e. Downed trees are located near the left corner on the upstream side of the structure.
- f. In 2021, 2022, and 2024 a piece of rebar and relatively small mass of concrete were observed extending into the lower west (right) side of the opening of the low flow weir. A steel threaded rod extended approximately 2 inches from the south face of concrete on the east (left) side of low flow weir.

- Protect the sides of the structure with armoring (rock or riprap) or reinforced vegetation to limit additional erosion. Alternatively, divert road runoff away from the structure.
- Remove downed trees near the upstream side of the structure.
- Sawcut and remove rebar and concrete chunk on east (left) side of low flow weir.
- Sawcut steel rod to be flush to concrete along south face of concrete on the east (left) side of the low flow weir.
- Repair chain link fence

- Monitor hairline crack in the control structure.
