# Memorandum

**To:** Bassett Creek Watershed Management Commission (BCWMC)  
**From:** Barr Engineering Co. (Barr) (Josh Phillips, Gabby Campagnola, Jim Herbert)  
**Subject:** Item 4F: Bassett Creek 2024 Flood Control Project Inspection - BCWMC December 19, 2024 Meeting Agenda  
**Date:** December 12, 2024  
**Project:** 23270051.62 1080 001

## 4F Bassett Creek 2024 Flood Control Project Inspection

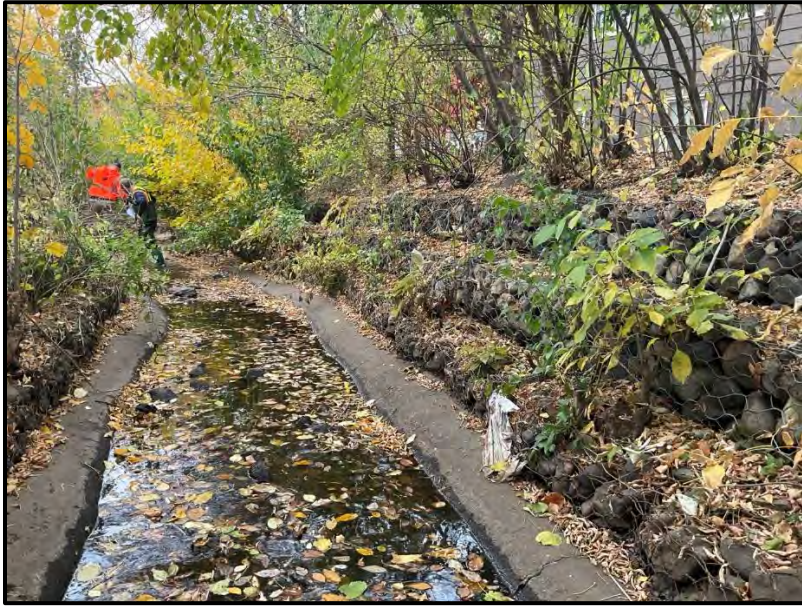
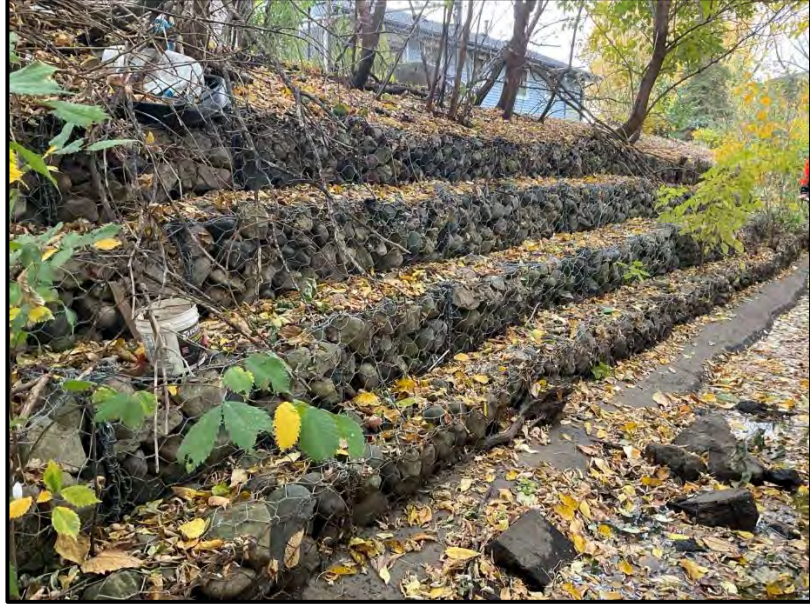
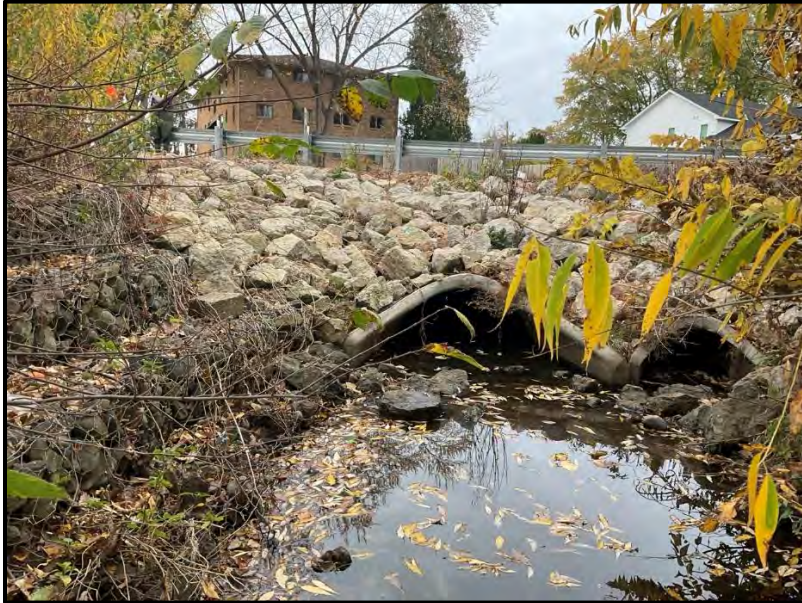
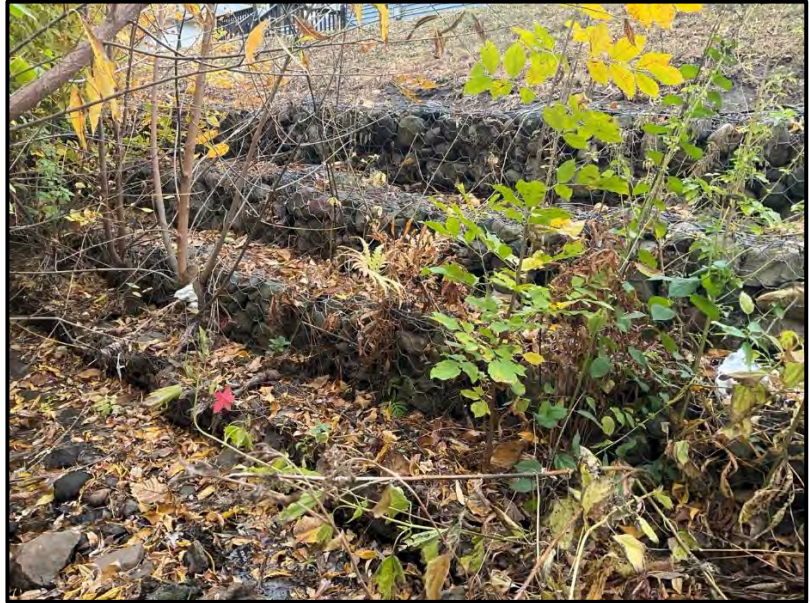
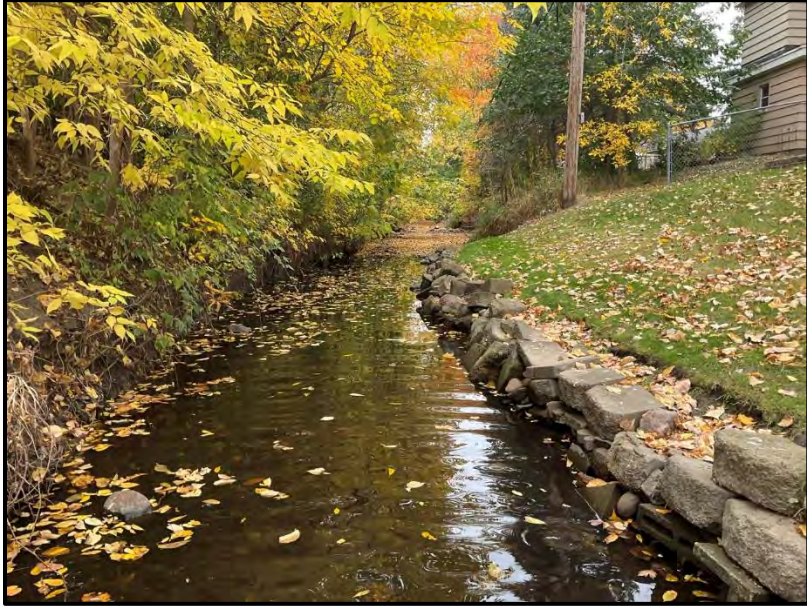
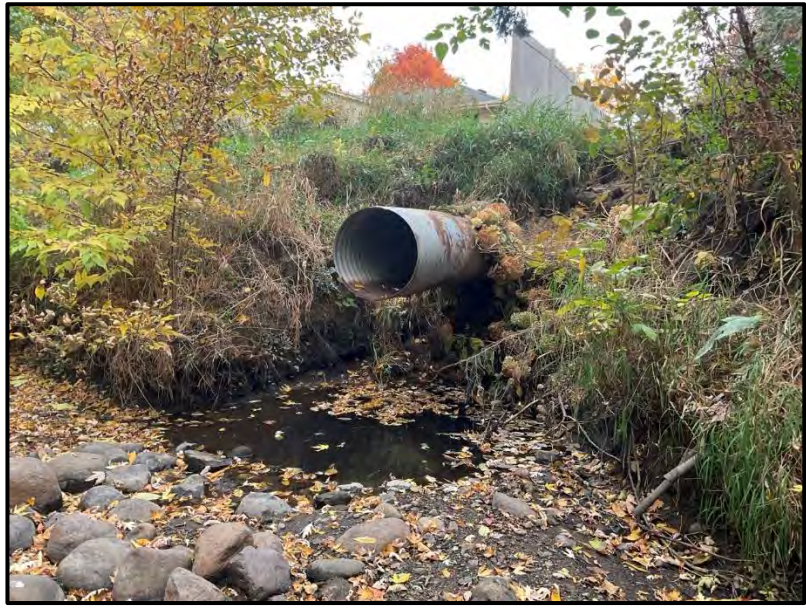
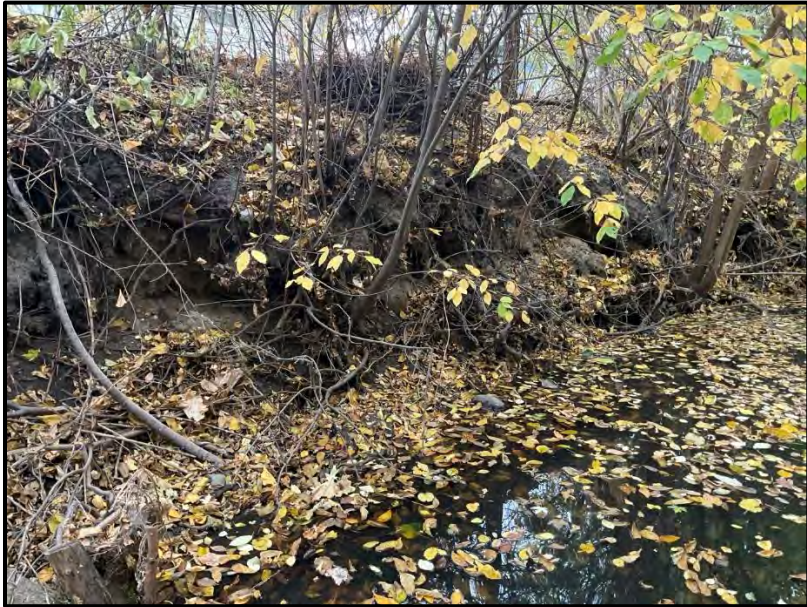
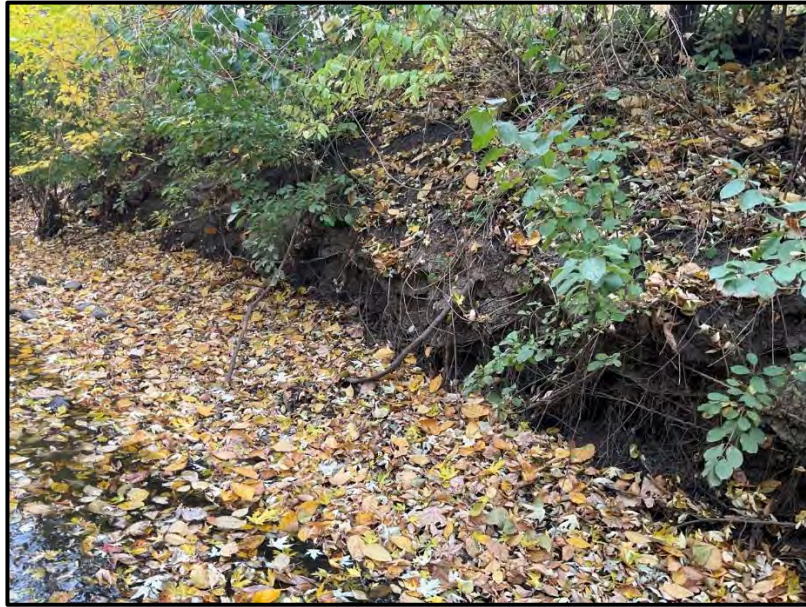
Markwood Open Channel (Crystal)

- a. The channel appeared to be in satisfactory condition.
- b. Vegetation growth was observed along the side slopes of the channel. Some areas appeared to have been cleared since the previous year's inspection.

- c. Erosion was observed along the toe of the north (left) and south (right) banks. This is consistent with previous inspections and has been noted since 2006.

- d. The retaining wall along the channel at 7010 36th Avenue is failing and falling into the channel, potentially impacting high flows and causing erosion.

- e. Other downstream retaining walls and fences along the channel were leaning toward the channel and, in some cases, appeared to be failing. This is consistent with previous inspections and has been noted since 2009.

- f. The City of Crystal's corrugated metal pipe (CMP) storm sewer, discharging into the channel between 6833 and 6825 Markwood Drive, was in poor condition. The pipe bottom was corroded and there was erosion and undercutting around the pipe end. The pipe was exposed approximately 10 feet, measured on the downstream side.

- g. Cinder blocks and miscellaneous debris (bed frame, chair) were observed in the creek.
- h. New bank erosion along right bank was observed downstream of the gabion section.

- i. While recent vegetation clearing appeared to have occurred along the gabion baskets section, the clearing could only be done above the top of the baskets and vegetation is still growing through the baskets. It was unclear if herbicide was used to prevent regrowth, but this vegetation may continue to pose a risk of damage to the gabion baskets.

- Clear woody vegetation to maintain flow capacity, protect the gabion baskets from damage, and allow access through the open channel. Consider clearing vegetation every other year. Chemically treat stumps with Garlon 3A herbicide (or other specialty herbicide for use in wetland sites and waterways) to prevent regrowth.
- Remove cinder blocks and debris from the creek.

- Although not part of the flood control project, the city may want to consider repairing or replacing the CMP storm sewer.
- Although not part of the flood control project, repair the failing retaining wall and/or stabilize the area at 7010 36<sup>th</sup> Avenue to prevent erosion and potential obstruction of channel flows.

- Monitor remaining retaining walls and fences for potential failure and obstruction of flow through the channel.
- Monitor erosion along the toe of the channel banks.

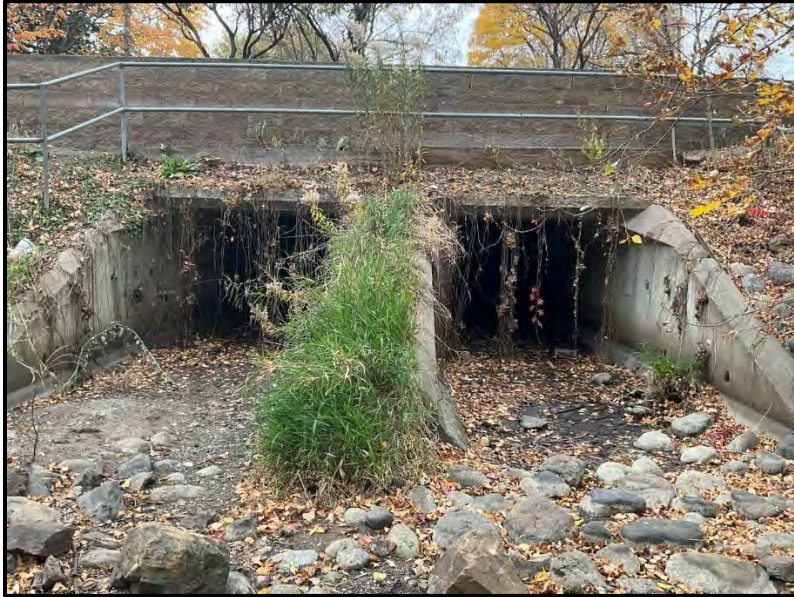
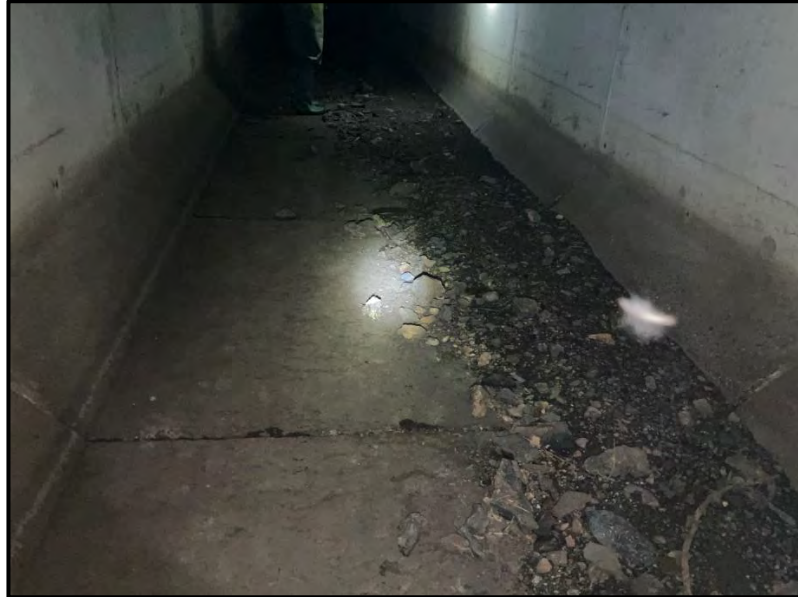
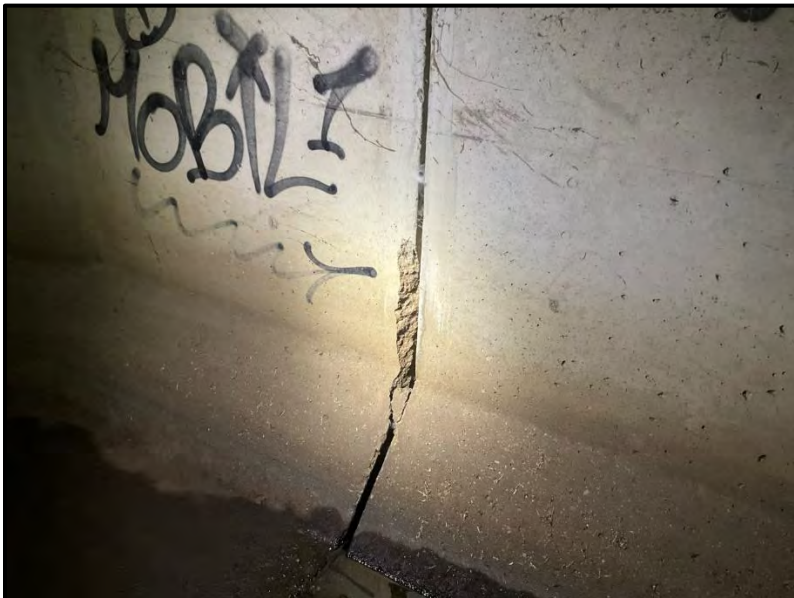
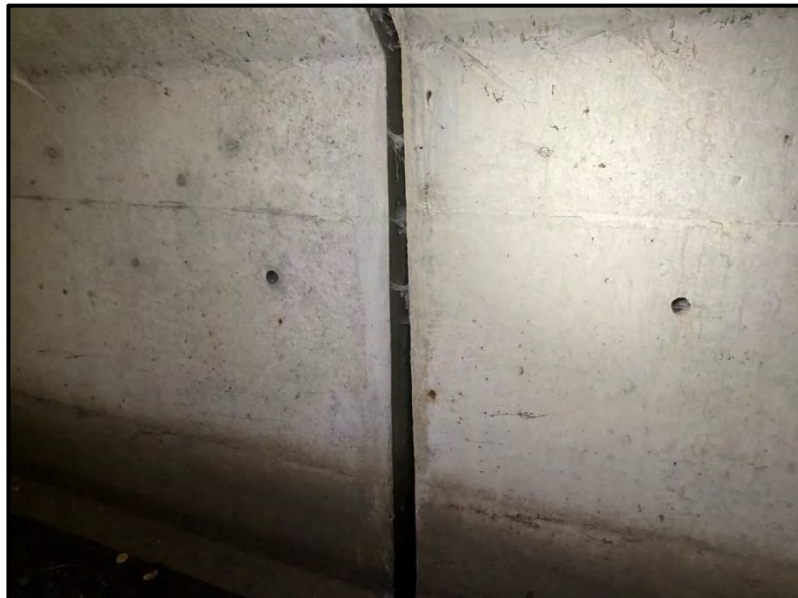
36th Avenue and Hampshire Avenue Crossing (Crystal)

- a. The concrete box culverts, joints and tie bars appeared to be in satisfactory condition.
- b. Some riprap has deposited in the box culverts.
- c. Sediment has deposited in the box culverts, mostly in the downstream half of the box culverts. This is consistent with previous inspections and has been noted since 2016.

- d. On both culverts, the fifth joint from the downstream end had a 2 ½ inch gap, which is a larger gap than the rest of the joints. This is consistent with previous inspections and has been noted since 2010.

- e. Various locations of spalled concrete and exposed reinforcing was observed through both culverts.
- f. Infiltration was observed into the north (left) culvert in 2019 and 2020 at the storm pipe connection upstream of the first culvert bend. However, infiltration was not observed into the culvert at this location from 2021 to 2024, potentially due to lower water levels and dryer conditions.

- g. Approximately 6 inches of sediment was observed on the downstream side of both culverts.

- Remove deposited riprap in the box culverts and replace upstream.

- Monitor sediment in the box culverts.
- Monitor the joint gaps in the box culverts.
- Monitor spalled concrete, and exposed reinforcing in the culverts.

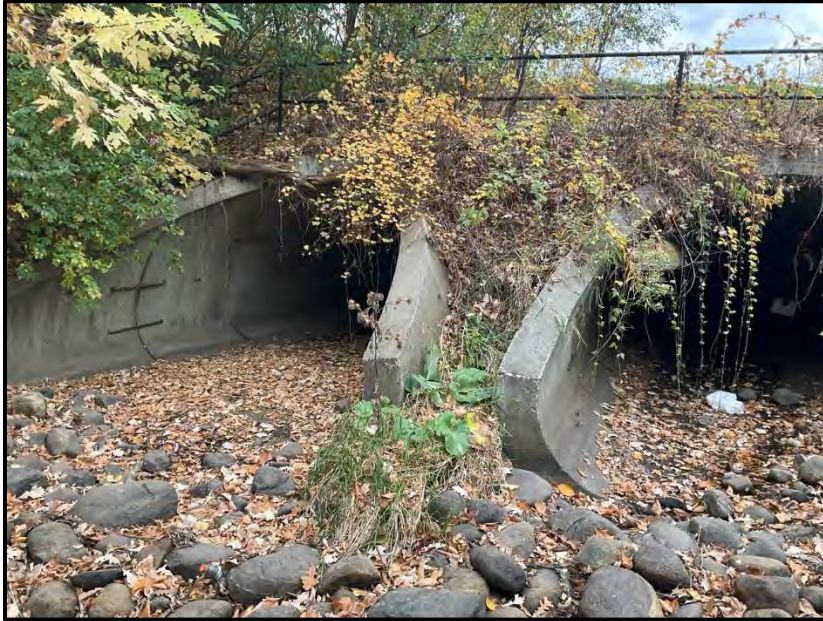
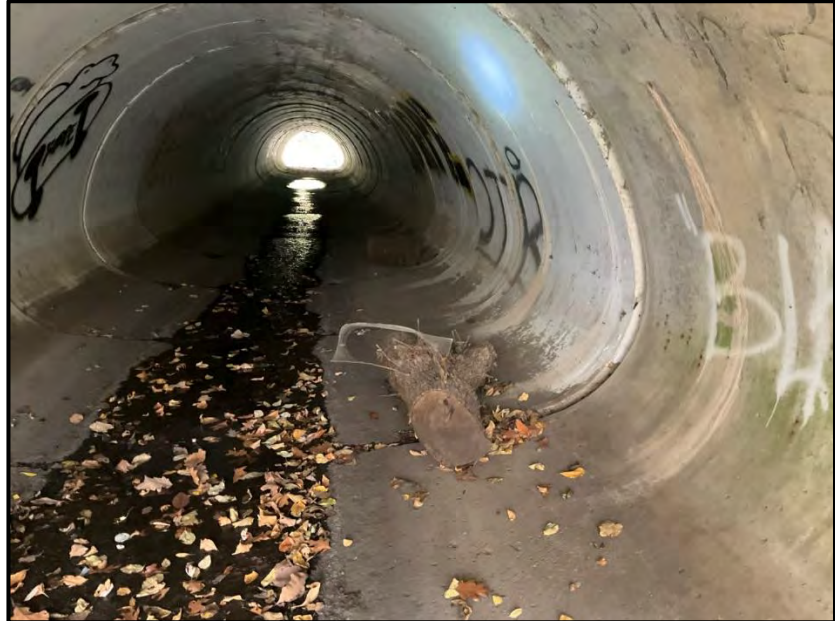
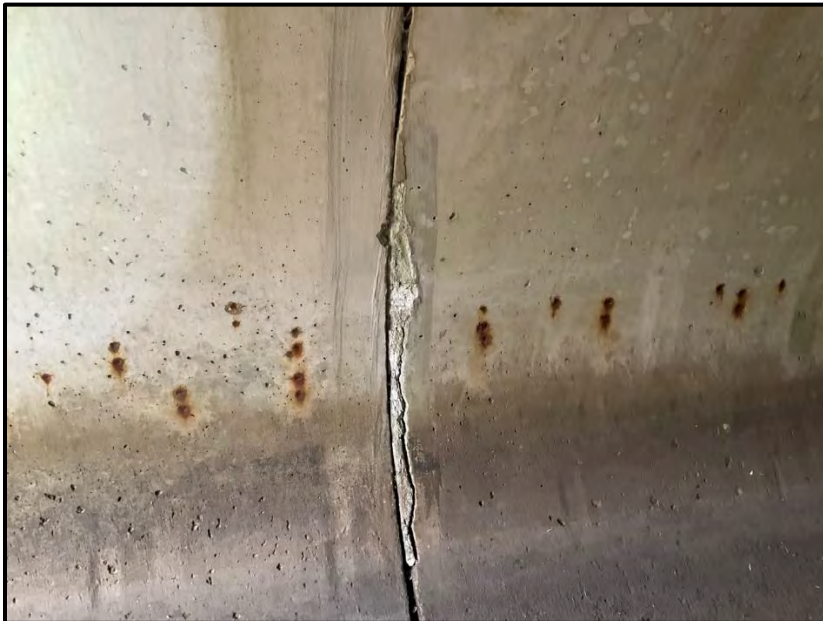
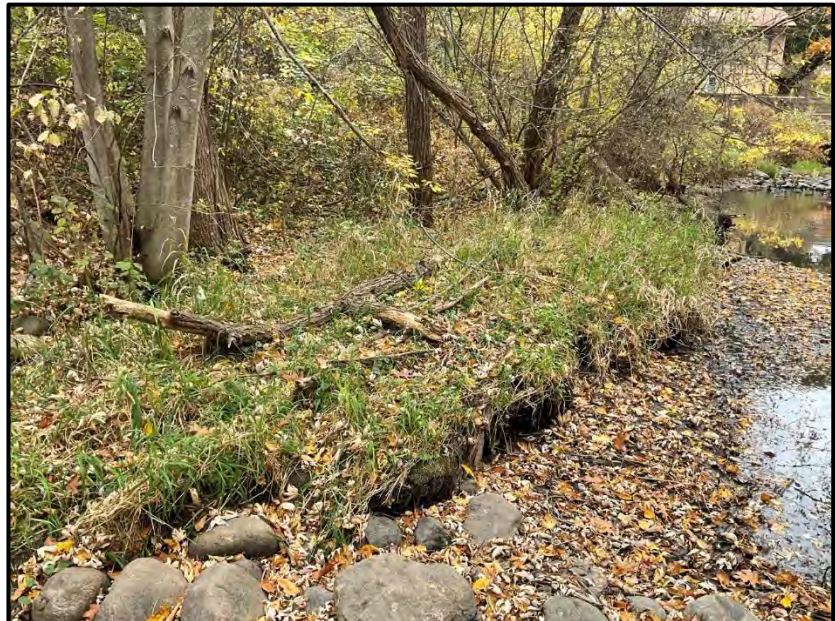
Georgia Avenue Crossing (Crystal)

- a. The concrete culverts appeared to be in satisfactory condition.
- b. Cracking and spalling were observed in the south (right) culvert at the second and fourth joints at approximately the five o'clock position.

- c. Cracking was observed in multiple joints in the north (left) culvert on the right side.
- d. Minor erosion was observed between the concrete culverts at the upstream end extending to nearly the first joint.

- Monitor cracking and spalling in the south (right) culvert.
- Monitor minor erosion between the concrete culverts on the upstream end.

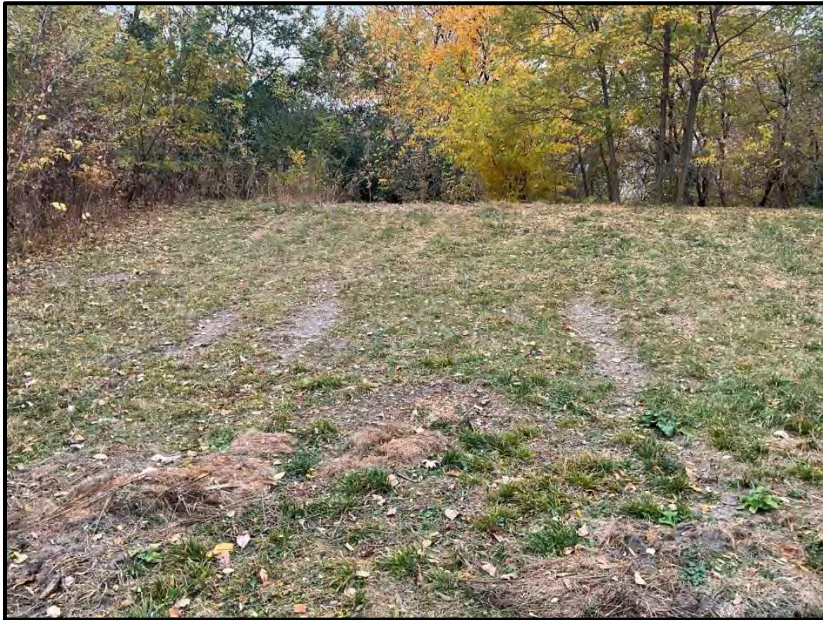
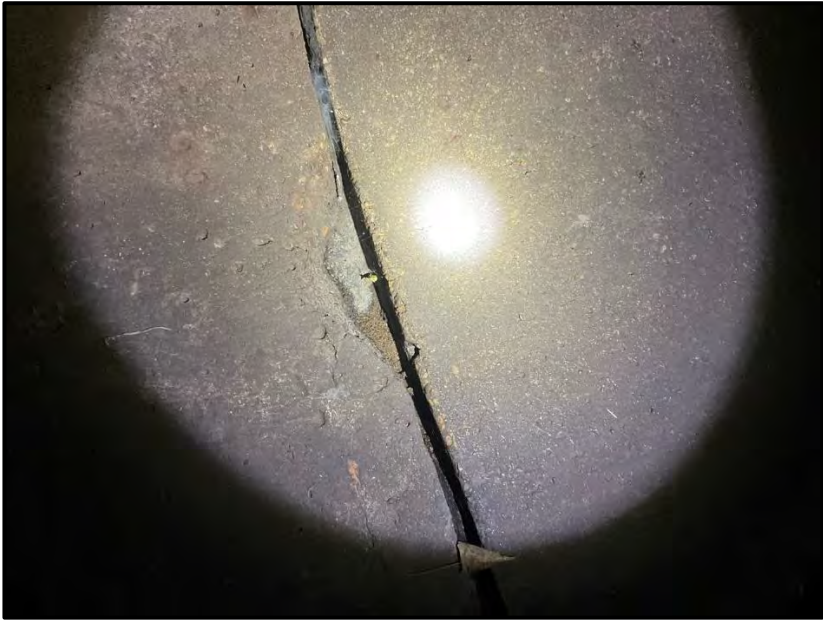
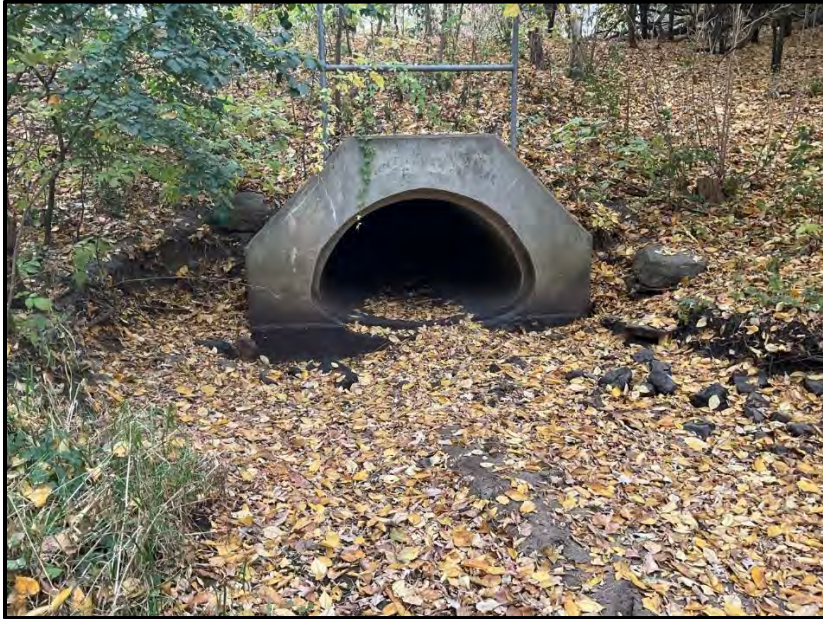
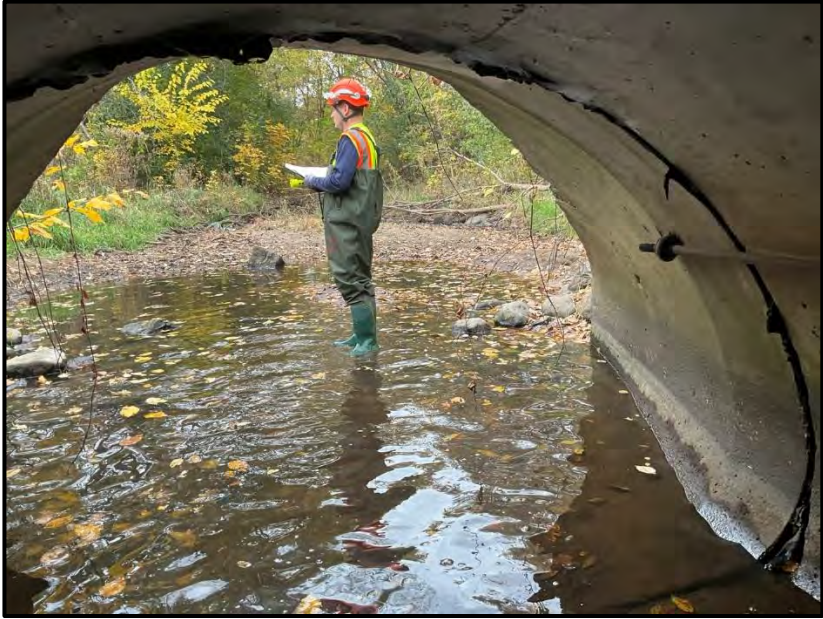
Edgewood Embankment (Crystal)

- a. The concrete culvert appeared to be in satisfactory condition.
- b. The embankment appeared to be in satisfactory condition.
- c. The creek was completely dry on upstream side of the embankment.

- d. No visible settlement or erosion was observed along the embankment.
- e. Trees and shrubs are growing on the embankment.
- f. The natural boulder riprap between the Edgewood embankment and Douglas Drive crossing is significantly overgrown with vegetation.

- g. Spalled concrete was observed at four joints in the culvert.
- h. Spalled concrete was observed on the north (right) and south (left) side of the downstream flared end section of the culvert.

- k. Small dead trees were observed downstream of embankment.

- Monitor spalled concrete at the fifth joint from the upstream end in the culvert.
- Monitor spalling on outlet structure.
- Monitor sediment accumulation in the pool downstream of the culvert.

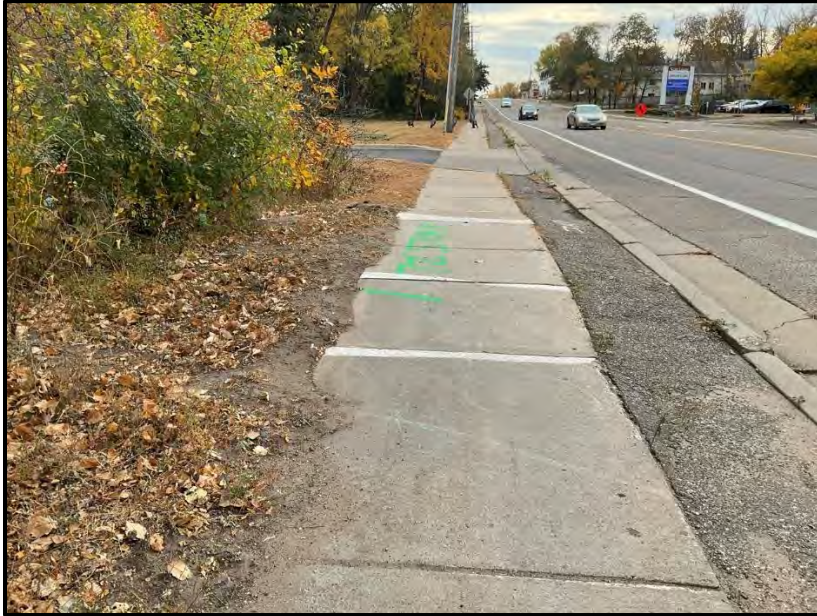
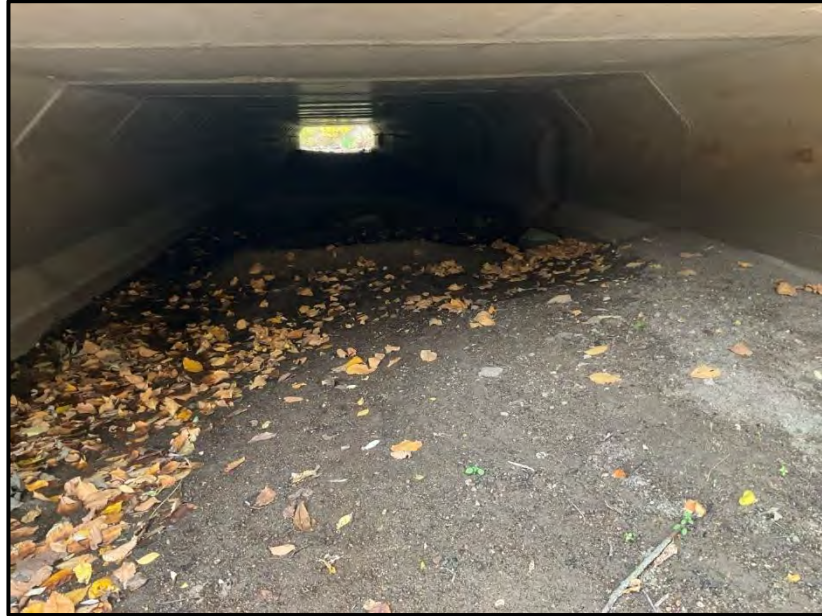
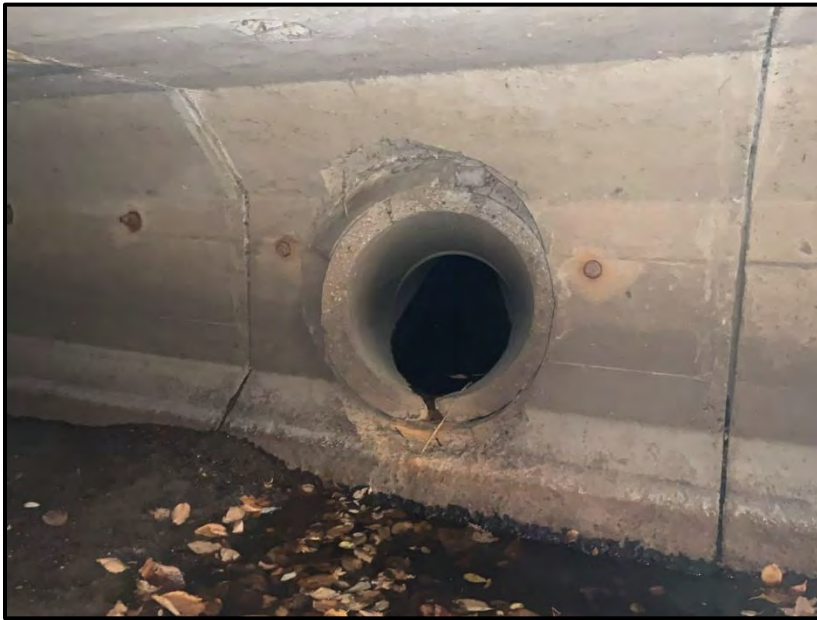
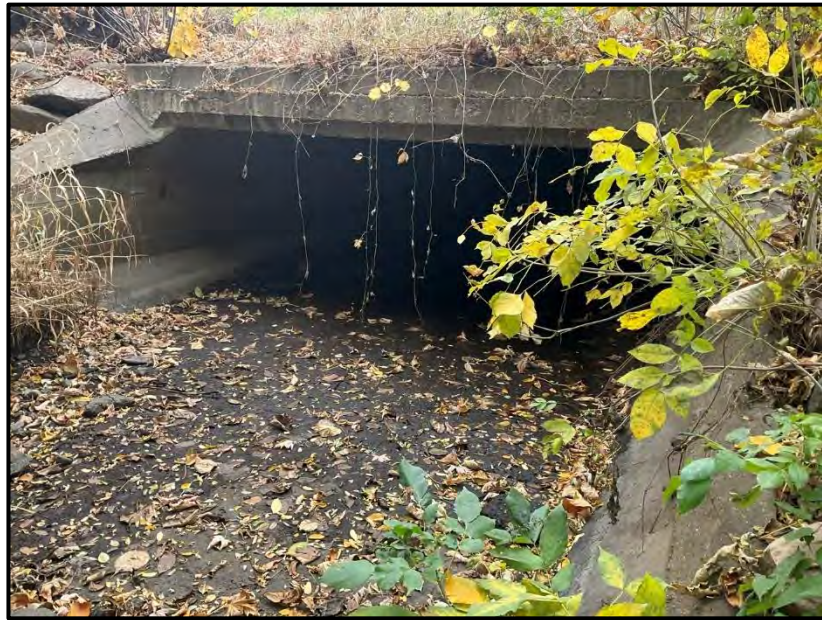
Douglas Drive Crossing (Crystal)

- a. The concrete box culvert was not entered due to low clearance but appeared to be in satisfactory condition, based on visual inspection.
- b. The grouted riprap installed on each side of the box culvert outlet has started to deteriorate, and a gap has opened between the grout and the wall of the box culvert. This is consistent with previous inspections and has been noted since 2016.

- c. Spalled concrete was observed at the downstream north (left) wing wall.
- d. Sediment has deposited in the bottom of the culvert, ranging from 0-8 inches deep.

- e. Some riprap was observed in the culvert.
- f. On the downstream end of the culvert, settling was observed in the sidewalk on each side of the culvert.

- g. Spalled concrete was observed on the top of the culvert on the downstream end.
- h. There are two reinforced concrete storm pipes in Douglas Drive that connect on the left (north) side and right (south side) of the culvert. The reinforced concrete storm pipe on the right (south) side of the culvert appeared to be significantly cracked.

- i. Small trees were observed adjacent to the structure at the downstream end.
- j. Although not part of the flood control project, the privately-owned CMP culvert downstream of the Douglas Drive crossing is in poor condition. Sagging of this culvert has been observed during inspections since 2009. The culvert is significantly bowing and settling has occurred on either side of the culvert, which is evident in the road pavement above the structure.

- Remove riprap from the culvert and replace upstream.
- Consider adding a railing along the sidewalk at the upstream and downstream end of the culvert.
- Consider repairing the reinforced concrete storm pipes in Douglas Drive that connect to the culvert on the right (south) side.
- Although not part of the flood control project, it is recommended that the city coordinate with the property owner to repair or replace the culvert downstream of Douglas Drive.

- Monitor deposited sediment in the culvert.
- Monitor grouted riprap at the downstream end of the box culvert.
- Monitor spalled concrete at the downstream north (left) wing wall.
- Monitor settling in the sidewalk at the downstream end of the culvert.

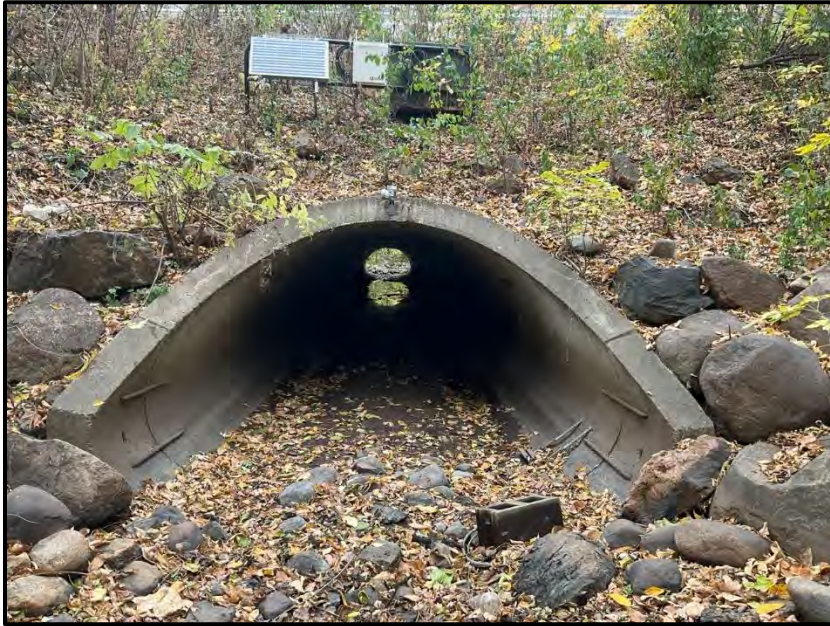
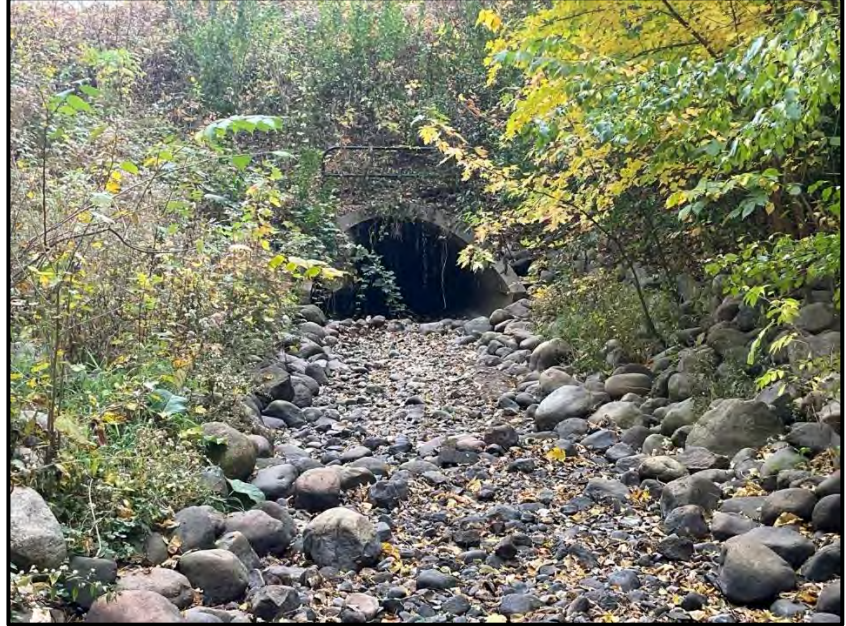
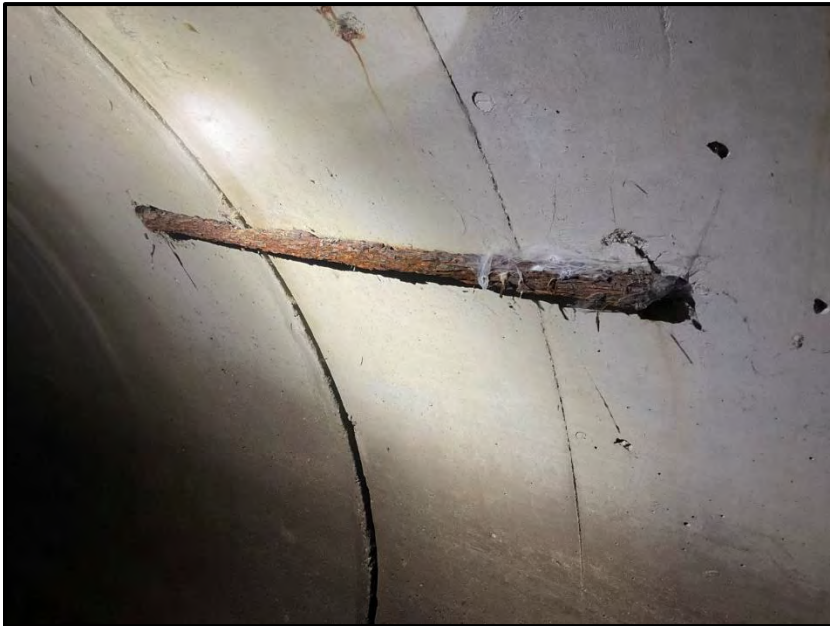
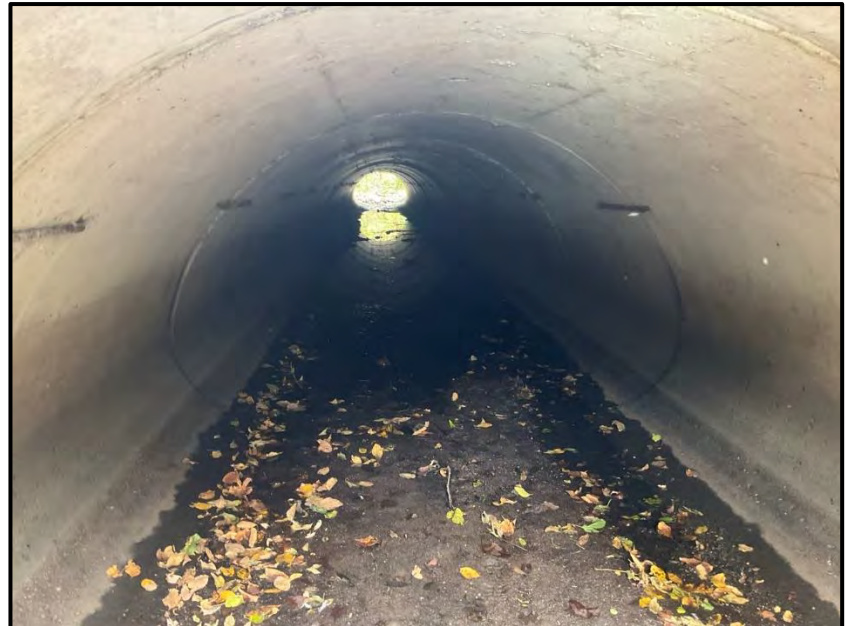
34th Avenue Crossing (Crystal)

- a. The concrete culvert appeared to be in satisfactory condition.
- b. Sediment has deposited in the bottom of the culvert, ranging from 0-4 inches deep. This is consistent with previous inspections and 0-12 inches of sediment has been noted in the culvert since 2002.
- c. The tie bars directly upstream and downstream of the manhole connection to the culvert were rusty and flaking. This is consistent with previous inspections and has been noted since 2008.
- d. An access trail to the creek was recently cleared on the upstream side of the structure.
- e. BCWMC has a monitoring station at this site.

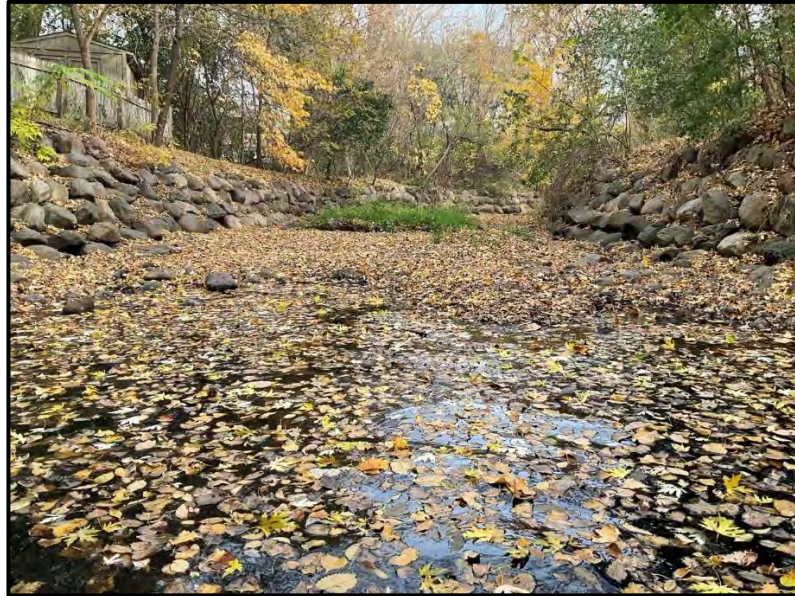
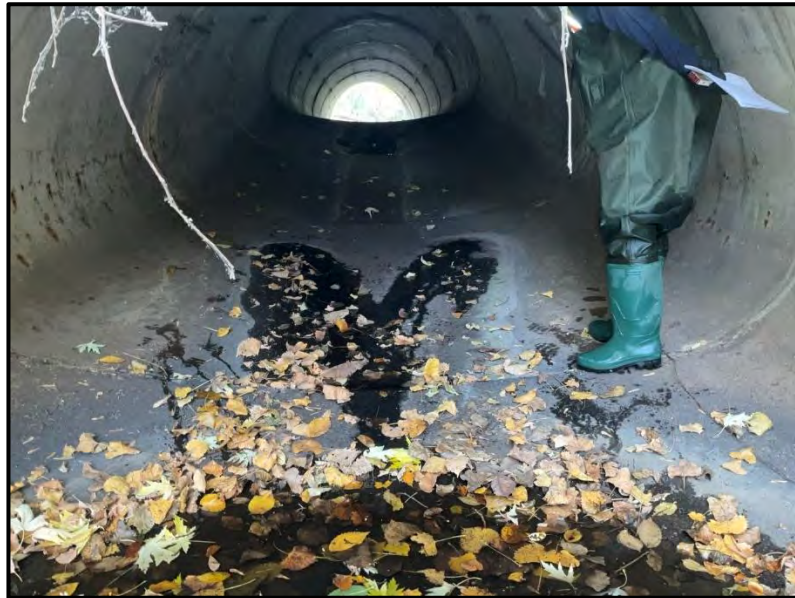
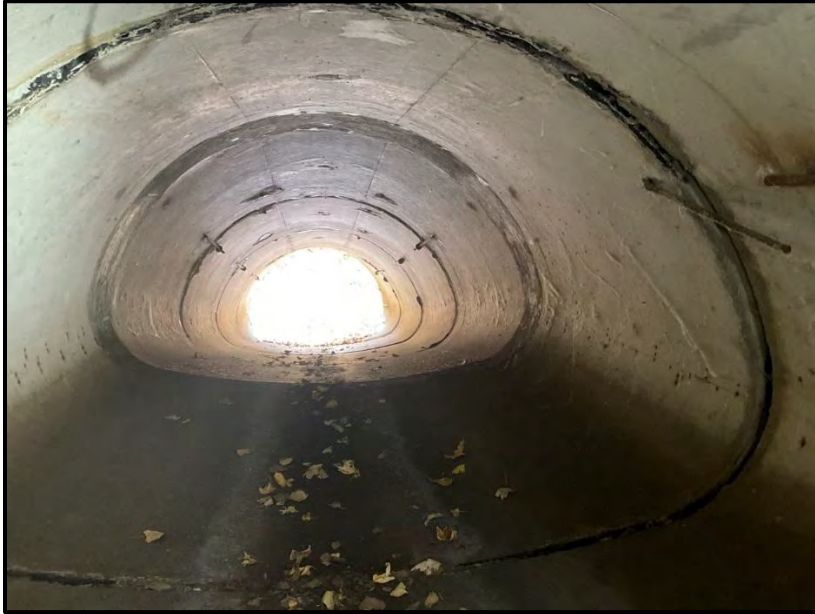
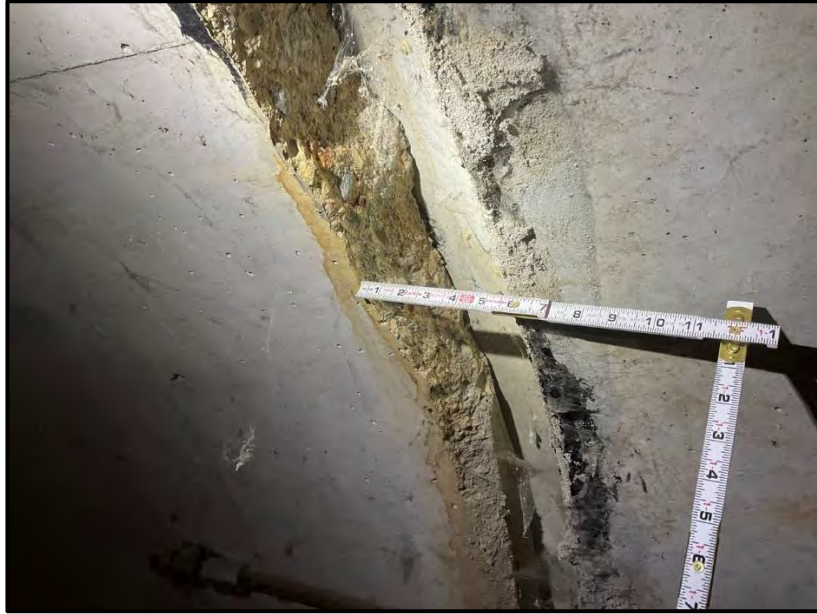
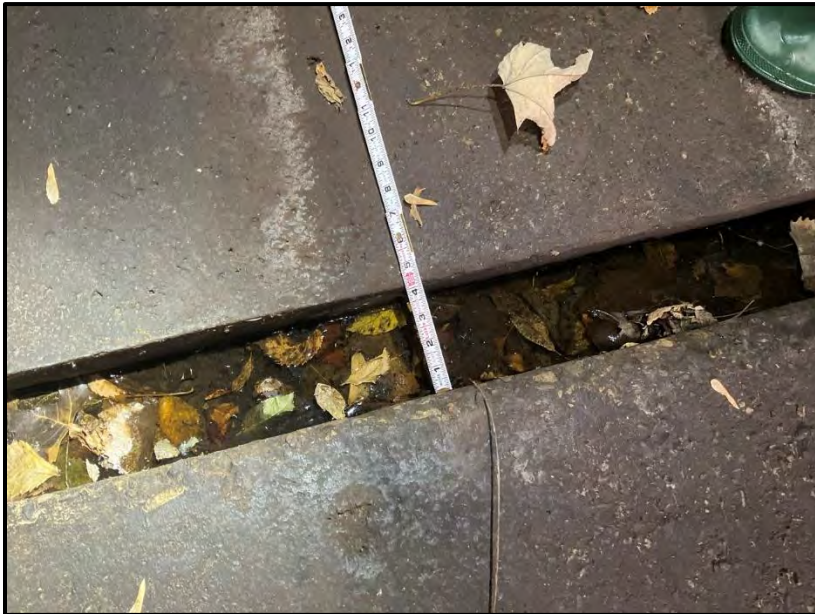
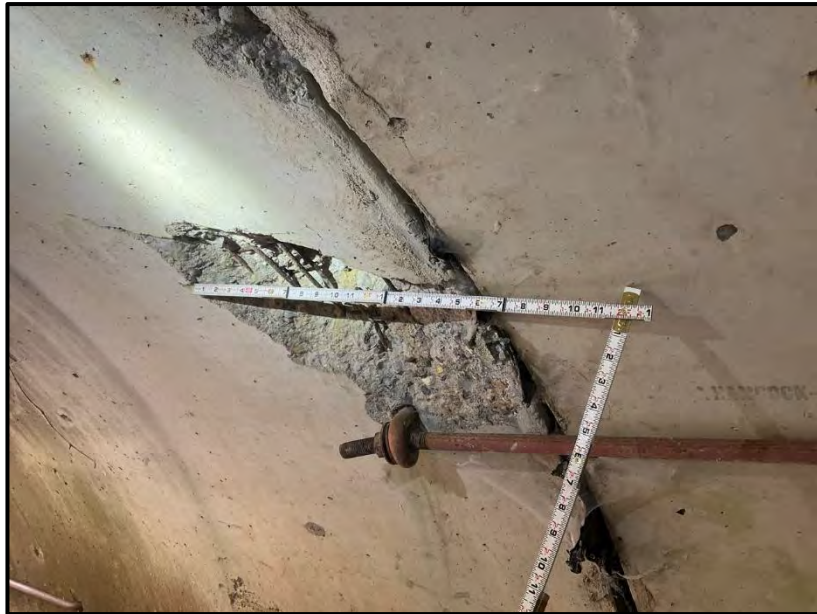
Brunswick Avenue Crossing (Crystal)

- c. Grout and grout repair appeared to be failing at all joints in both culverts. Fractured pieces of concrete and grout were observed at multiple joints in both culverts.

- d. Longitudinal and circumferential cracks were observed in both culverts.
- e. Strained and detached tie bars were observed in the north (left) culvert. One joint with broken tie bars was previously re-grouted by the City of Crystal, but the joint reopened and a 1.5-inch-gap in the joint was observed during the 2008 inspection. A 3-inch gap in the joint has been noted since 2009.

- f. At the 2<sup>nd</sup> and 5<sup>th</sup> joint from the downstream side of the north (left) culvert, broken tie bars on both sides of the culvert were observed.

- g. Two holes were observed at the 2<sup>nd</sup> joint from the downstream side of the north (left) culvert. Water appeared to be seeping through 2<sup>nd</sup> downstream joint and coming out of the hole.

- m. A scour hole was observed at the downstream side of the left culvert.
