**To:** Bassett Creek Watershed Management Commission (BCWMC)  
**From:** Barr Engineering Co.: Josh Phillips, P.E., Jim Herbert, P.E., Joe Welna, P.E.  
**Subject:** Item 4D: Bassett Creek Box Culvert Inspection Report: Inspection Date: November 2024 -  
BCWMC February 20, 2025 Meeting Agenda  
**Date:** February 13, 2025  
**Project:** 23270051.65 1080 002

# Bassett Creek Double Box Culvert Inspection Report

Prepared for  
Bassett Creek Watershed Management Commission

Inspection Date: November 2024

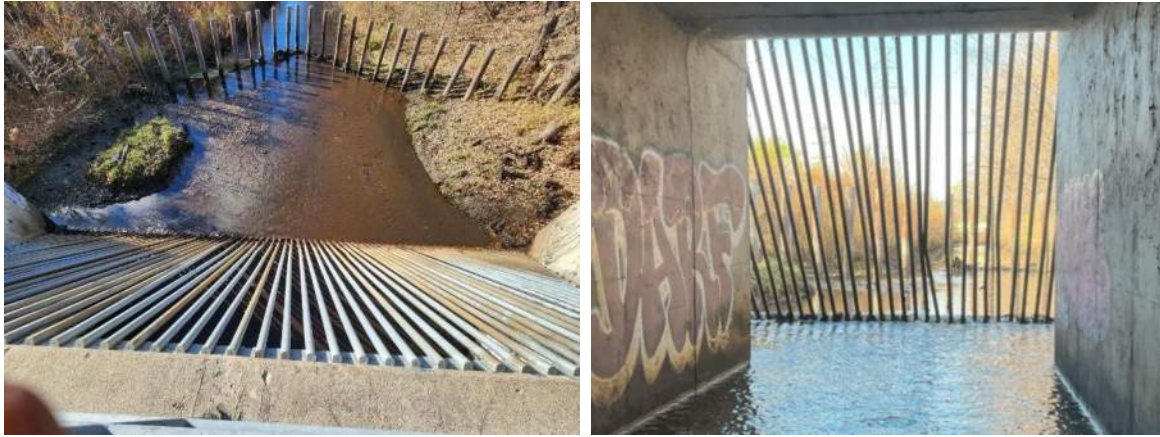
**Figure 3-2 Trash Rack Debris Following Cleaning By City of Minneapolis**
