FEASIBILITY Report

June 10, 2014

DRAFT 2015 Bassett Creek Main Stem Restoration Project

DRAFT FEASIBILITY STUDY FOR 2015 BASSETT CREEK MAIN STEM RESTORATION PROJECT

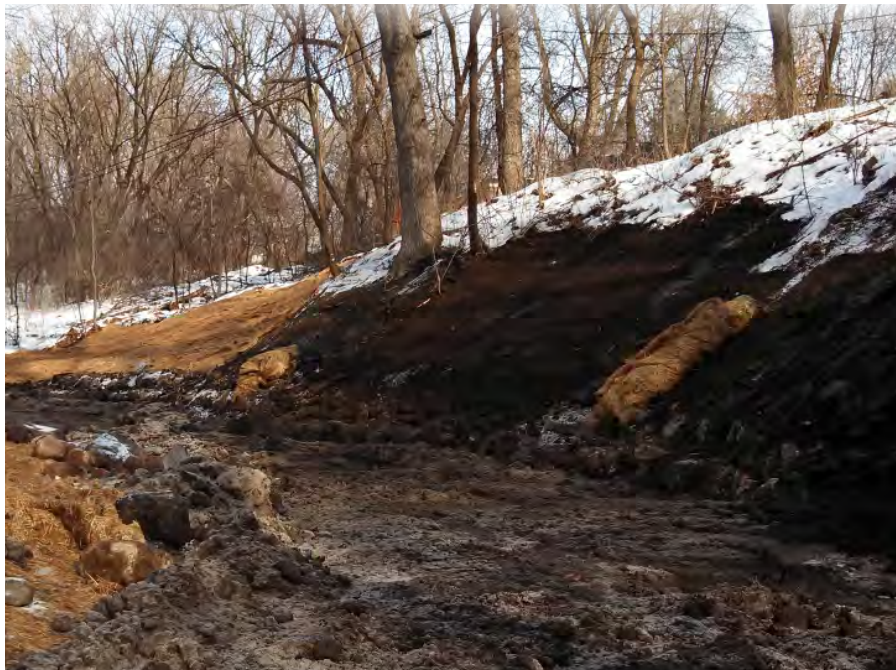
Slope Preparation

This work consists of shaping the contours of the maintenance areas to achieve slopes as shown on the plans. Slope preparation will aid in the placement of the selected slope stabilization method. It is anticipated that earthwork on this project will balance on site.

In many places, the eroding bank will be graded to a 3:1 slope. This provides a stable slope that will not naturally slough and it provides a surface that is flat enough on which vegetation can be planted or seeded. **Figure 4** illustrates this practice.

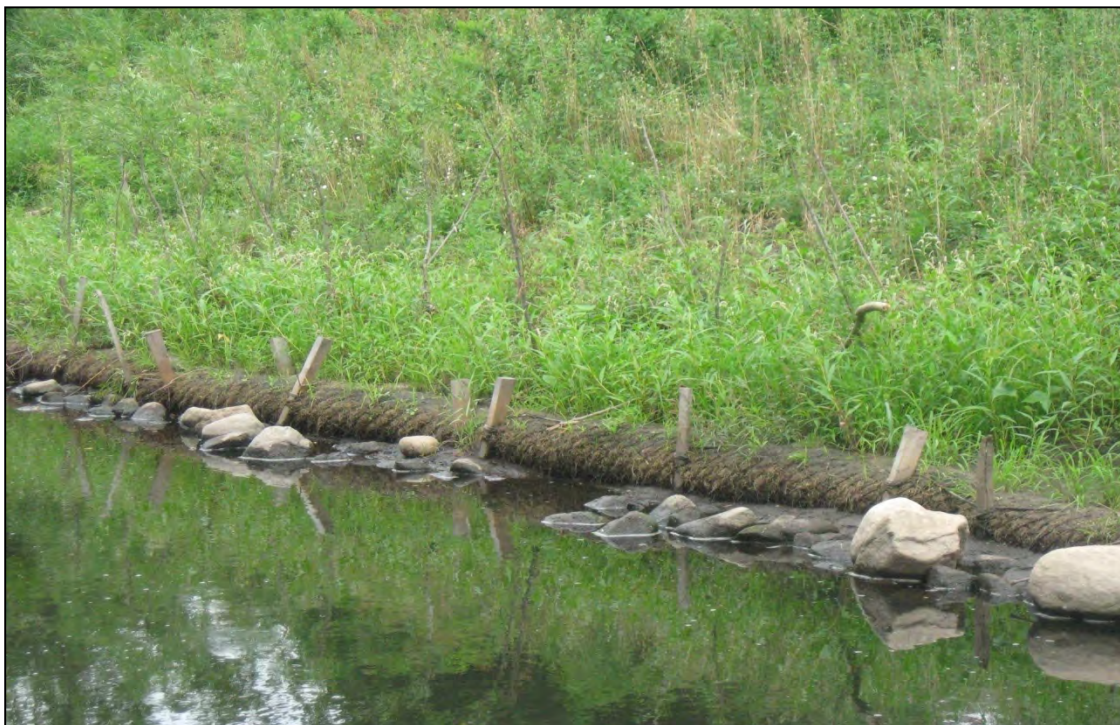
Bio-log Bank Protection

Bio-logs are natural fiber rolls made from coir fiber that are laid along the toe of the stream bank slope to stabilize the toe of the stream bank. The bio-logs are typically 12 inches in diameter. Because they are made of natural fiber, vegetation can grow on the bio-logs. When needed, grading of the stream bank slope above the bio-log will achieve a more stable slope (2:1 to 3:1). Cord grass plugs will be placed within the bio-log three feet on center.

Biologs are natural fiber rolls made from coir fiber that are laid along the toe of the stream bank slope to stabilize the toe of the stream bank. Biologs 12 inches in diameter are typically used. Because they are made of natural fiber, vegetation can grow on the biologs. When needed, grading of the stream bank slope above the biolog is used to create a more stable slope (2:1 to 3:1). **Figure 5** illustrates this practice.

Biologs are natural fiber rolls made from coir fiber that are laid along the toe of the stream bank slope along with a one foot section of Class II Fieldstone Rip Rap to stabilize the toe of the stream bank. Biologs 12 inches in diameter are typically used. Because they are made of natural fiber, vegetation can grow on the biologs while the Fieldstone Rip Rap provides a slightly greater stabilization characteristic. When needed, grading of the stream bank slope above the biolog is used to create a more stable slope (2:1 to 3:1). **Figure 5** illustrates this practice.

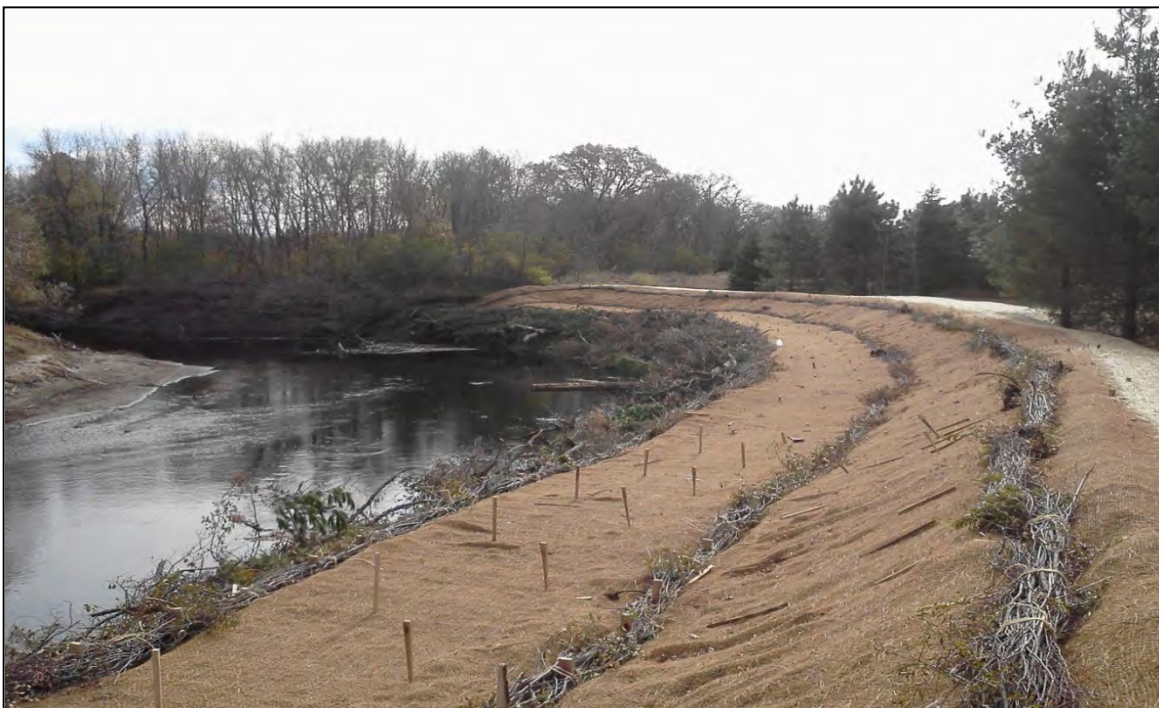
Live Facines

Live Fascines

Live fascines also use dormant willow and dogwood cuttings installed during the dormant season. In this case, the cuttings are bundled together and planted in a row parallel to the stream flow. They can be effective in reducing sheet erosion along a slope because a portion of the fascine extends above the ground surface

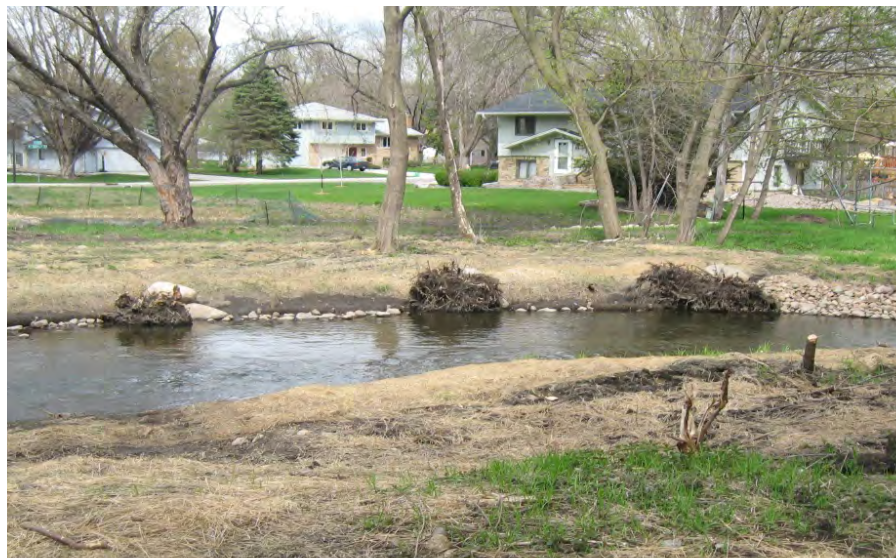
Root Wads

Root wads are constructed from root balls of trees removed as part of this project. The trunks are buried into the bottom of the stream bank, with the root wad end sticking out into the stream. Supporting "footer logs" and boulders are used to stabilize the root wads.

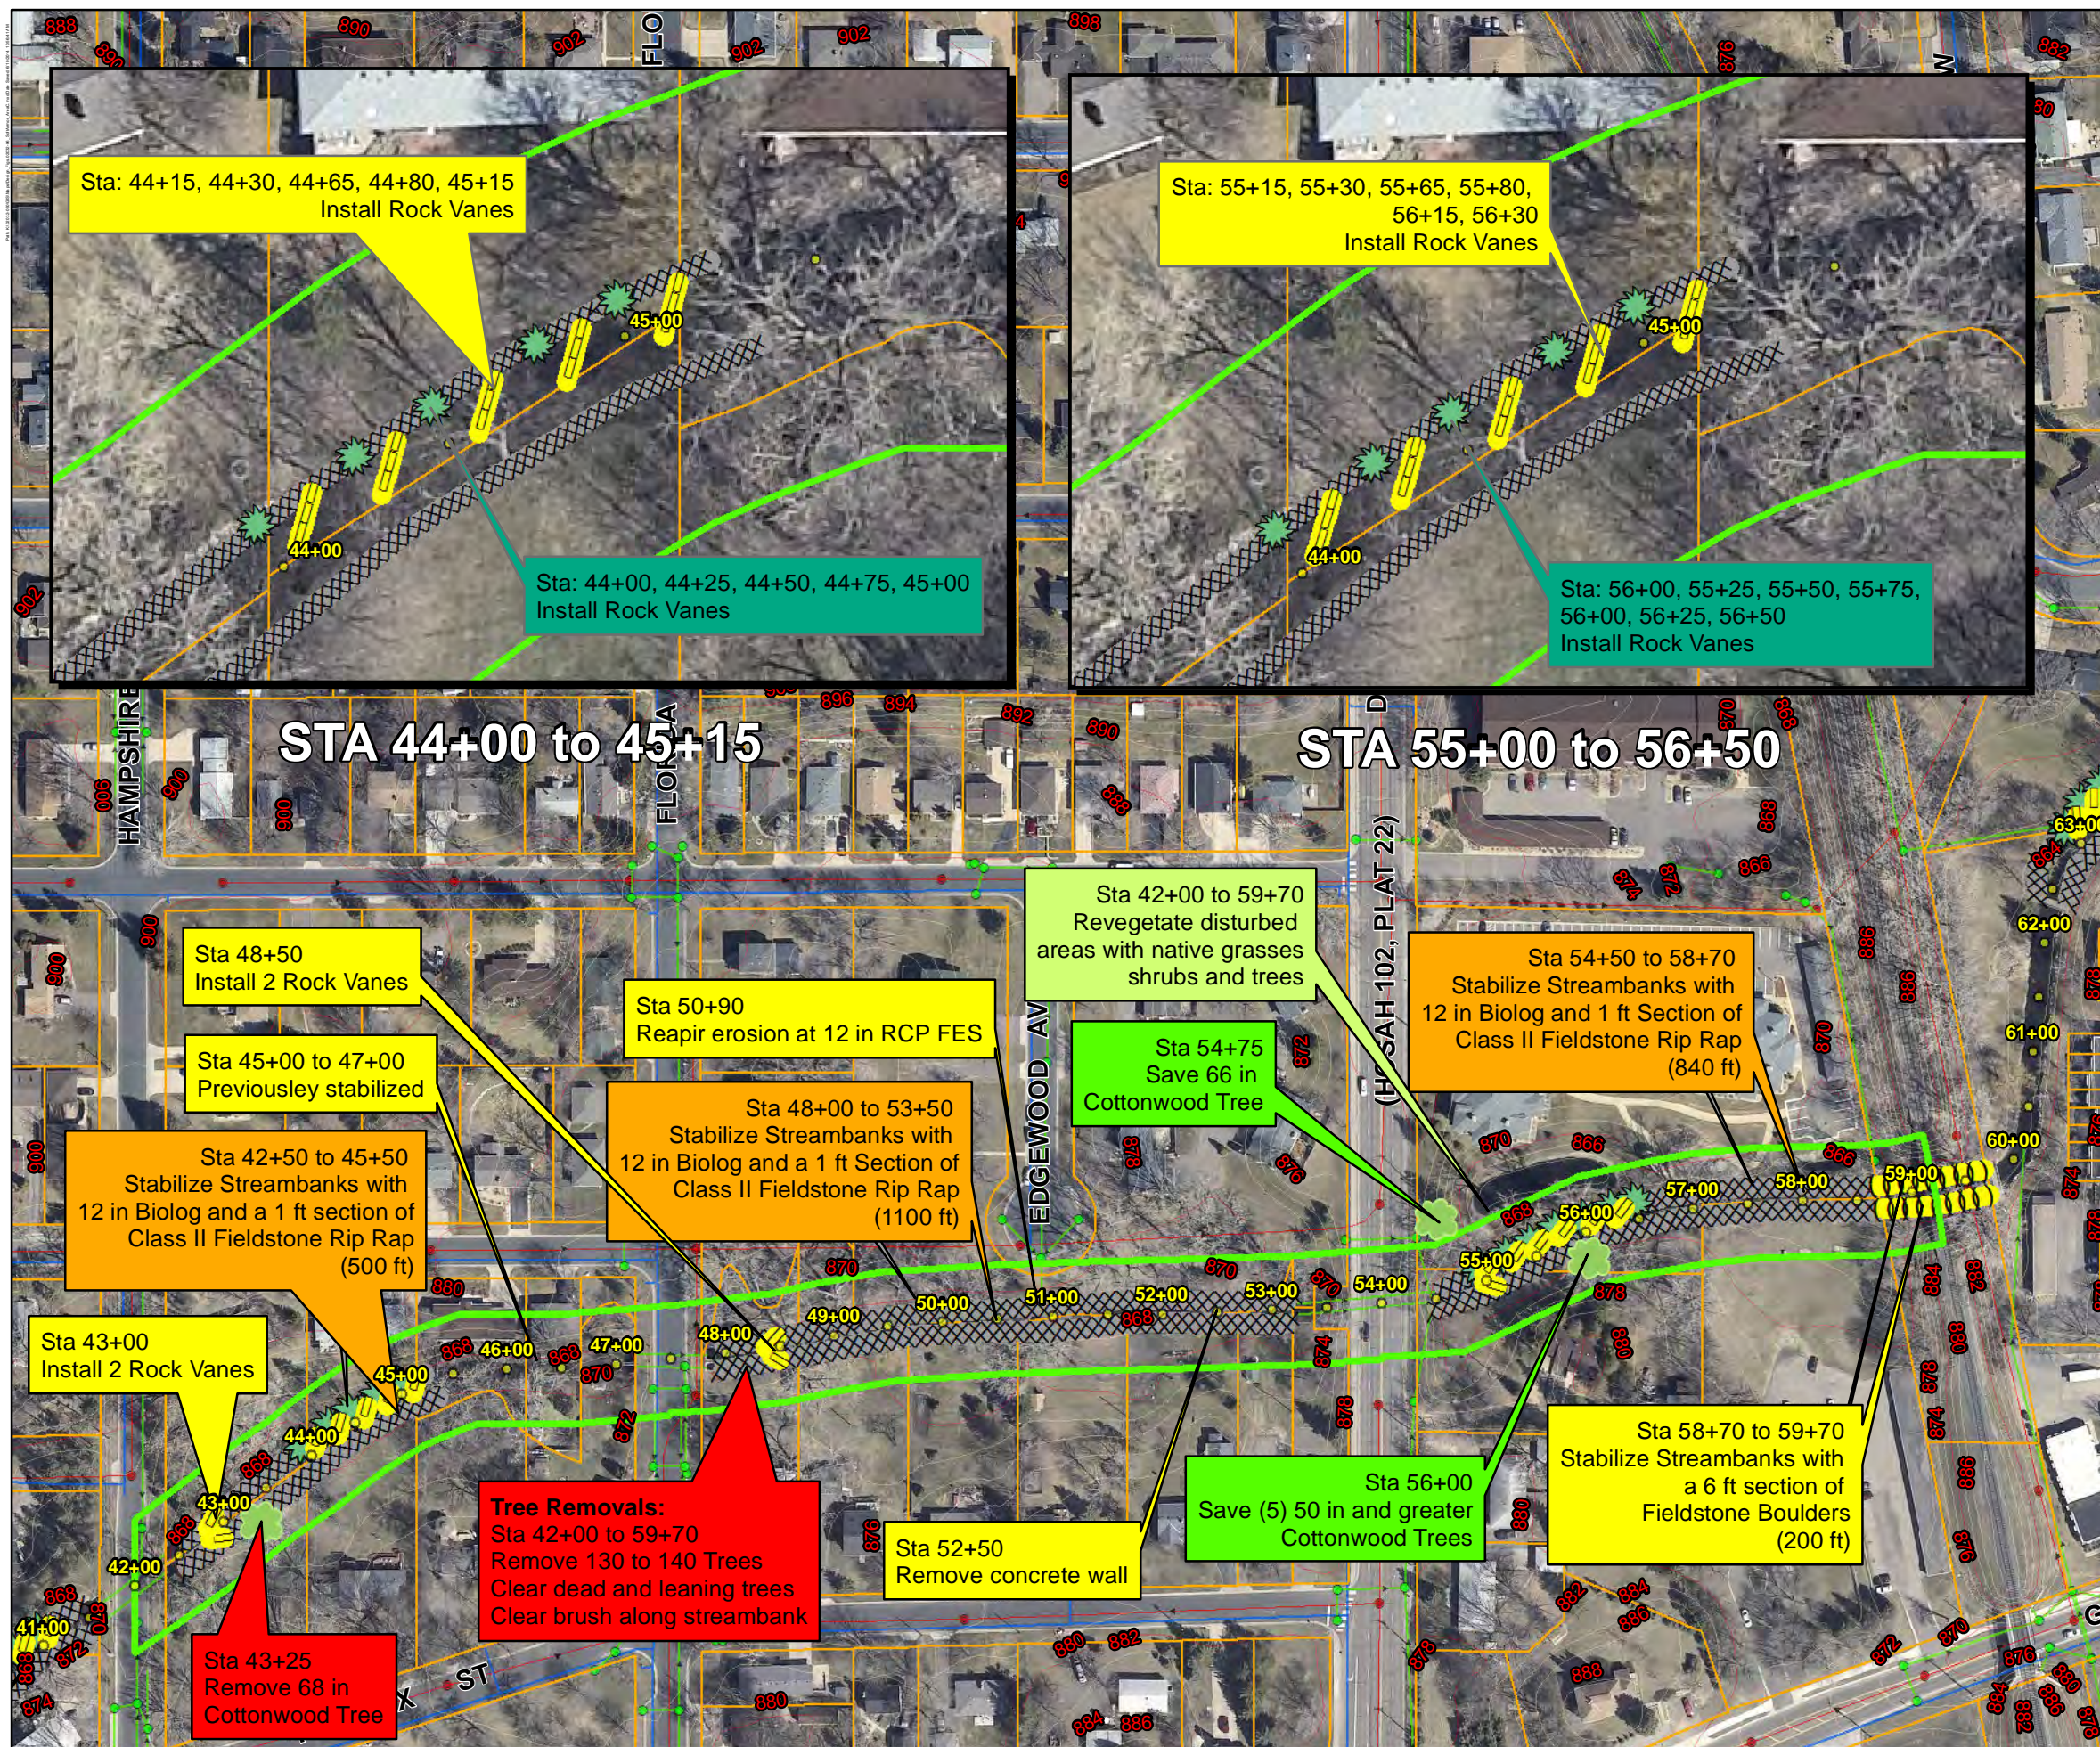
**Feasibility Study
for the
2015 Bassett Creek Main Stem
Restoration Project
City of Golden Valley
Minnesota
Hard Armoring Option
Area C**
