# Medicine Lake TMDL Status Assessment

**Prepared for Bassett Creek Watershed Management Commission**

April 17, 2025

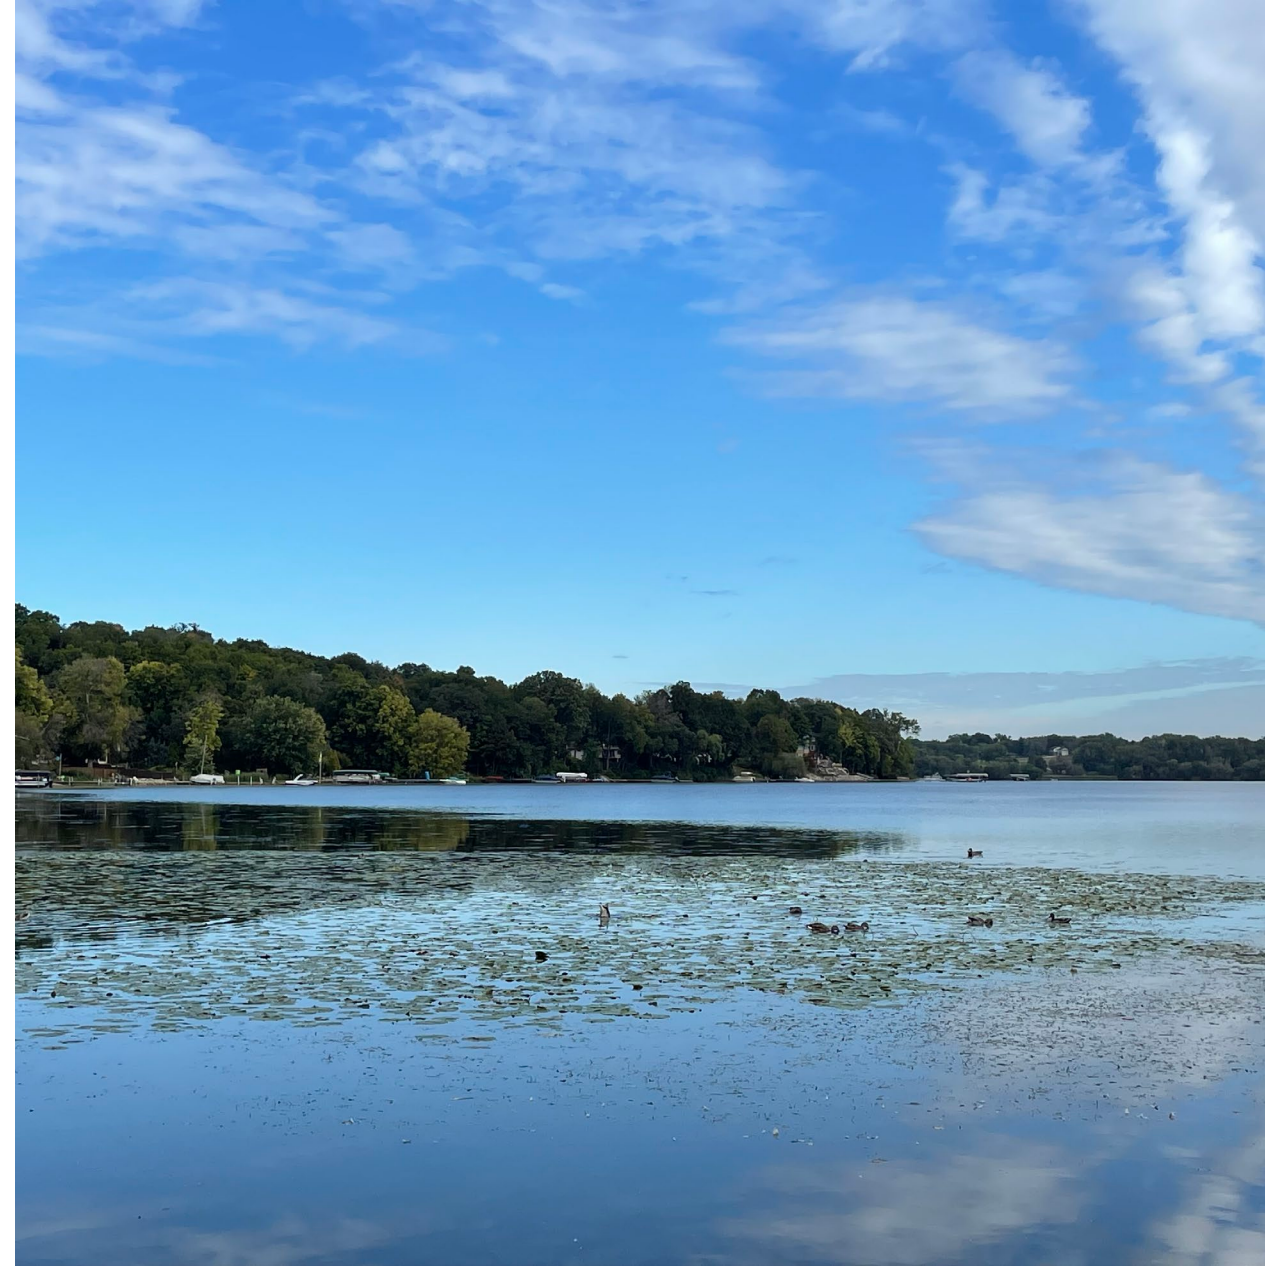
# TMDL Assessment Overview

## Watershed

- Seven MS4s
- Plymouth and Medicine Lake are direct; rest indirect
- Plymouth represents 83% of watershed area

## Total Maximum Daily Load (TMDL)

- Maximum allowable pollutant load that meets water quality standards
  - Pollutant loads assigned to each MS4 (Wasteload Allocation)
  - Internal load and atmospheric deposition

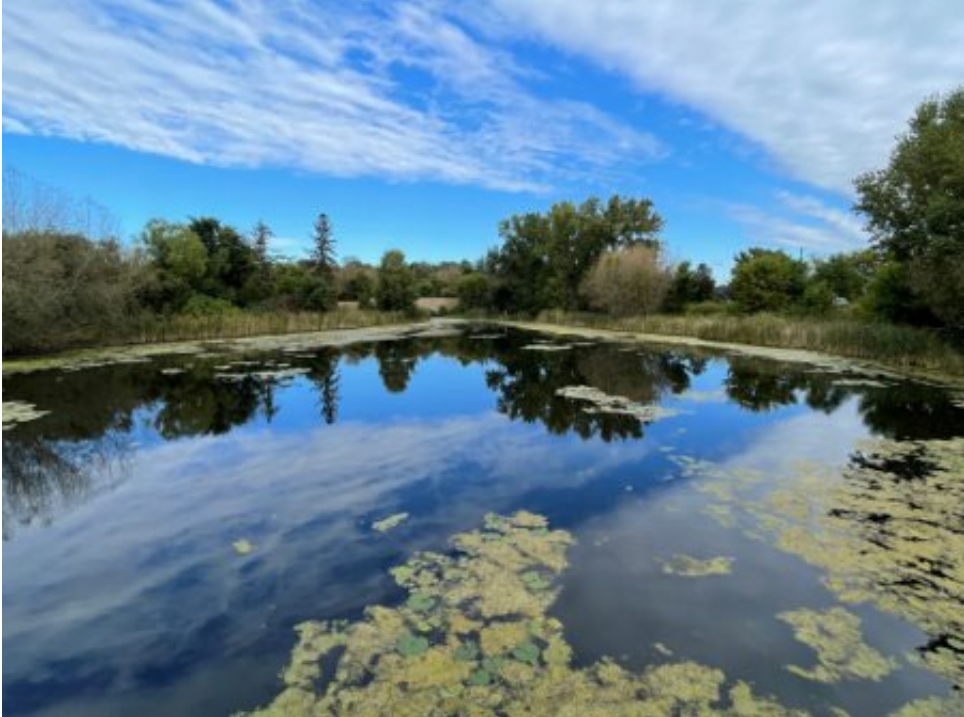
Water quality (P8) modeling of post-2006 projects/practices indicates

- Overall TP load reduction is about 400 lbs short of 1,287 lbs per year TMDL requirement
- Combined TP treatment efficiency of all BMPs exceeds 70%, which limits attainability of additional treatment
- BMP TP load reductions are less than monitoring indicates

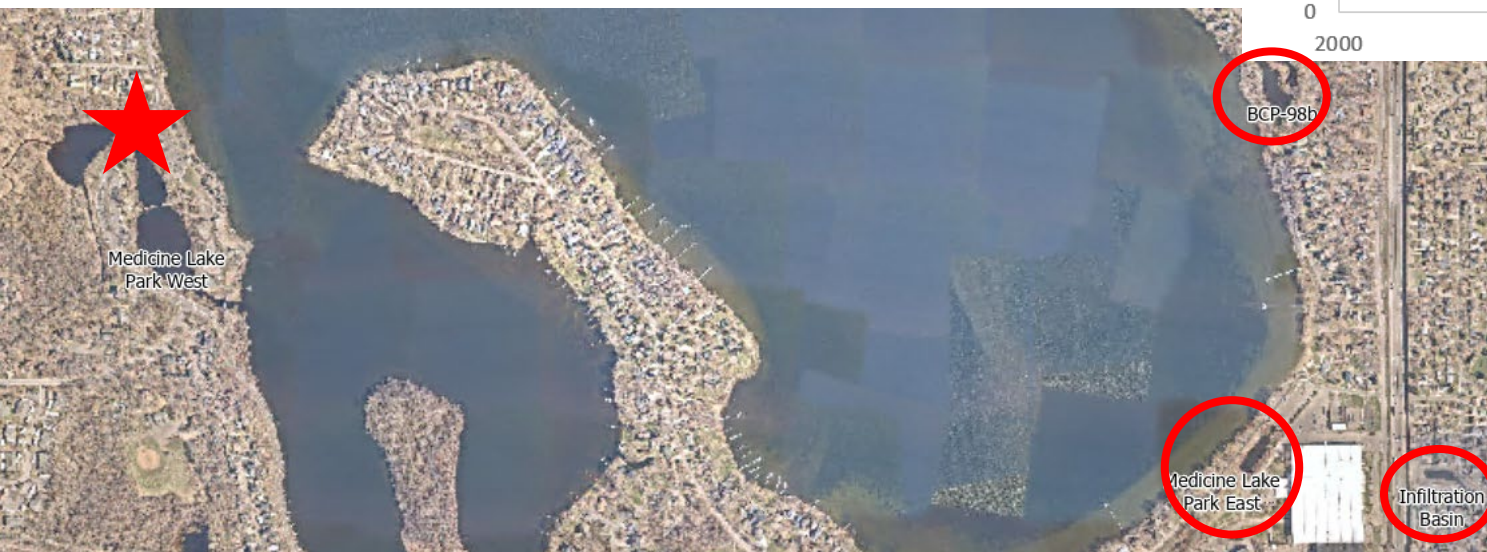
## Plymouth Creek tributary

- Contributes more than 50% of the watershed TP load, based on TMDL modeling
- Station has 23 years of monitoring data
- West Medicine Lake Park Ponds project implemented/functioning by spring of 2010
- Recent monitoring shows significantly improved water quality since BMP implementation
