Bassett Creek Main Stem Restoration (2024 CR-M)

# Ĥaĥá Wakpádan/Bassett Creek Main Stem Restoration Project

# Bassett Creek Main Stem Erosion Issues and Restoration Prioritization

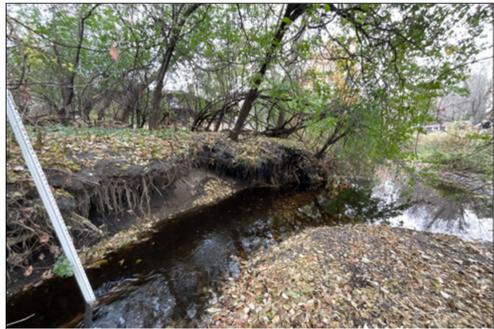
Streambank undercutting

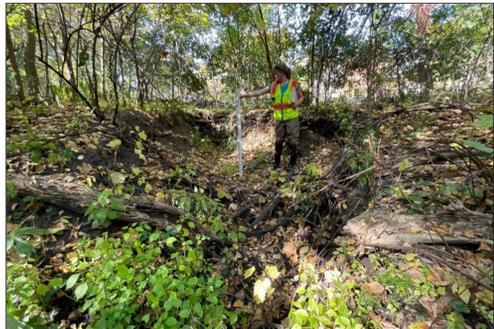
Tributary erosion

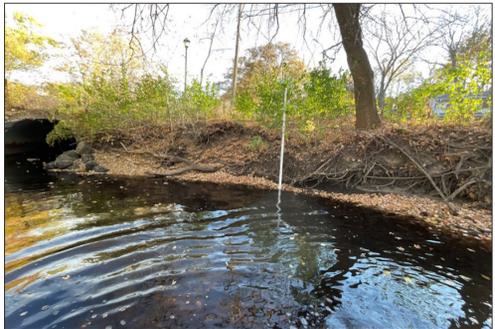
Scour near culverts

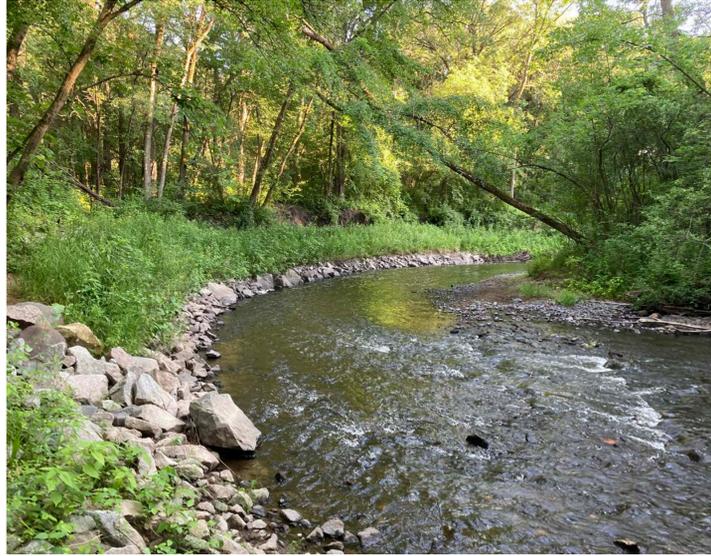
Vegetated Reinforced Soil Stabilization (VRSS) with Riprap Toe

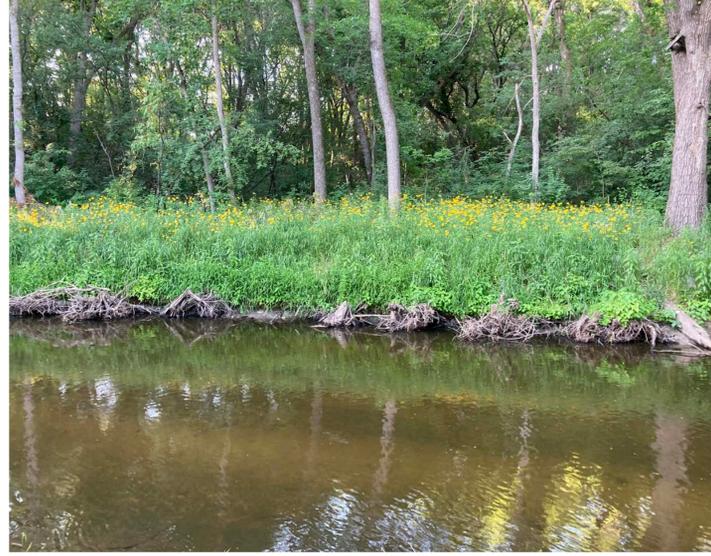
Toe Wood with VRSS and Grading

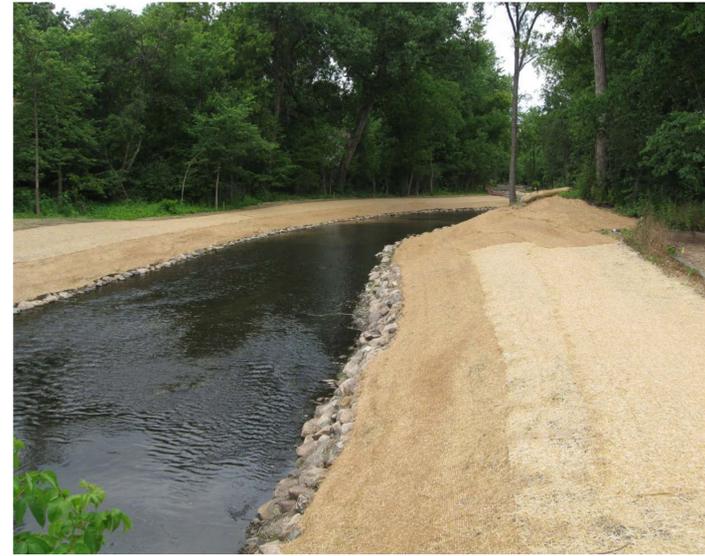
Riprap Toe with Grading to Improve Floodplain Connection - Post construction

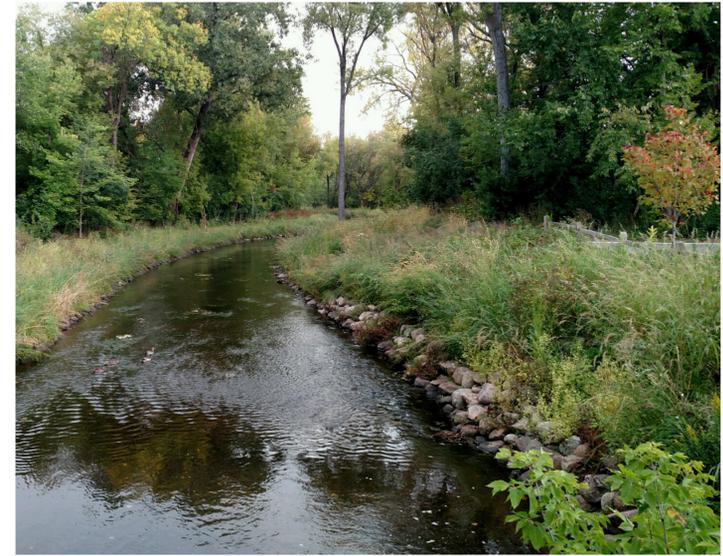
Riprap Toe with Grading to Improve Floodplain Connection - Two years after construction

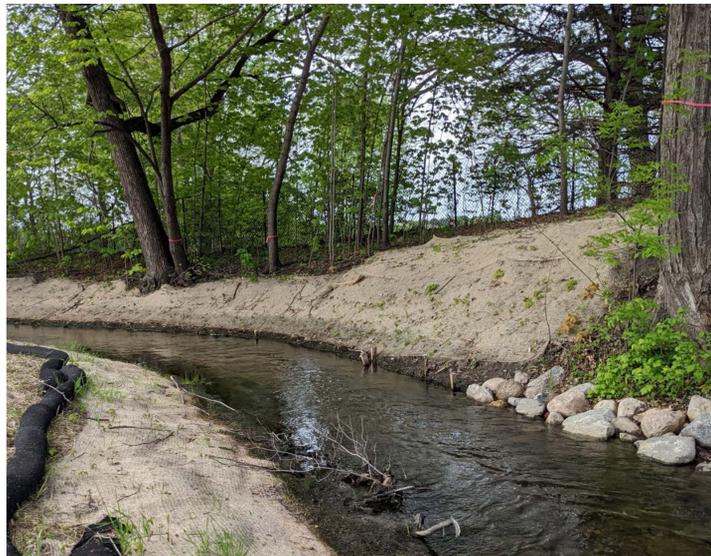
Coir Log with Bank Grading

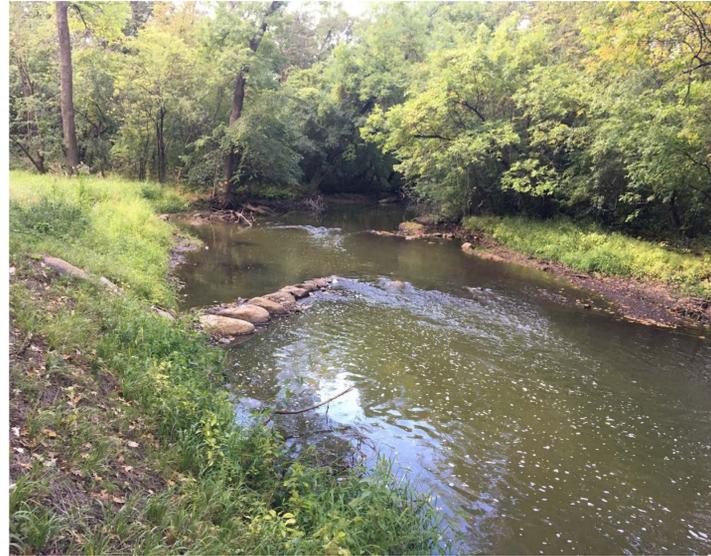
J-hook

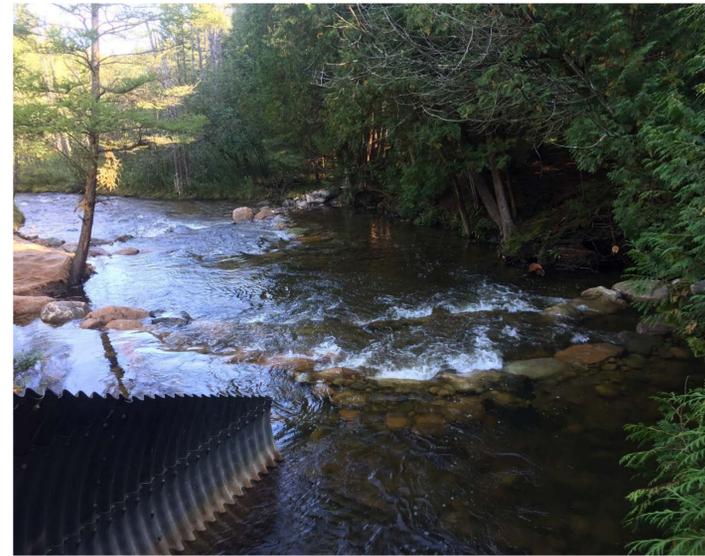
Cross Vane

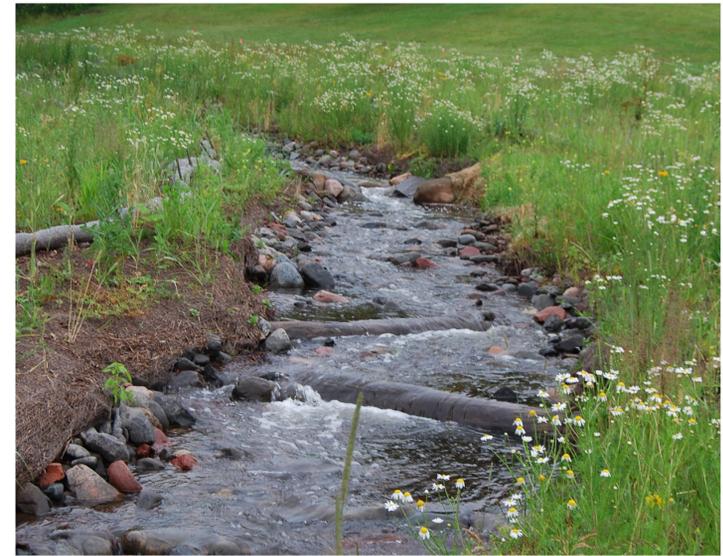
Rock Toe with Log Vanes

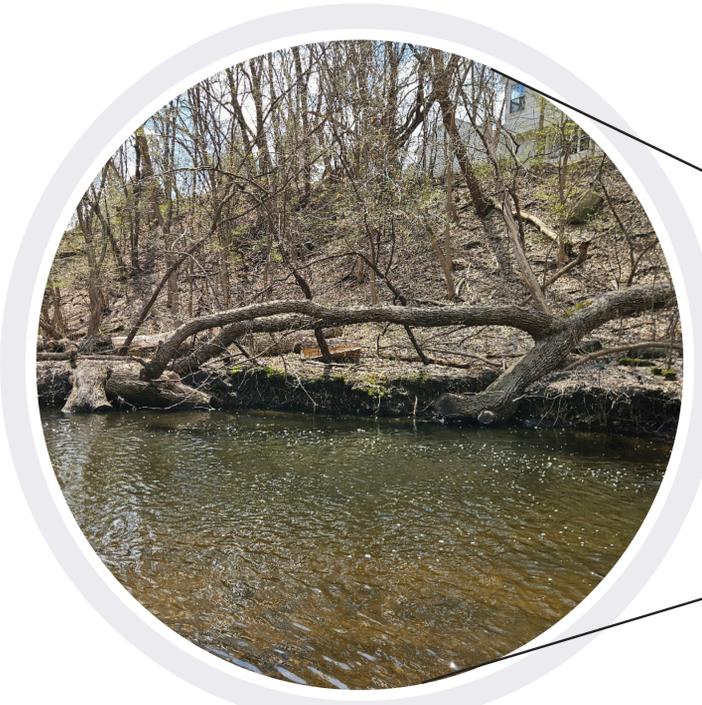
# Preliminary Concept for Reach 2, Noble Avenue to Bassett Creek Drive

- Install cross vanes to provide protection for sanitary sewer crossings
- Stabilize stream bank toe with rock riprap, toe wood, and fascines
- Regrade channel and stream banks to improve floodplain connection
- Stabilize stream bank with vegetative material (seed, live plugs, shrubs, and/or live cuttings)

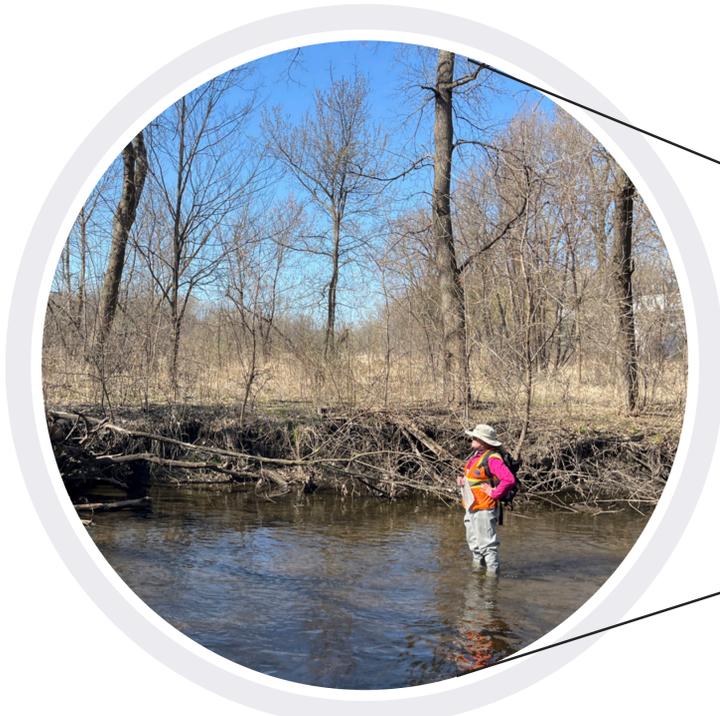
# Preliminary Concept for Reach 3, Bassett Creek Drive to Station 61+00

- Regrade channel and stream banks to improve floodplain connection
- Stabilize stream bank with vegetative material (seed, live plugs, shrubs, and/or live cuttings)
- Install cross vanes to prevent erosion upstream and downstream of road and bridge crossings
- Install J-Hooks to route erosive flows away from the bank and towards the center of the channel

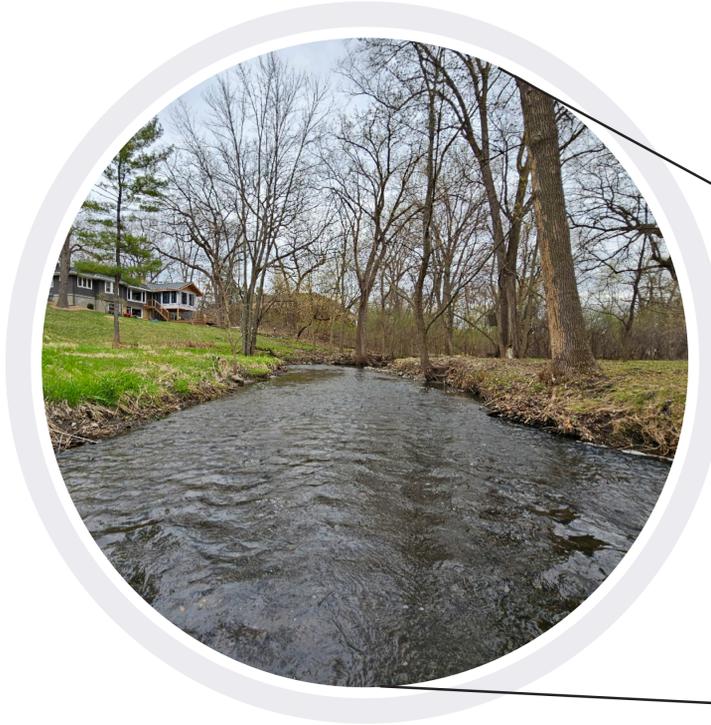
# Preliminary Concept for Reach 4, Station 61+00 to Golden Valley Road

- Regrade channel and stream banks to improve floodplain connection
- Stabilize stream bank with vegetative material (seed, live plugs, shrubs, and/or live cuttings)
- Install cross vanes to maintain channel grade and j-hook vanes to route erosive flows away from stream banks, especially those that have sanitary sewer
- Stabilize stream bank toe with rock riprap, toe wood, facines, and coir log

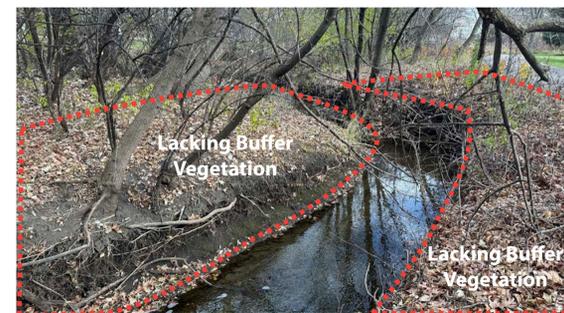
Bassett Creek Riparian Buffer: **Erosion Due to Lack of Vegetation**
