Memorandum

To: Bassett Creek Watershed Management Commission (BCWMC)
From: Barr Engineering Co.
Subject: Bassett Creek 2018 Flood Control Project Inspection
Date: December 12, 2018
Project: 23/27-0051.42 2018 4065

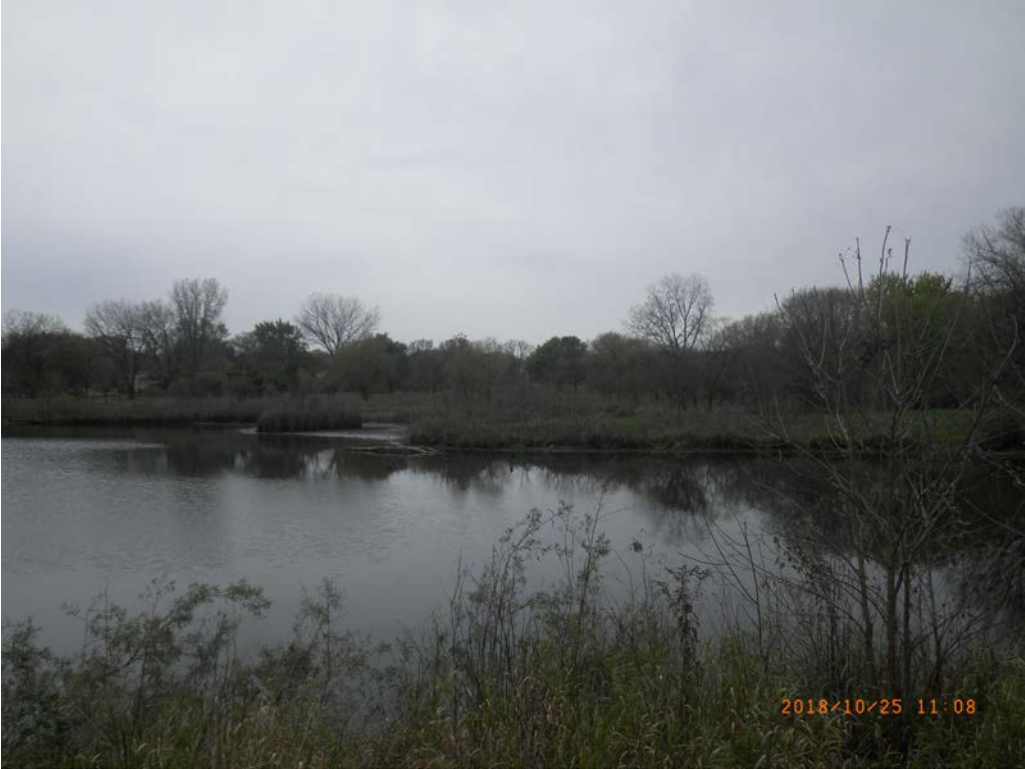
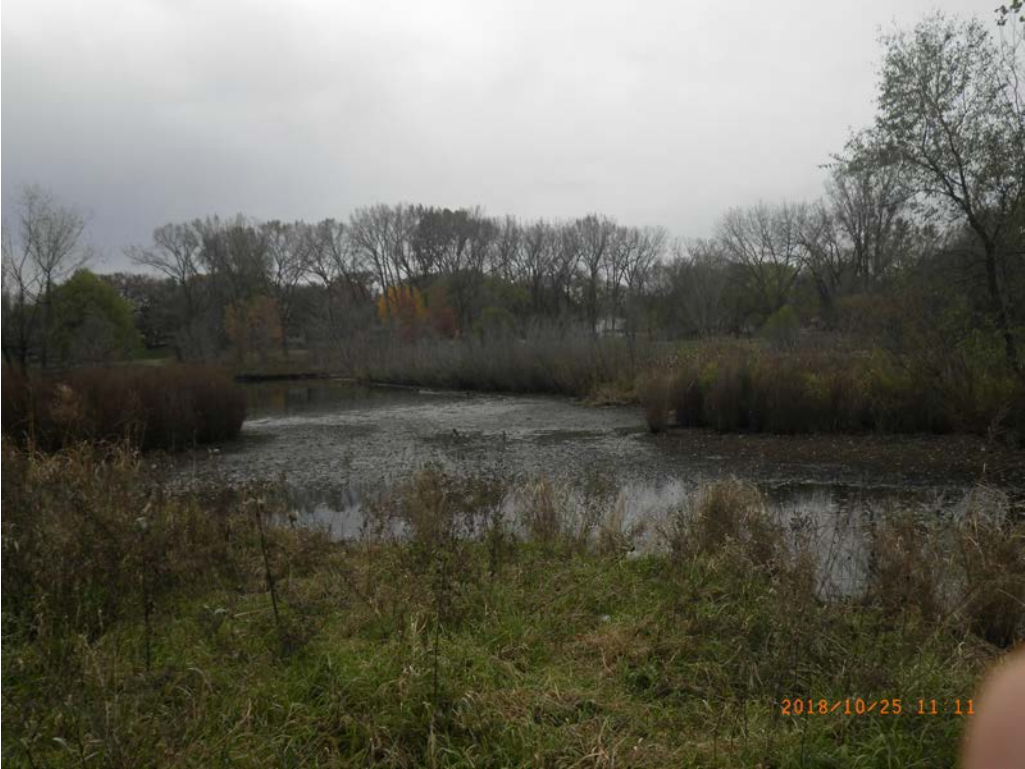
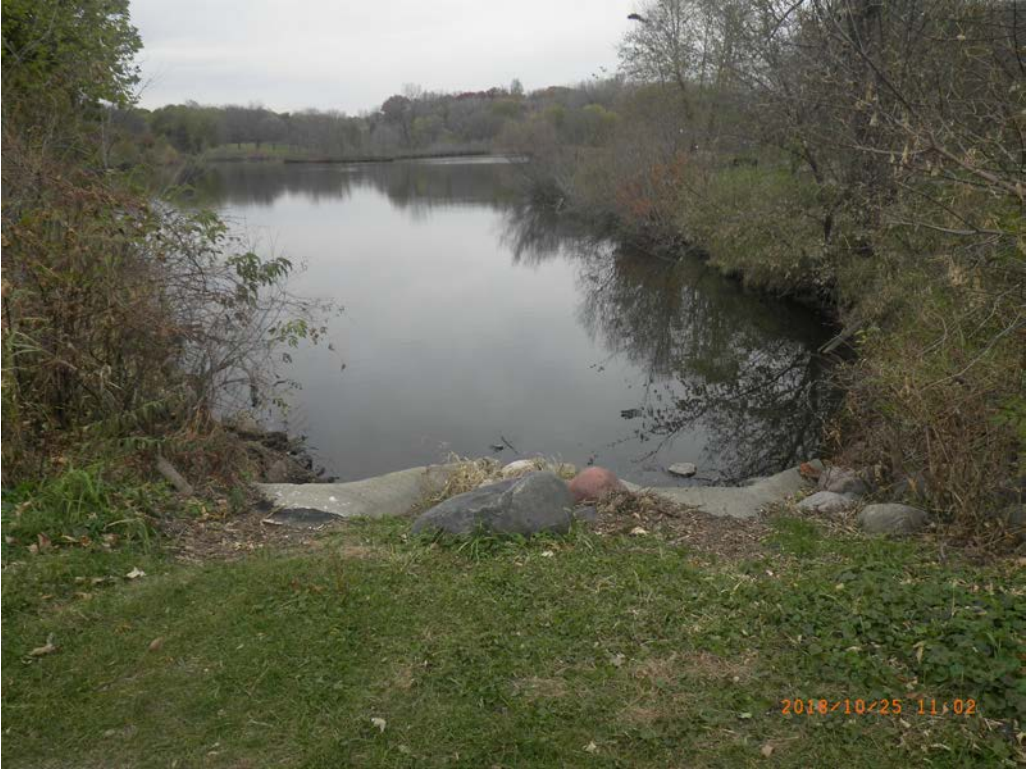
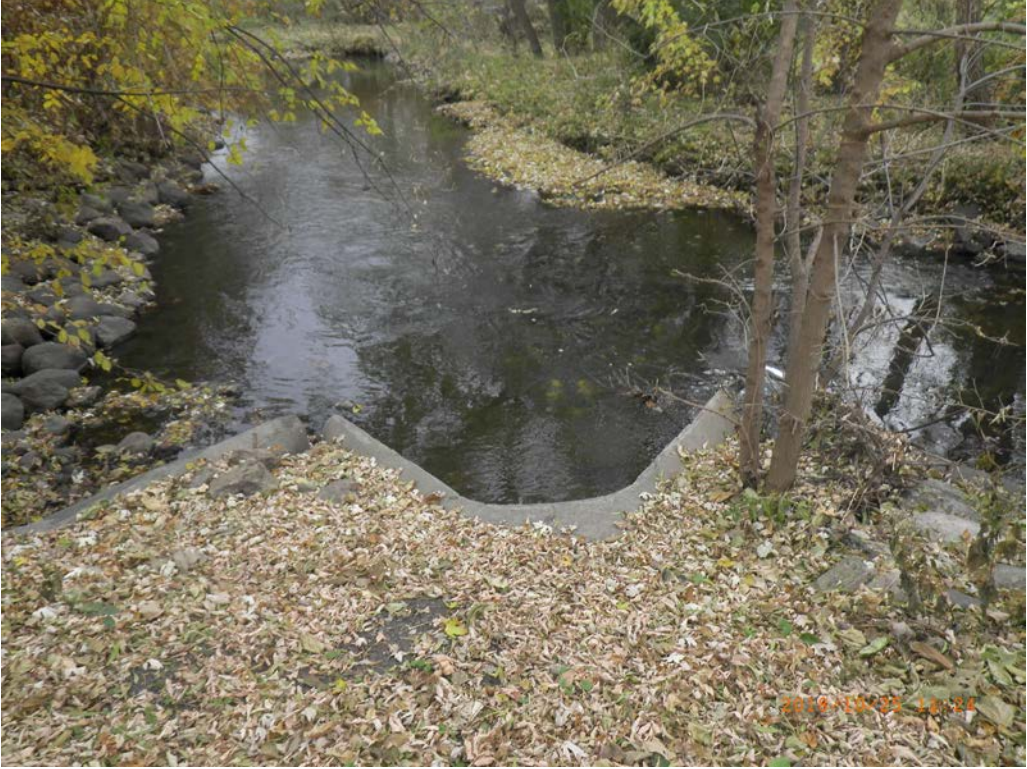
Bassett Creek Park Pond and Outlet (Crystal)

- a. Bassett Creek Park Pond appeared to be in satisfactory condition.
- b. Sediment has deposited in the northwest corner of Bassett Creek Park Pond and formed multiple deltas, which are overgrown with trees and vegetation. This has been noted since 2006 and the sediment deposition appears to be increasing.

- c. The outlet pipes appeared to be in satisfactory condition.

Recommended Action:

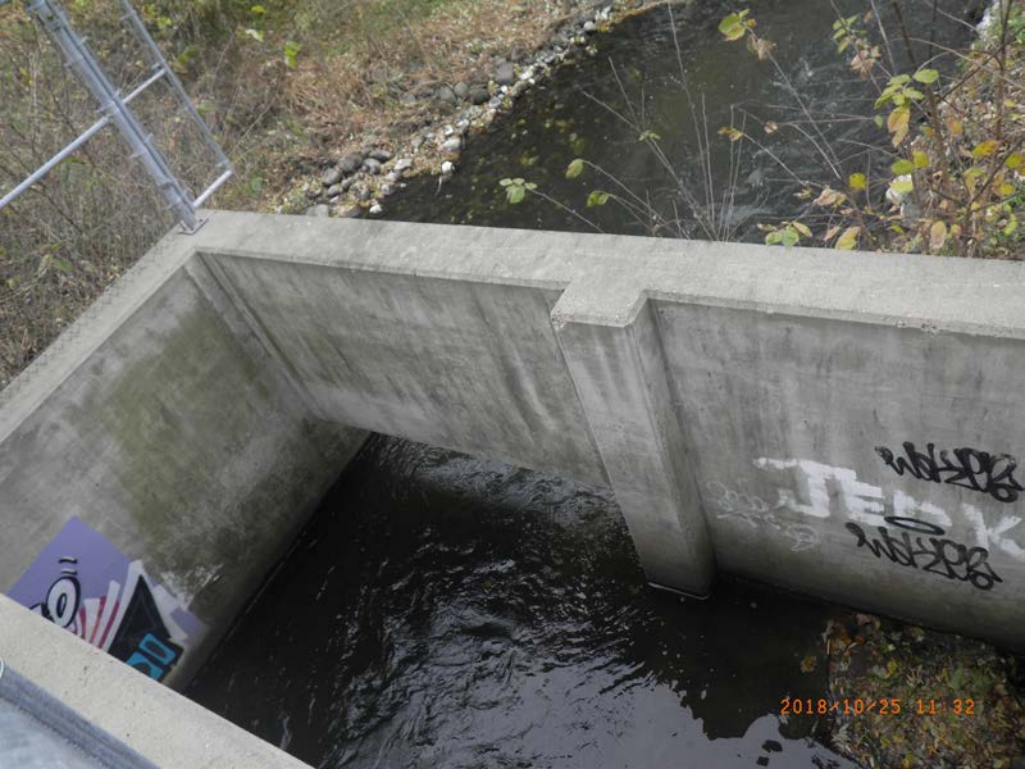
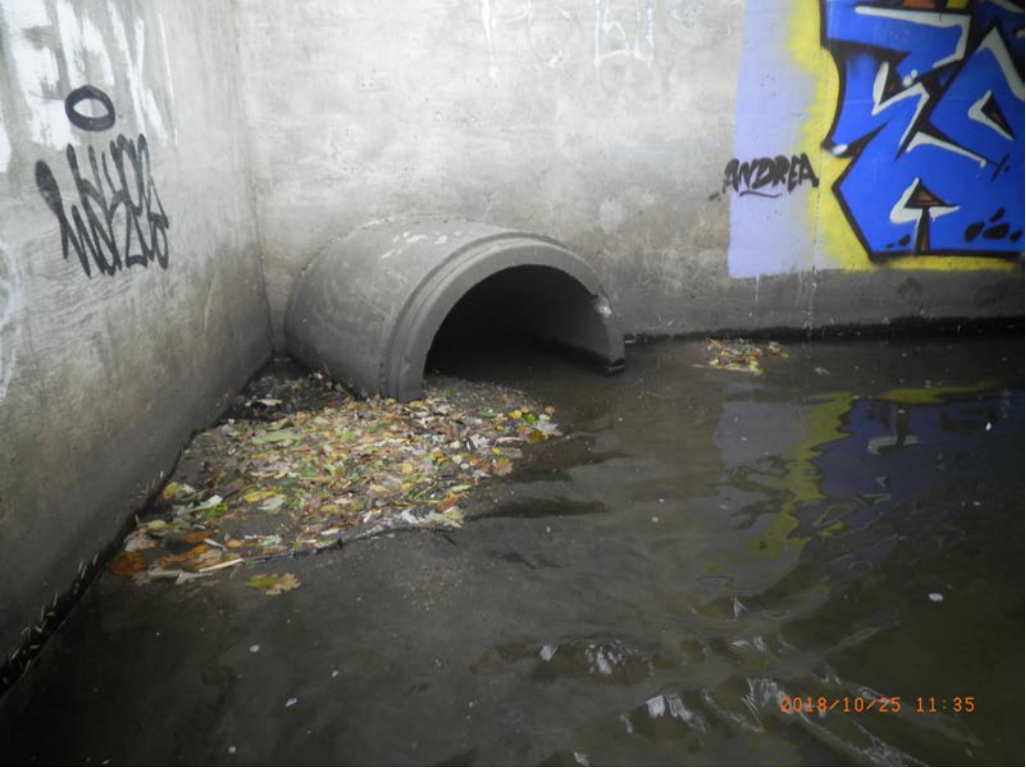
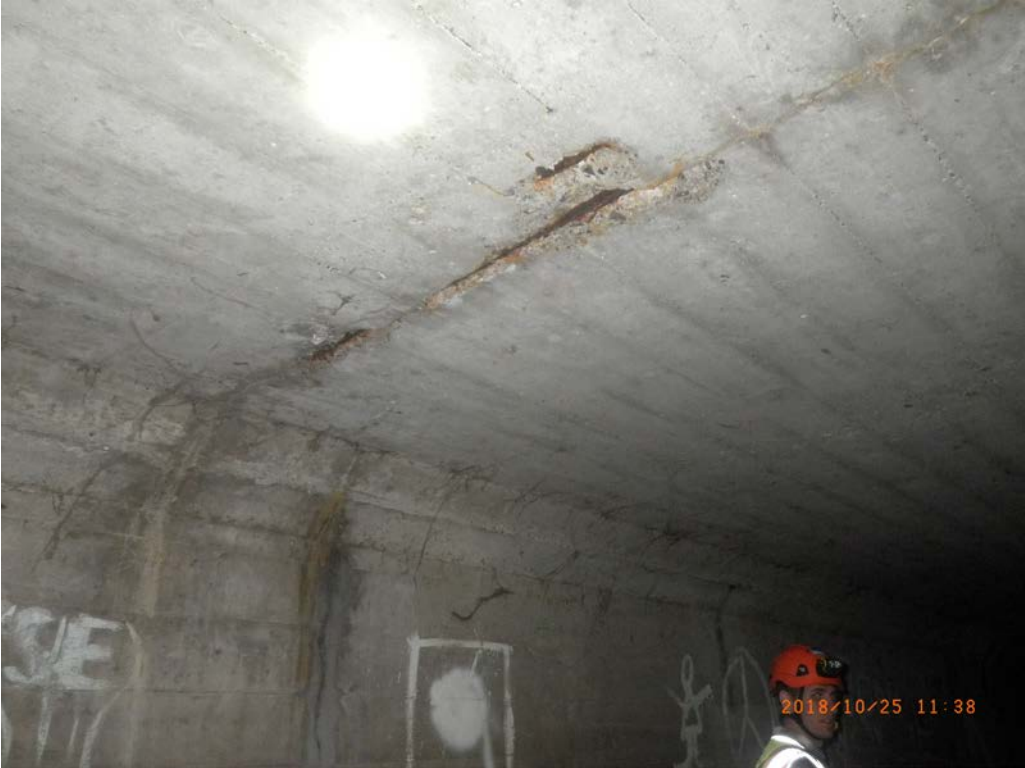
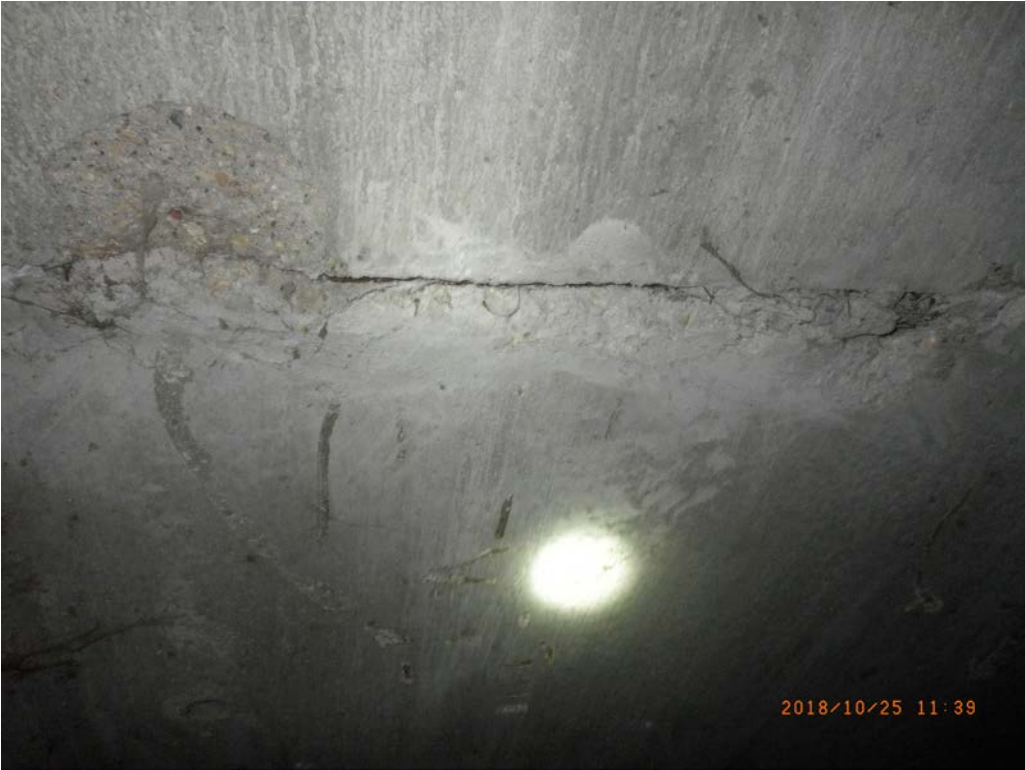
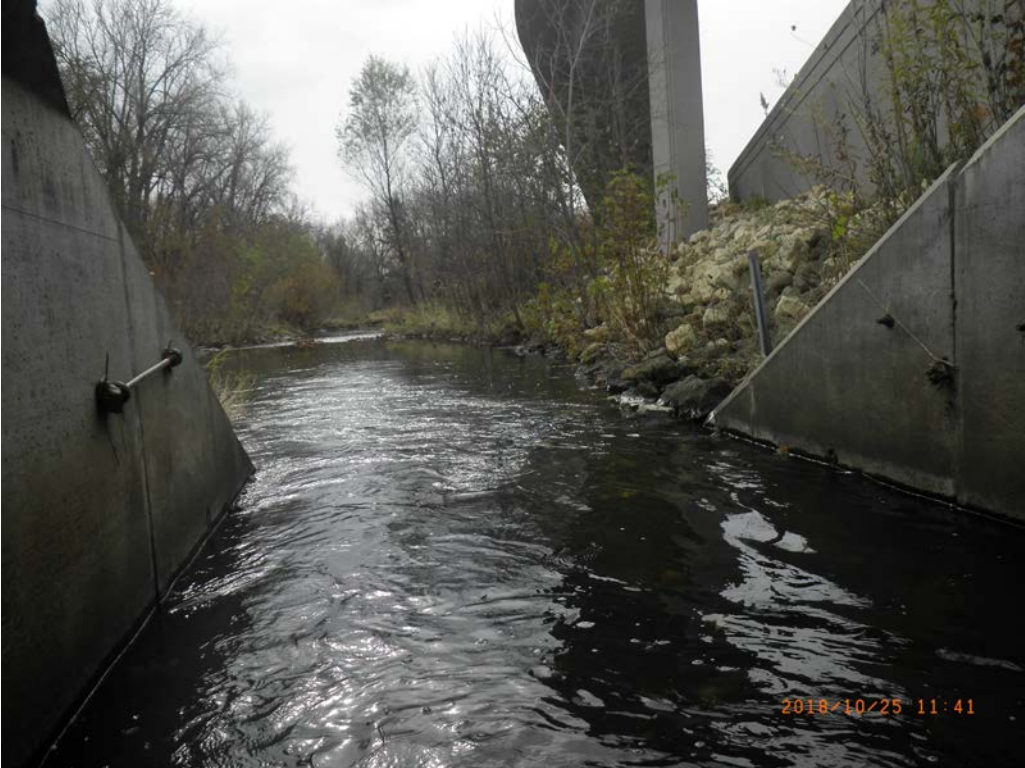
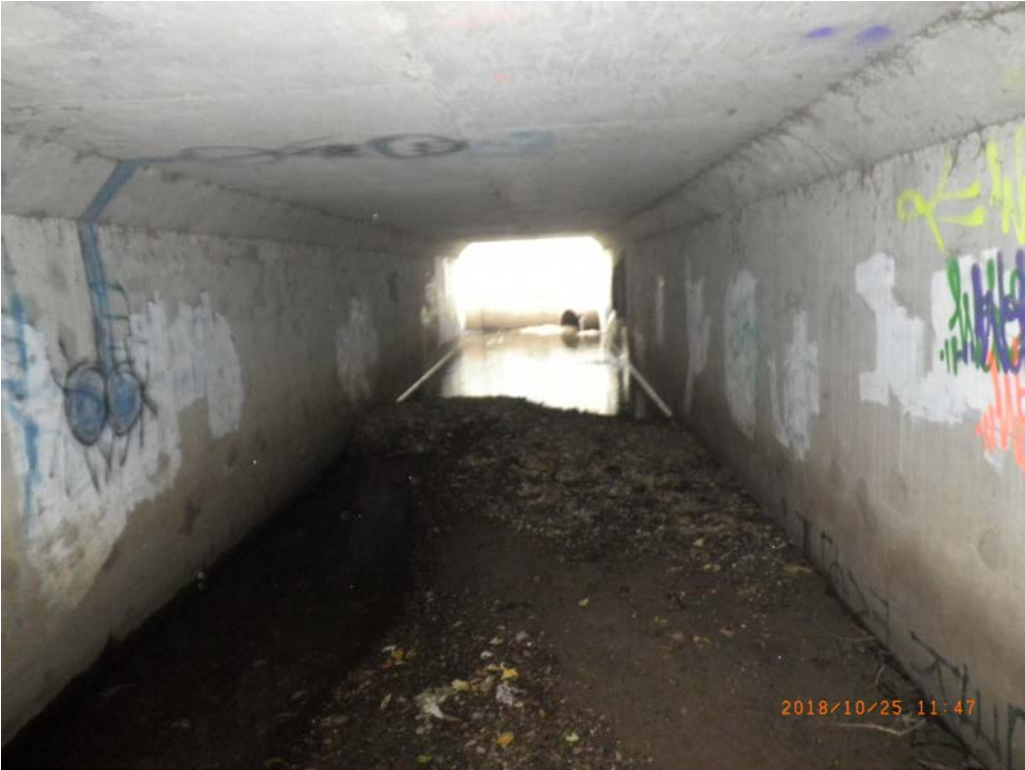
Highway 100 Double Box Culverts (Crystal/Golden Valley)

- a. The concrete box culverts and concrete inlet structure appeared to be in satisfactory condition.
- b. Longitudinal cracks, circumferential cracks, and areas of spalled concrete were observed along the top of the south (right) box culvert. MnDOT performed repairs to the culverts in 2007, but cracks have been noted since 2008 and areas of concrete spalling have been noted since 2014.
- c. Deposited sediment was observed in the north (left) box culvert, generally ranging from 8 to 12 inches deep with some locations up to 24 inches deep. This is consistent with previous inspections and 6-24 inches of deposited sediment has been observed in the north (left) box culvert since 2002.
- d. The outlet portion of the structure appeared to be in satisfactory condition.

- Monitor accumulated sediment in north (left) box culvert and consider future removal.
- Monitor cracking and spalling concrete in the south (right) box culvert.

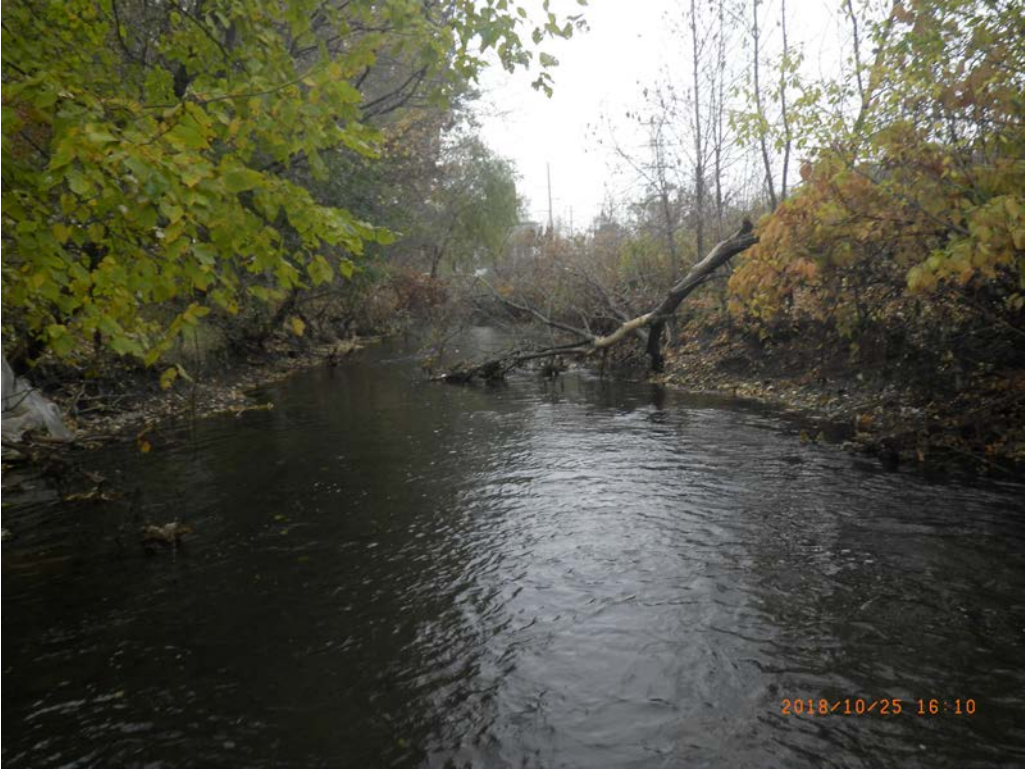
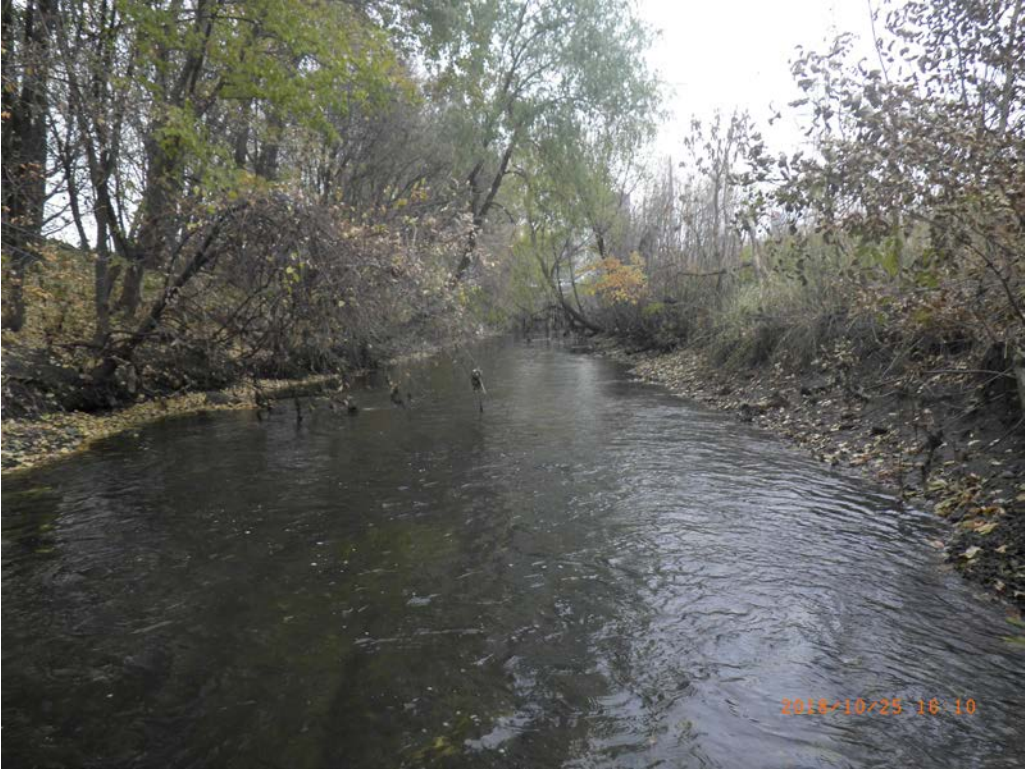
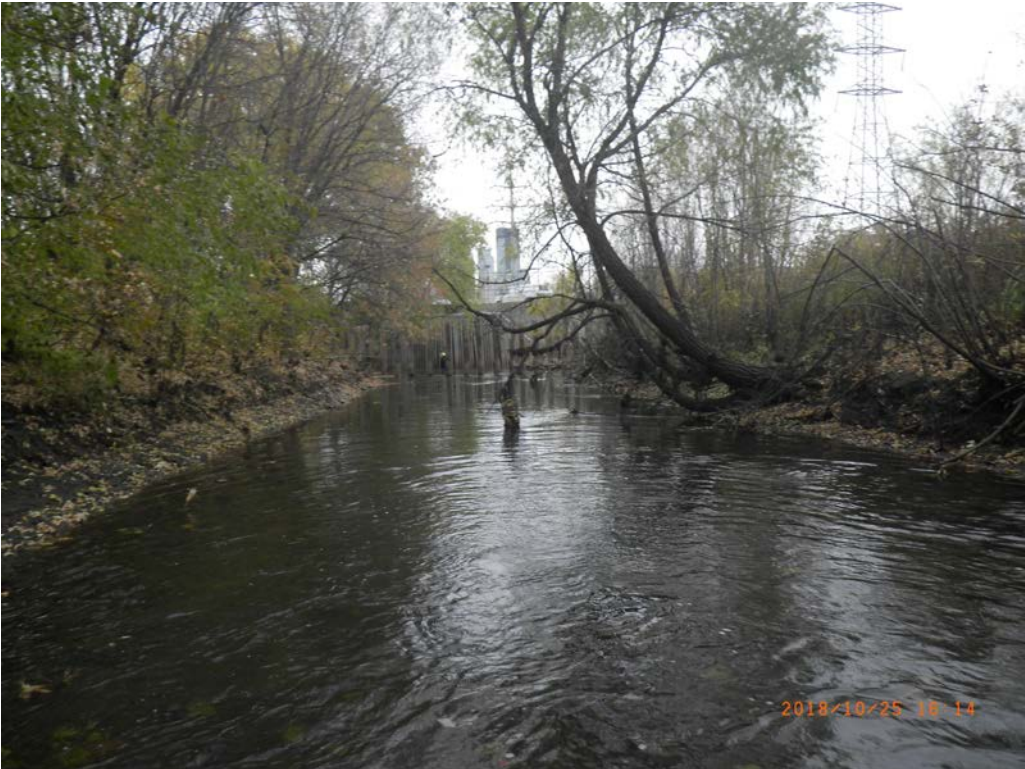
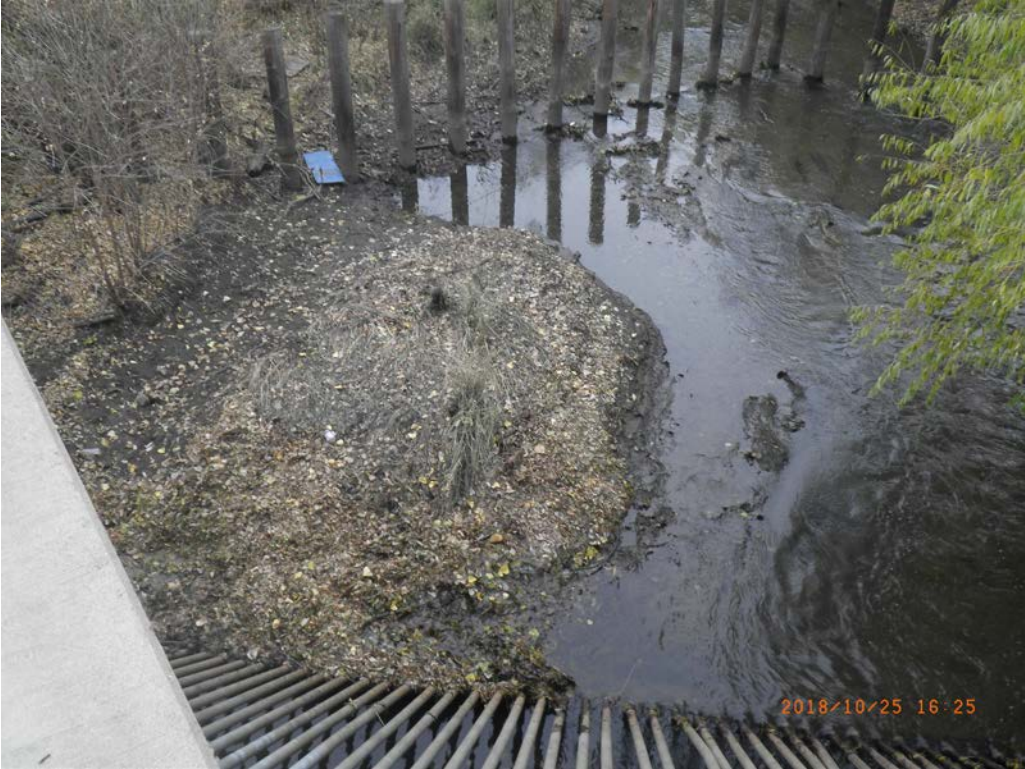
Open Channel (Minneapolis)

- a. The open channel, from Van White Memorial Boulevard to the inlet structure, appeared to be in satisfactory condition.
- b. The banks were generally covered with brush and trees about 3-4 feet above the channel bottom. Below the level of the trees and brush, the banks were bare soil on both sides for most of the length of the channel, however no obvious signs of bank erosion were noted.
- c. Some dead trees had partially fallen into the channel and were collecting debris.
- d. Sediment has deposited and formed a delta on the south (right) side of the channel between the debris barrier and inlet structure. Vegetation was growing on the delta and approximately one-third of the channel was blocked by the sediment, debris, and vegetation.

- Remove accumulated sediment and debris on the south (right) side of the channel between the inlet structure and debris barrier.
- Monitor downed trees and debris and remove as needed.
- Bassett Creek Main Stem Erosion Repair Project (CIP 2017 CR-M) is included in the BCWMC CIP Table 5-3. The BCWMC completed a feasibility study for the project in May 2016, and ordered construction of the project at their September, 2016 meeting. The project is currently undergoing a National Historic Preservation Act (NHPA) review and cultural resources investigation through the United States Army Corps of Engineers and is scheduled for construction in 2019. The resultant construction project should minimize future erosion concerns and reduce the amount of sediment depositing near the inlet structure.
