Bassett Creek 3rd Avenue and 2nd Street Tunnel Inspection Report

Prepared for
Bassett Creek Watershed Management Commission

Inspection Date: October 2020

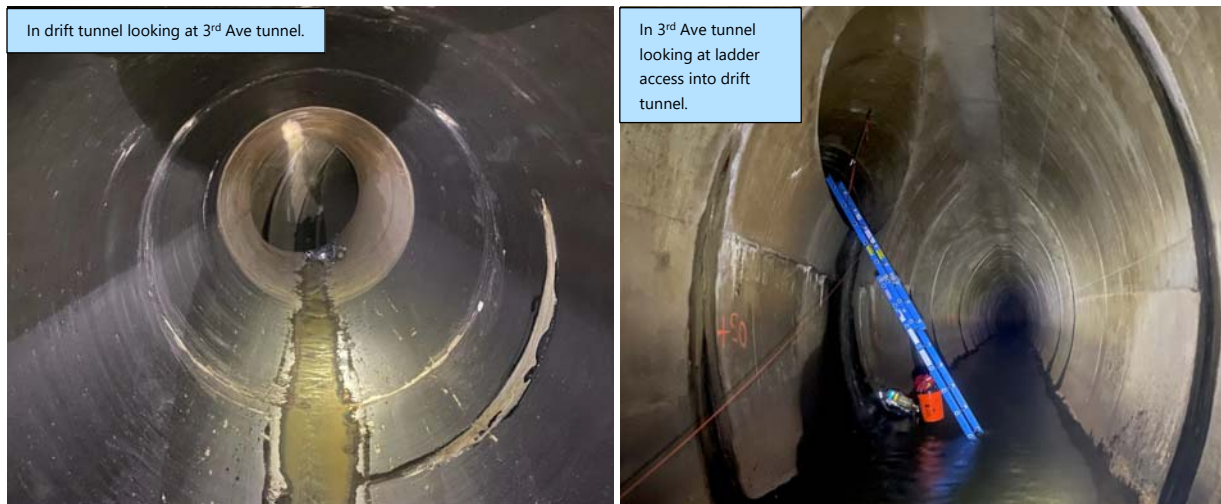
Figure 3-3 Drift Tunnel and Ladder Access

Once the entrant exits the basket, they must traverse a 6-foot-diameter, 75-foot-long drift tunnel to where it connects with the 3rd Avenue tunnel approximately 7 to 8 feet below the drift tunnel. A ladder must be installed at the connection and secured to an existing eyebolt to enter the 3rd Avenue tunnel as shown in Figure 3-3.
