# Memorandum

**To:** Bassett Creek Watershed Management Commission (BCWMC)  
**From:** Barr Engineering Co. (Barr) (Josh Phillips, Gabby Campagnola, Jim Herbert)  
**Subject:** Item 4F: Bassett Creek 2024 Flood Control Project Inspection - BCWMC December 19, 2024 Meeting Agenda  
**Date:** December 12, 2024  
**Project:** 23270051.62 1080 001

## 4F Bassett Creek 2024 Flood Control Project Inspection

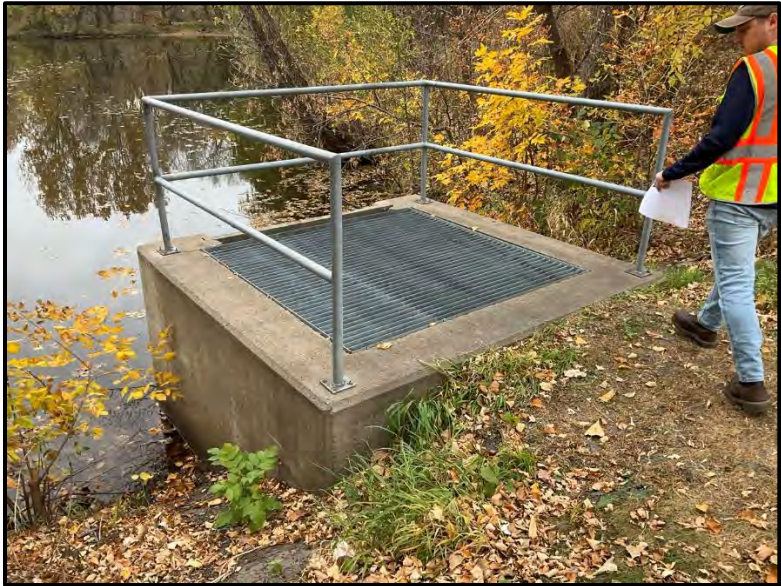
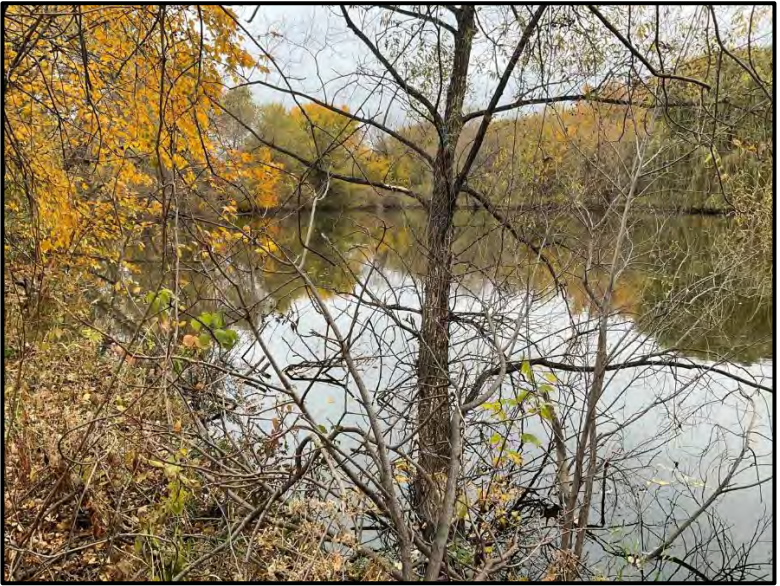
Detention Pond and Outlet Structure (Crystal)

- b. The detention pond appeared to be in satisfactory condition, but a survey is needed to assess accumulated sediment.

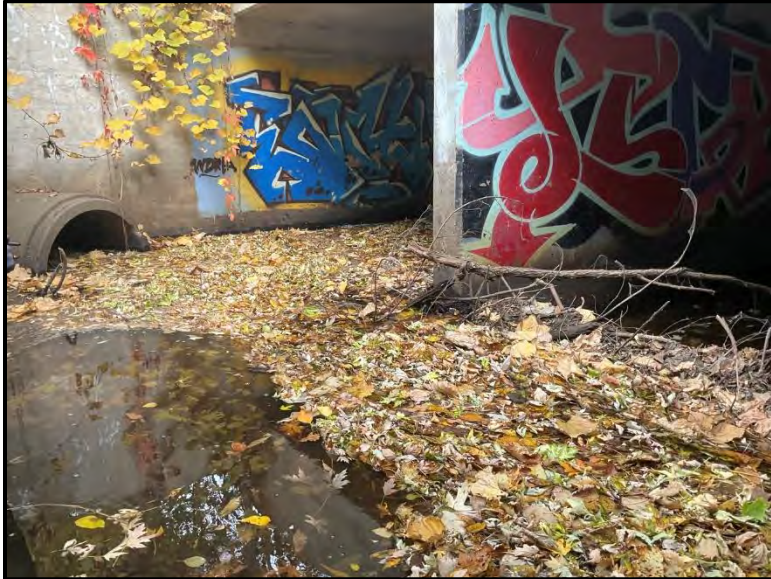
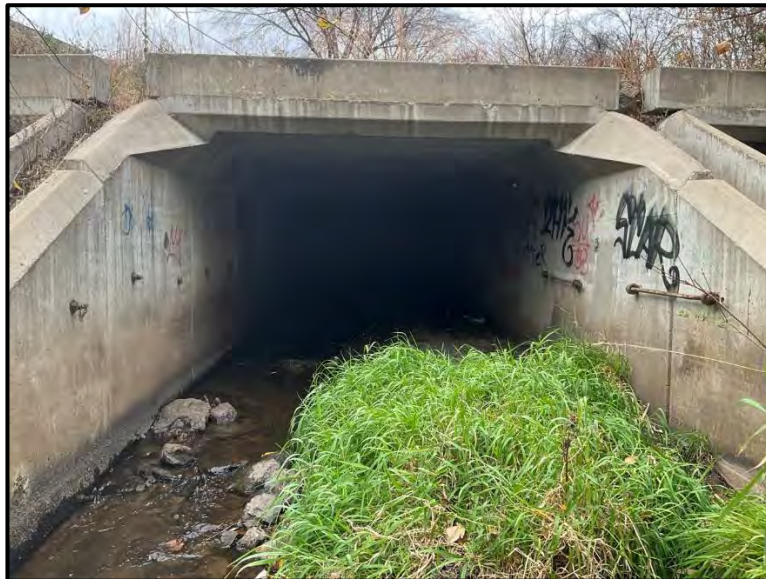
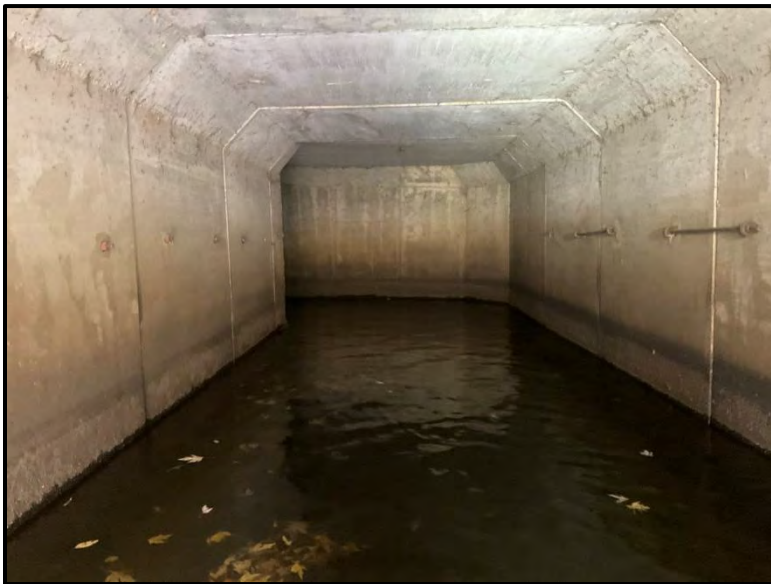
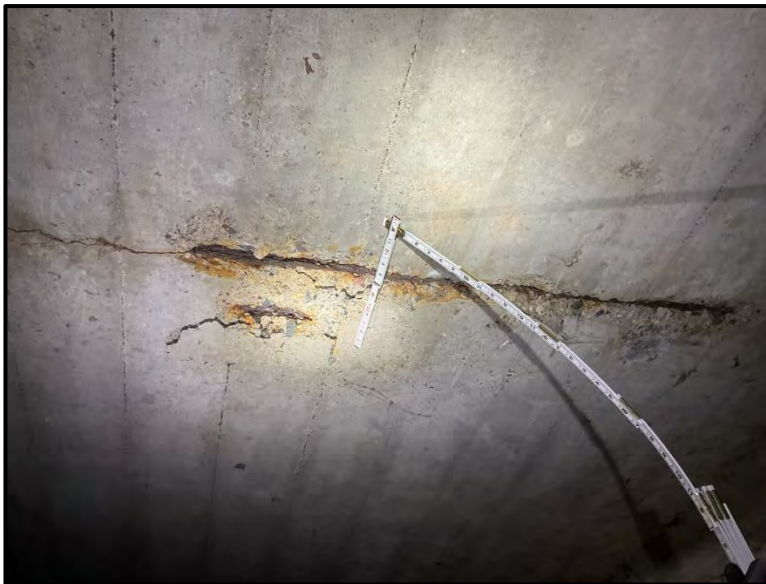
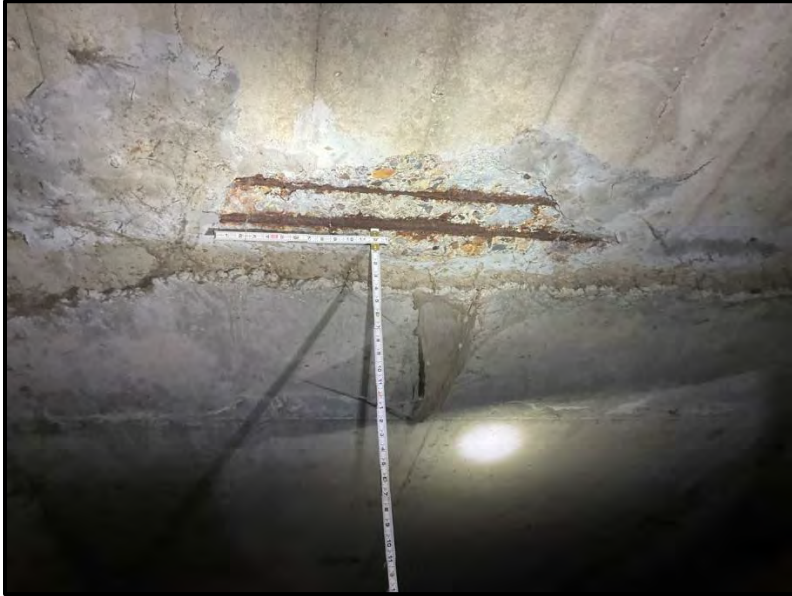
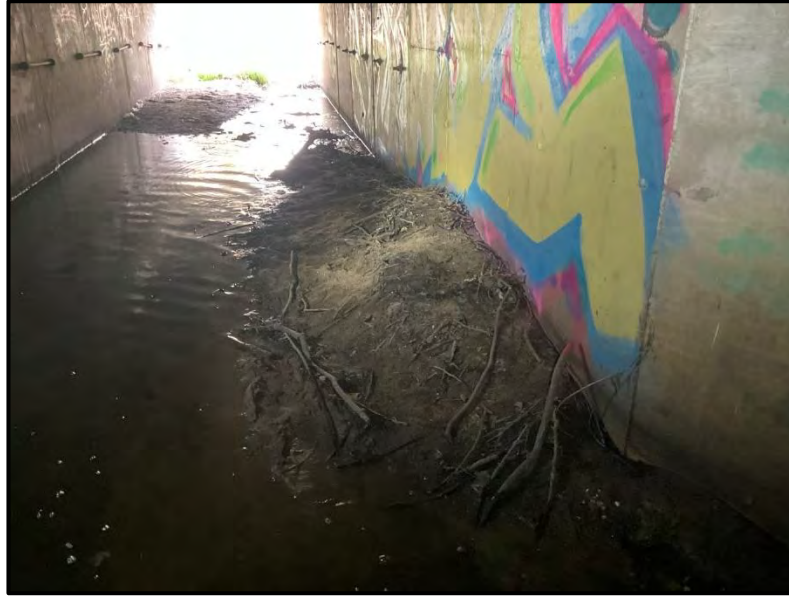
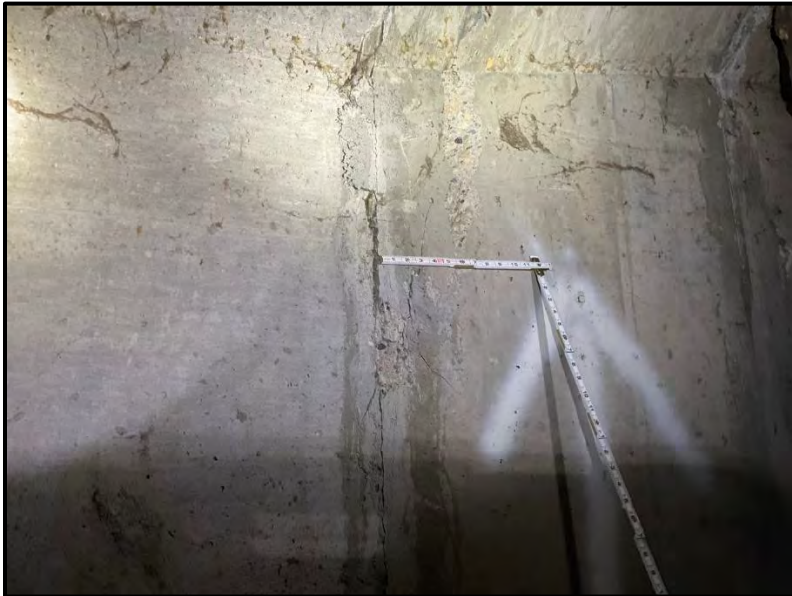
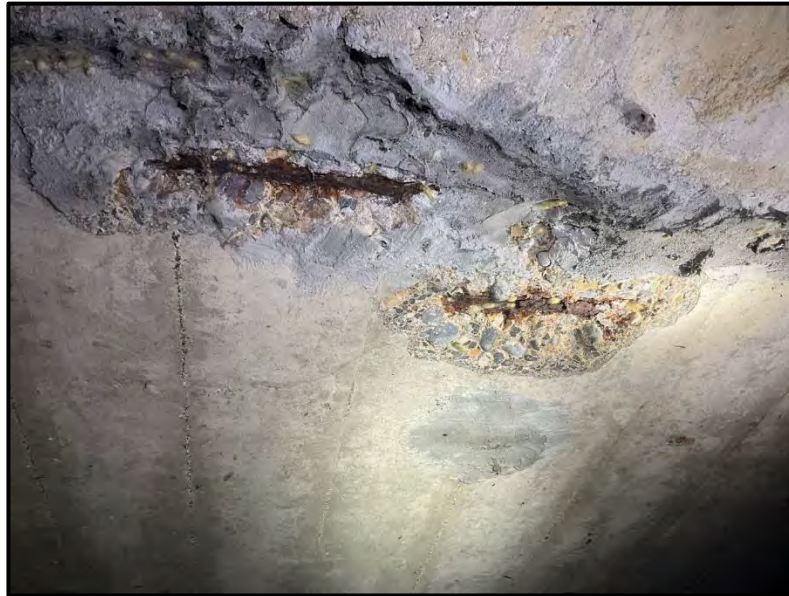
Highway 100 Double Box Culverts (MnDOT Responsibility, Located in Crystal/Golden Valley)

- c. During the inspection there was 4" of water in the right box and 18" of water in the left box, due to the debris dam and accumulated sediment.
- d. Circumferential cracks and approximately 14 locations of spalled concrete, 13 of which had exposed reinforcement, were observed in the north (left) box culvert.

- e. Two areas of spalled concrete on the right wall of the south (right) box culvert were observed.
- f. Four longitudinal cracks, circumferential cracks, and areas of spalled concrete with exposed reinforcement were observed along the top of the south (right) box culvert. MnDOT performed repairs to the culverts in 2007, but cracks have been noted since 2008 and areas of concrete spalling have been noted since 2014.

- g. Deposited sediment was observed in the north (left) box culvert, generally ranging from 6-36 inches deep. This is similar to previous inspections that noted 6-24 inches of deposited sediment has been observed in the north (left) box culvert since 2002.

- h. The outlet portion of the structure appeared to be in satisfactory condition.
- i. Riprap was observed in the inlet structure near entrance to the south (right) box culvert.

- Monitor accumulated sediment in north (left) box culvert and consider future removal.
- Monitor cracking, spalling concrete, and exposed reinforcement in both box culverts.
- MnDOT should assess the defects and repair, as necessary.

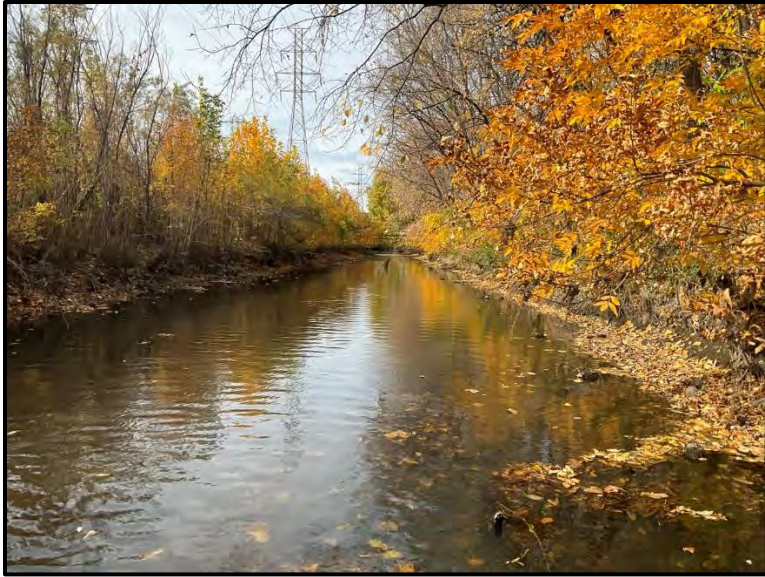
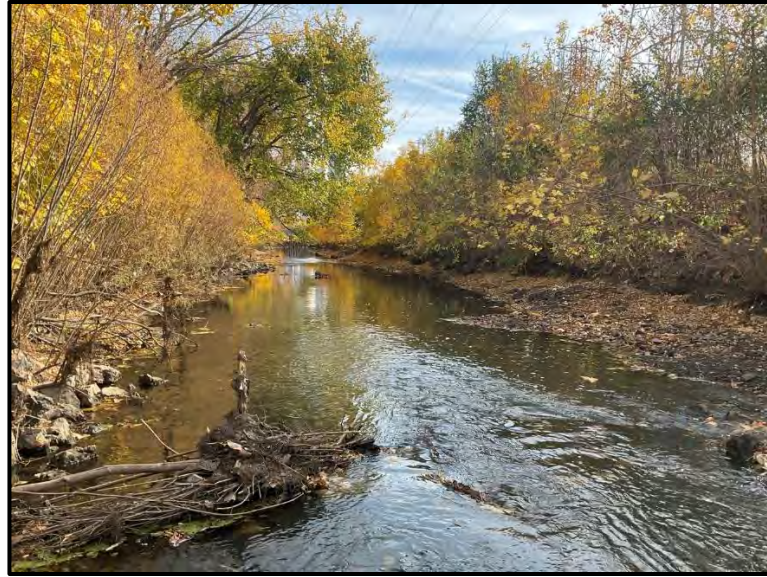
Open Channel (Minneapolis)

- a. The open channel, from Van White Memorial Boulevard to the inlet structure, appeared to be in satisfactory condition.
- b. The banks were generally vegetated. Some areas had exposed soil and steep slopes but seemed stable and no obvious signs of bank erosion were noted.
- c. Sediment has deposited and formed a delta on the south (right) side of the channel between the debris barrier and inlet structure, extending approximately 10% of the channel width. Vegetation was growing on the delta. This is consistent with previous years' observation.

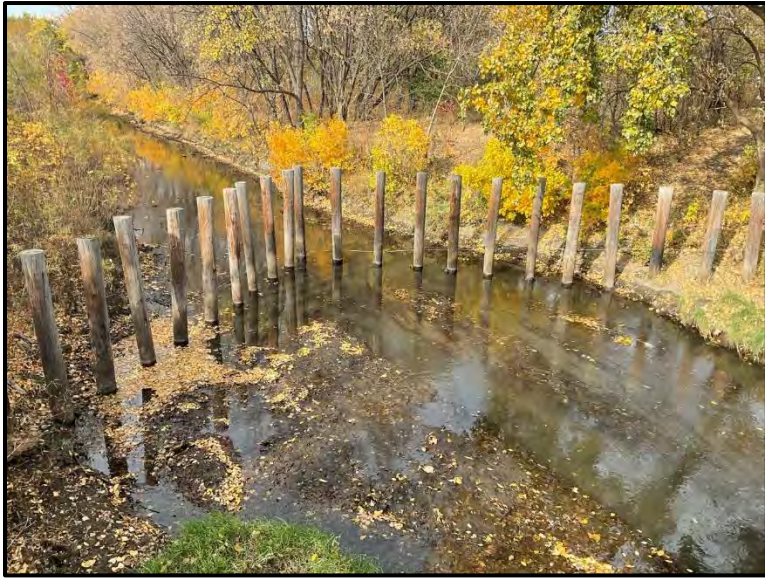
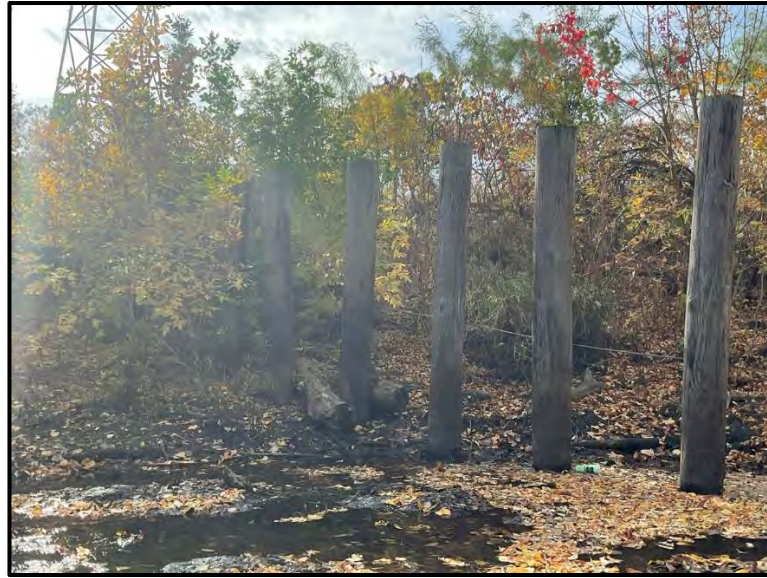
Debris Barrier (Minneapolis)

- a. The debris barrier piles appeared to be in satisfactory condition.
- b. The steel cable was repaired by the City in 2023 and extended across the channel, attached at each post.
- c. A large log was deposited on the right side of the barrier.

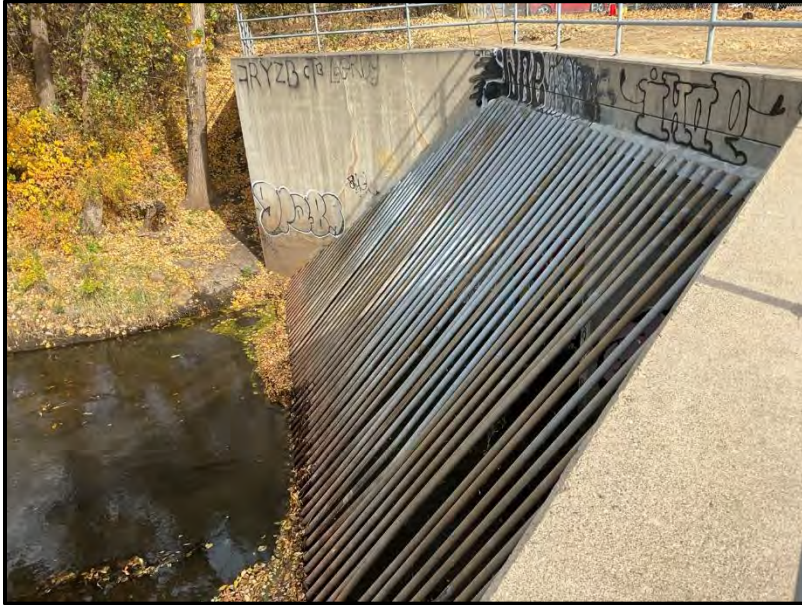
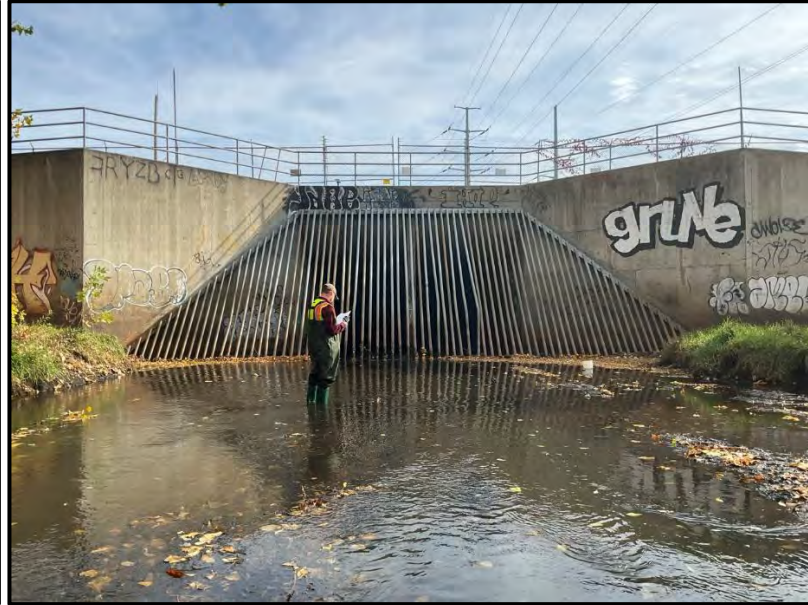
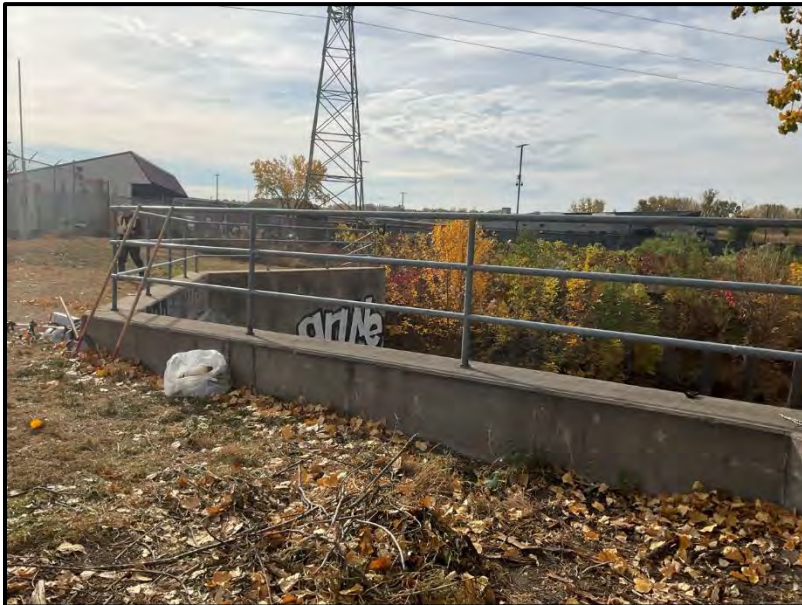
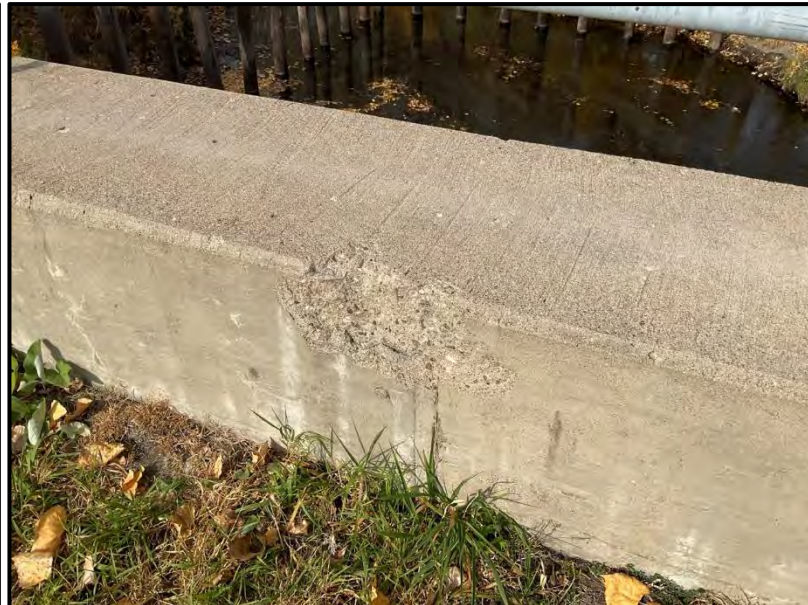
Inlet Structure (Minneapolis)

- a. The concrete inlet structure appeared to be in satisfactory condition.
- b. Vertical cracks were observed in the concrete on either side of the structure.

- c. Cracks were observed near where the handrail posts are embedded.
- d. The railings appeared to be in satisfactory condition.
- e. Some of the vertical bars have been bent and projecting a slight bow but generally appeared to be in satisfactory condition.
- f. The inlet structure was full of leaves but was clear of larger debris.
- g. Spalled concrete was observed behind the railings on the right side of the structure.

- Monitor cracks in the concrete inlet structure.
- Monitor concrete spalling behind the railings.
