**To:** Bassett Creek Watershed Management Commission (BCWMC)  
**From:** Barr Engineering Co.: Josh Phillips, P.E., Jim Herbert, P.E., Joe Welna, P.E.  
**Subject:** Item 4D: Bassett Creek Box Culvert Inspection Report: Inspection Date: November 2024 -  
BCWMC February 20, 2025 Meeting Agenda  
**Date:** February 13, 2025  
**Project:** 23270051.65 1080 002

# Bassett Creek Double Box Culvert Inspection Report

Prepared for  
Bassett Creek Watershed Management Commission

Inspection Date: November 2024

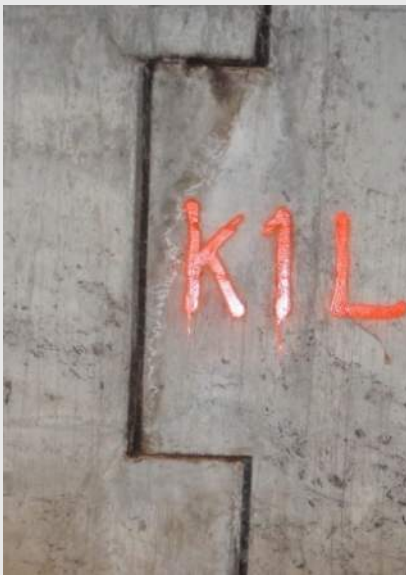
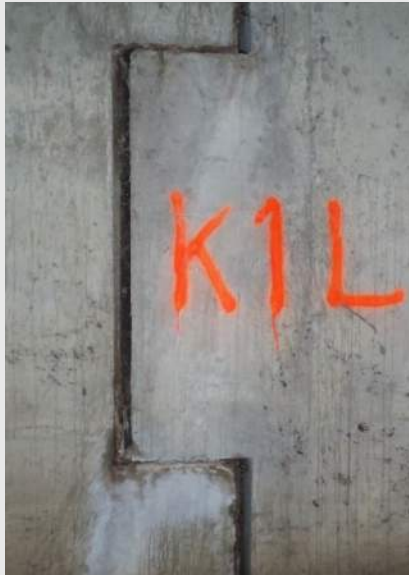
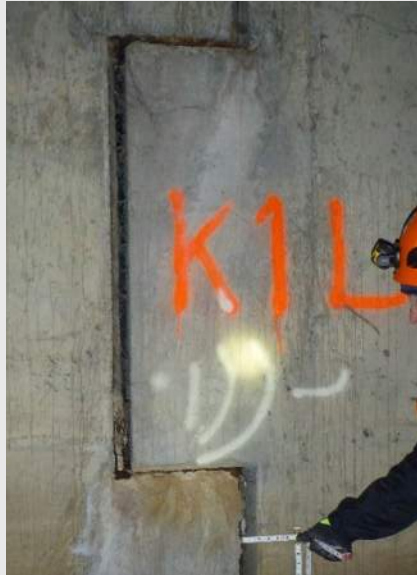
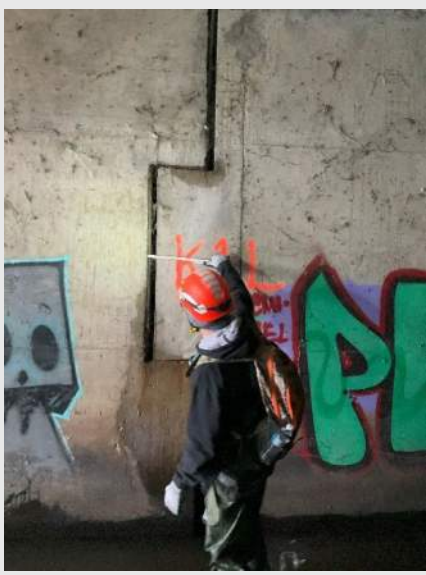
| | 2009 | 2014 | 2019 | 2024 |
|---|---|---|---|---|
| K1L | | | | |

**Shear Keys - Structural:** A large portion of the identified significant defects, including fractures, spalling, and evidence of differential settlement were observed at the shear keys. Future inspection programs should continue to monitor the shear keys for continued degradation and/or differential settlement.

**Shear Key Joint Repair:** It is recommended that the BCWMC repair or replace the shear key joint material to minimize infiltration and potential for soil transport into the tunnel. It is recommended that this work occur in the next 5 years.

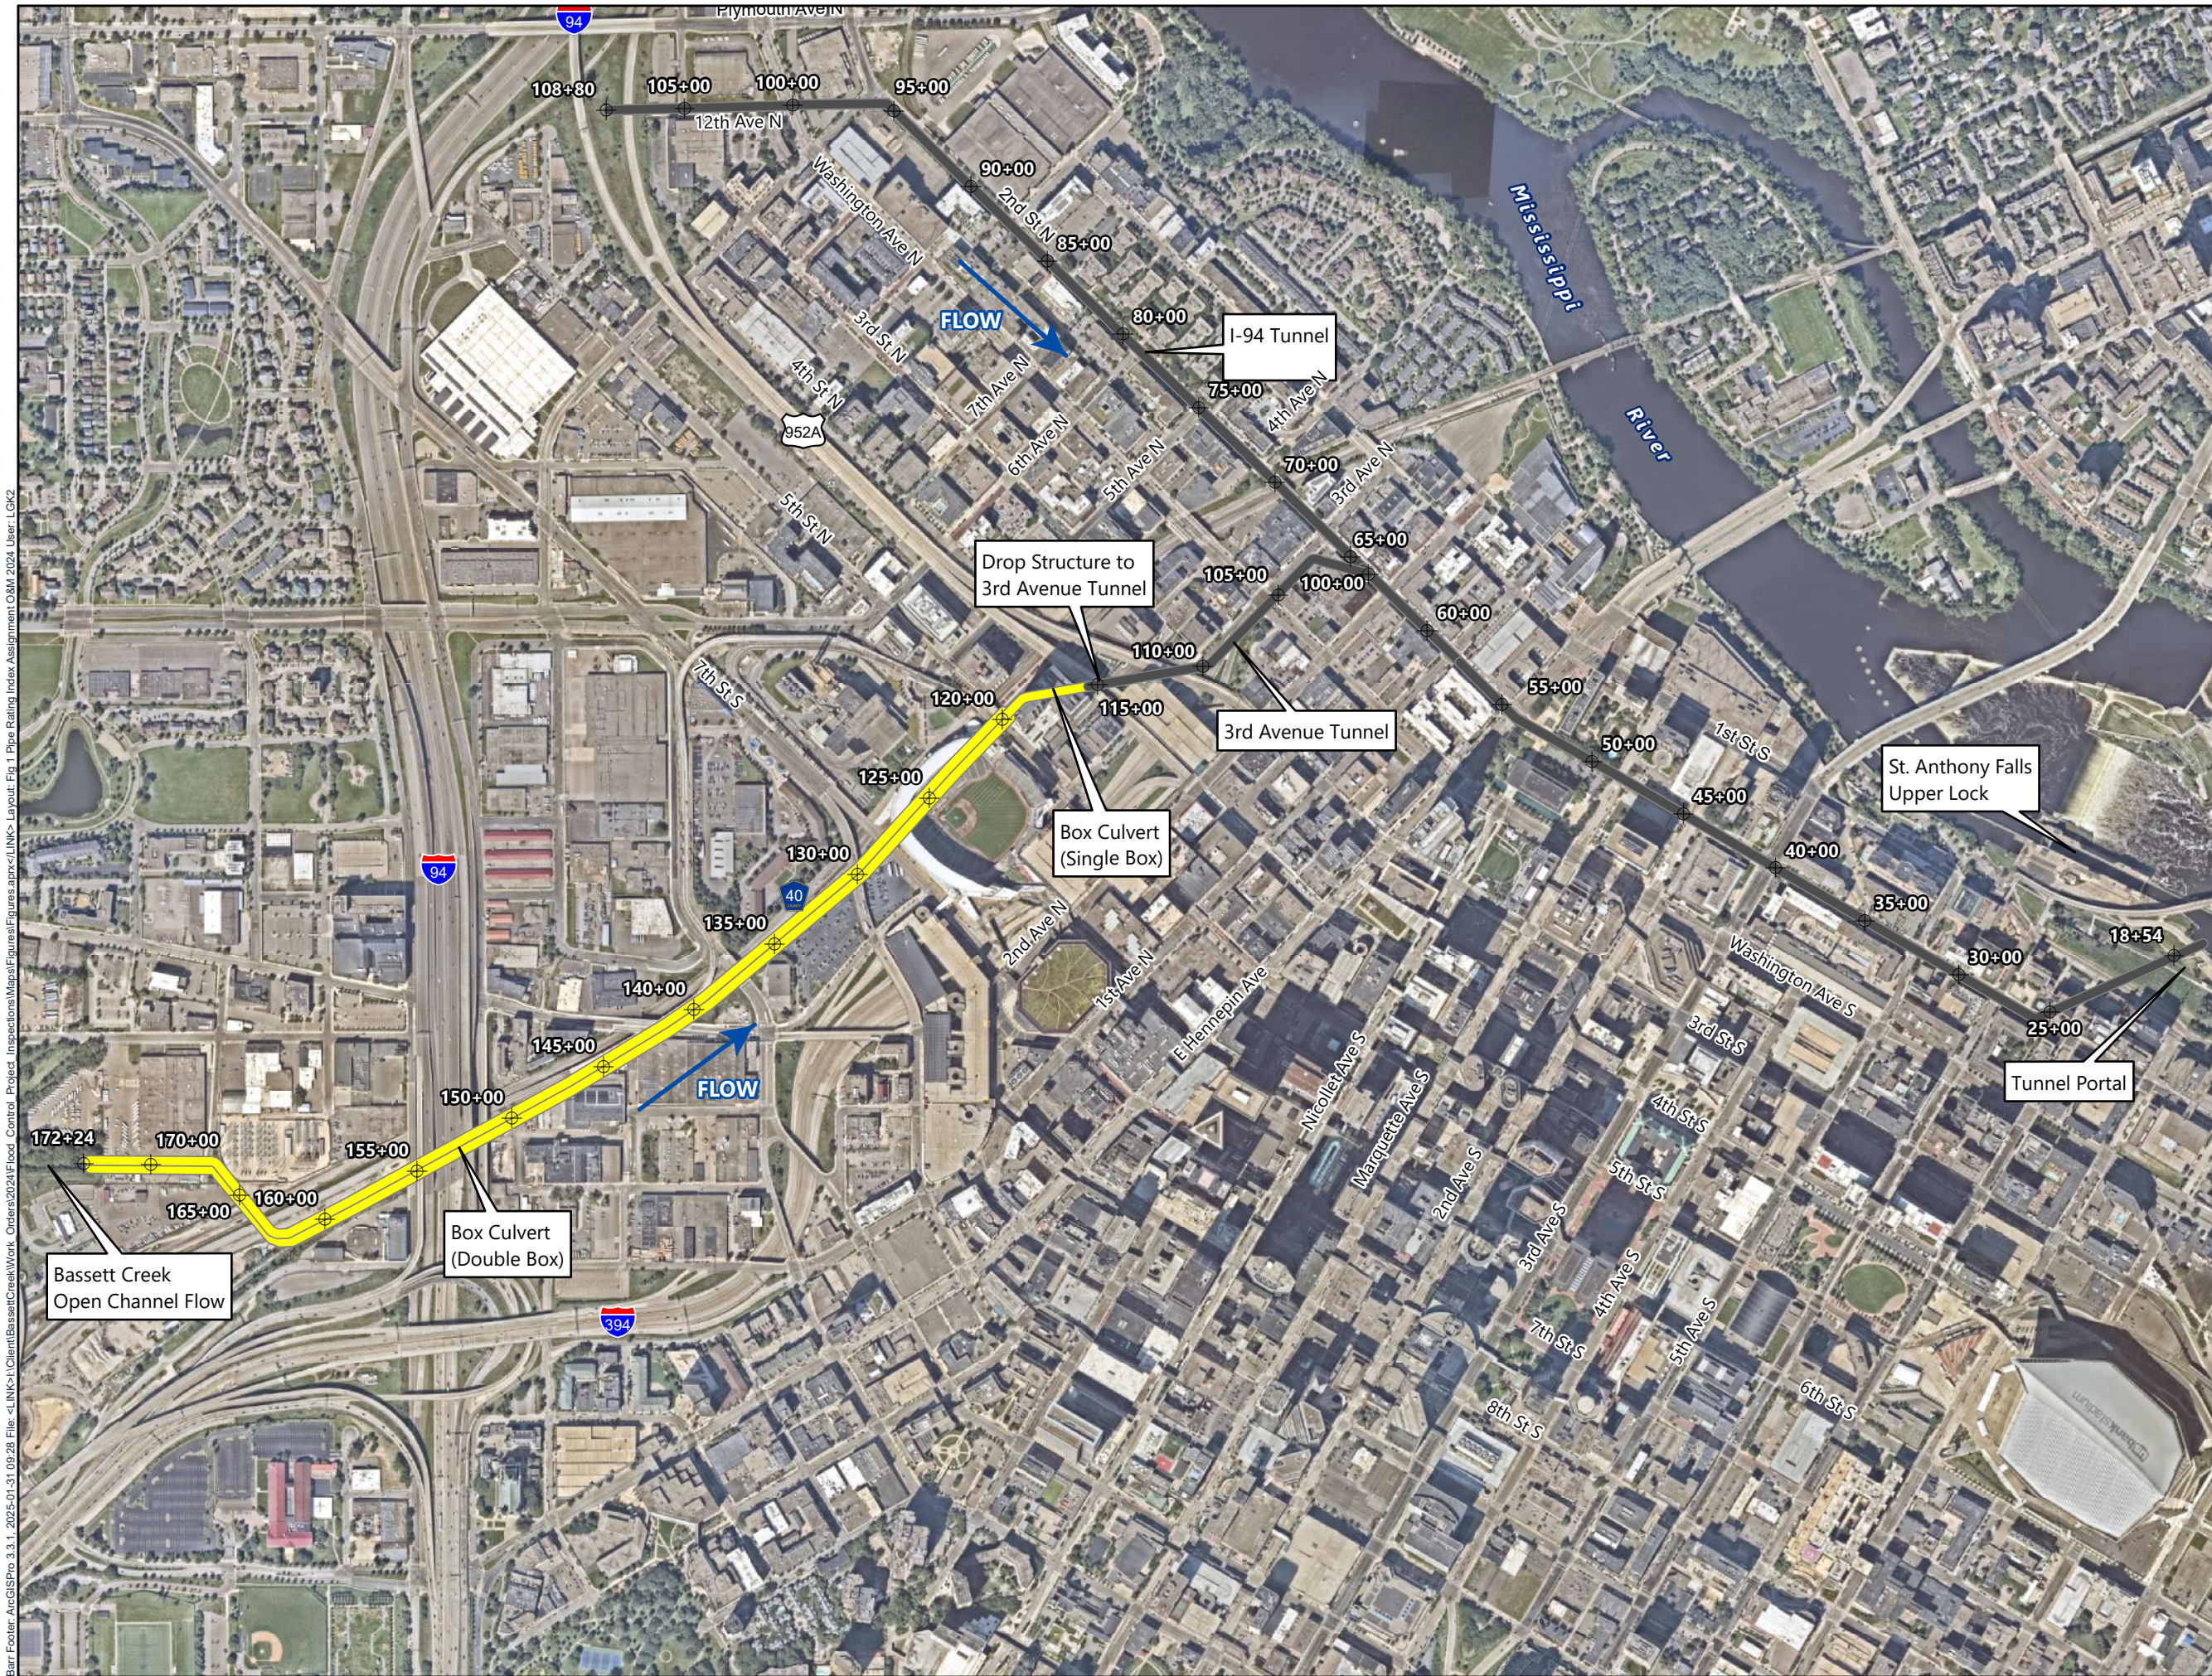
**FIGURE 1**

**Notes:**  
1. Legend represents tunnel conditions from an operations and maintenance standpoint.
