Minnesota Wetland Conservation Act Notice of Application

City of Plymouth Hollydale Distribution Project Wetland Delineation Report

September 2019

Prepared for Xcel Energy
Project Name City of Plymouth Hollydale Distribution Project Wetland
Delineation Report
Xcel Project # 4500390136
Cardno Project # J153001M13
Project Manager Dan Salas, Cardno
Date September 2019

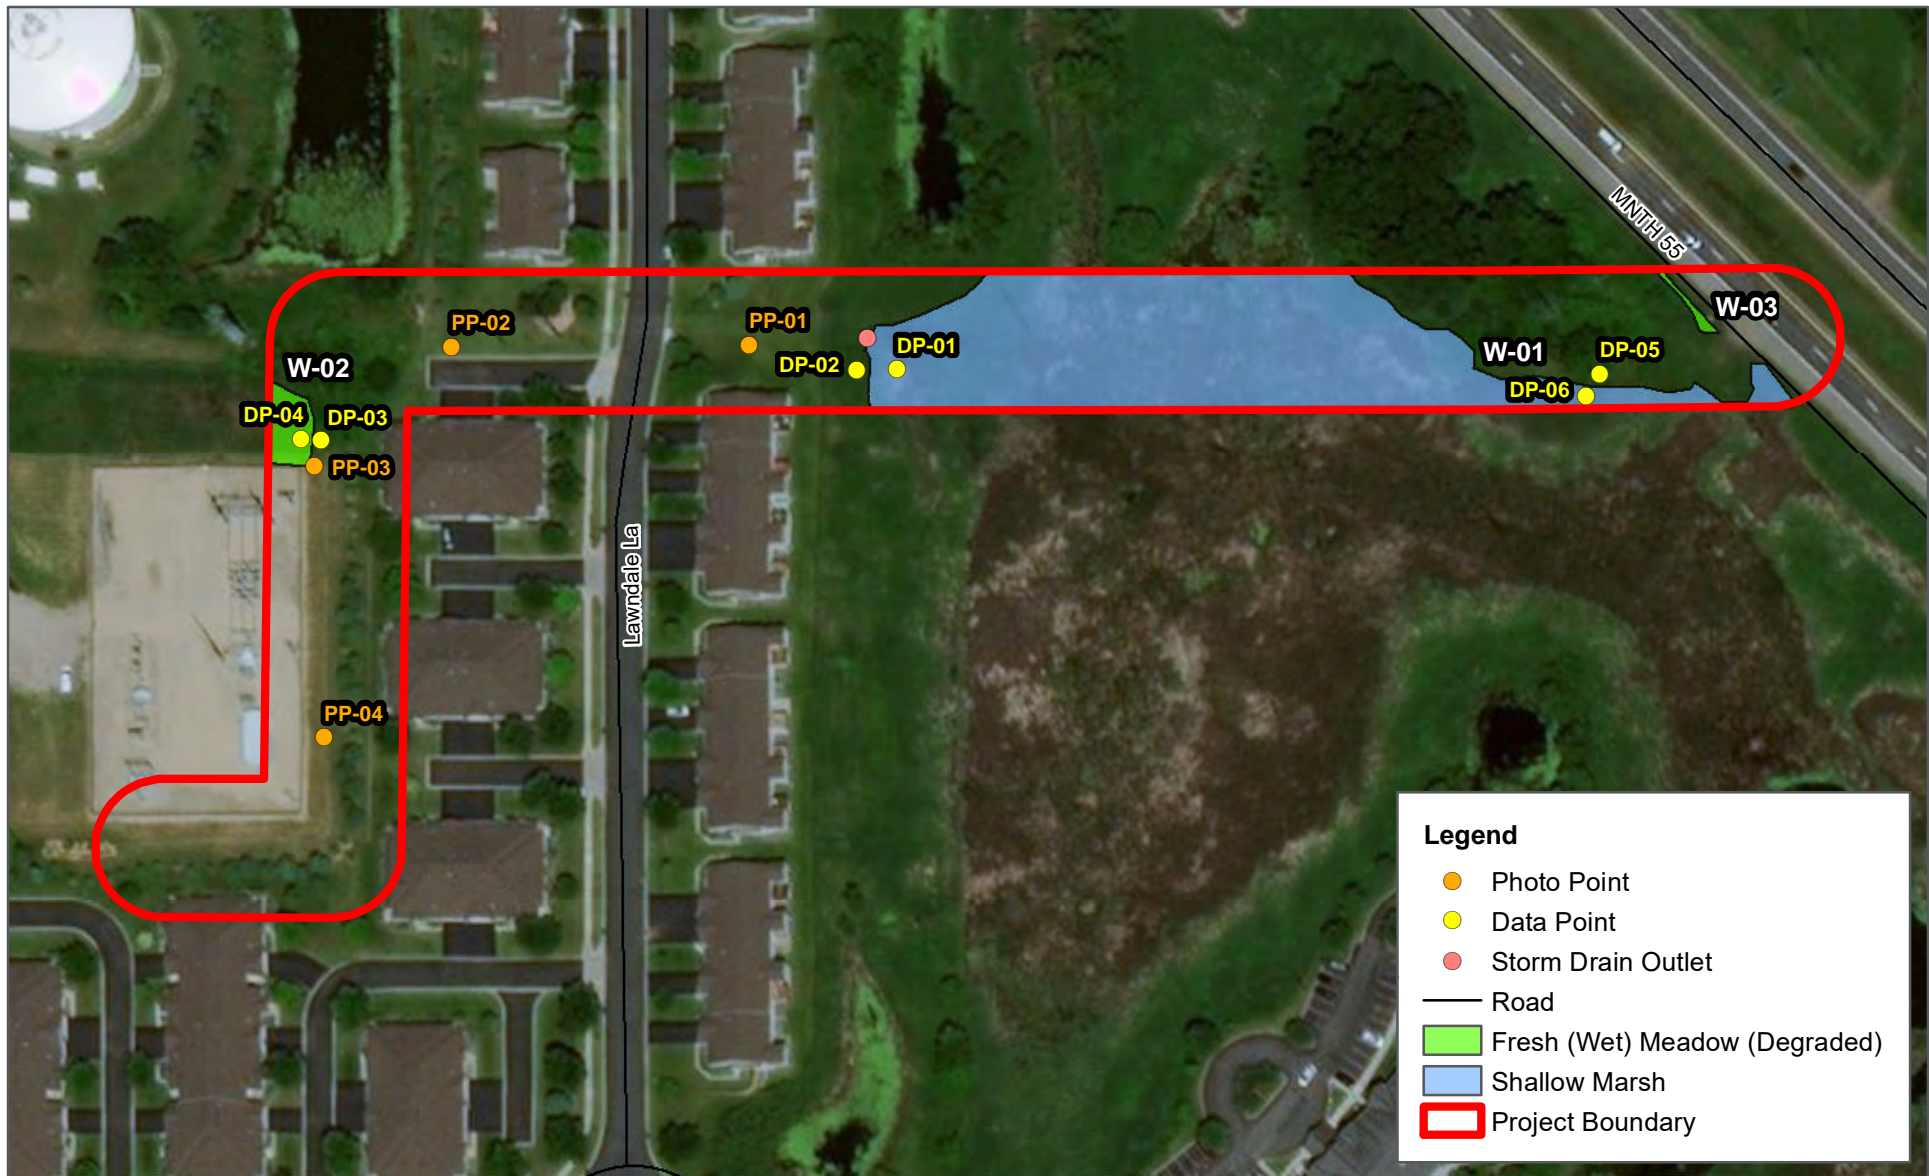
- Photo Point
- Data Point
- Storm Drain Outlet
- Road
- Fresh (Wet) Meadow (Degraded)
- Shallow Marsh
- Project Boundary

impermeable surfaces and man-made basin features. Factors in determining wetland boundaries included topography of the landscape, dominant vegetation, soil, and hydrology observation. Documentation of these features, including wetland community type, associated data points, observed hydrology and hydric soil indicators, and dominant vegetation may be found in the wetland determination forms found in Appendix B, while general descriptions for observed wetland communities are found in Table 3-3 below.

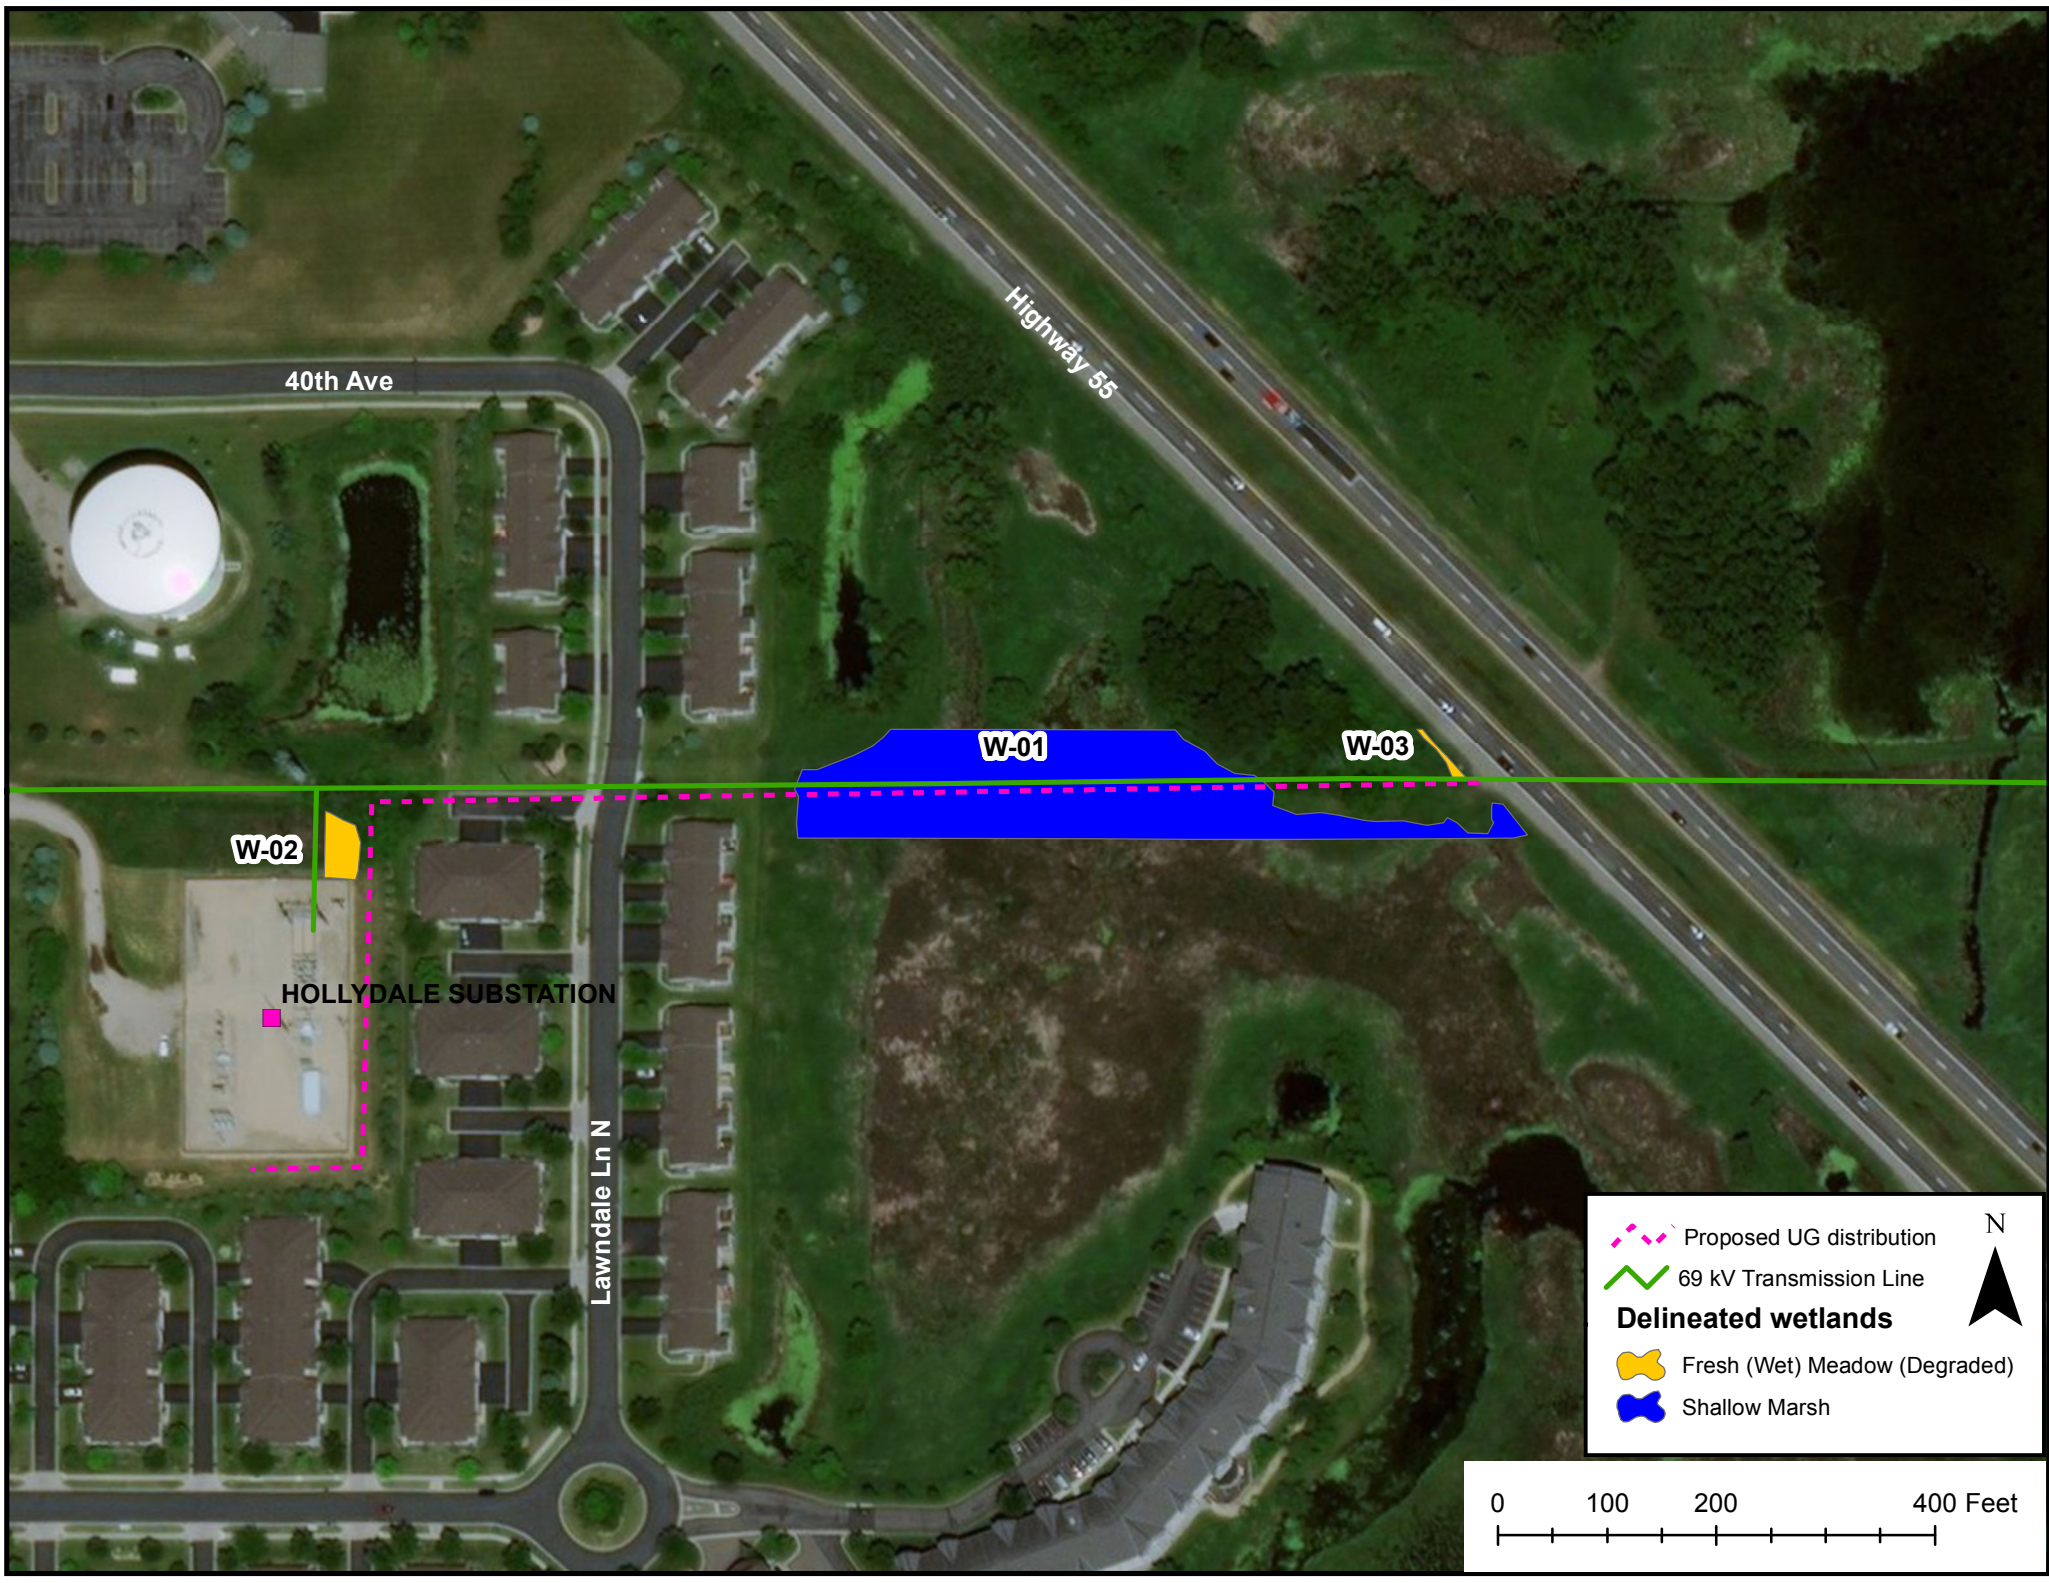
- Fresh (Wet) Meadow (Degraded)
- Shallow Marsh

Hollydale Substation located west of Lawndale Ln N. The duct line will be installed via open trench installation, and the trench will be closed and restored following completion of the installation. The area of wetland to be impacted is estimated to be 430 feet in length and approximately 4-10 feet in width. The project was initially expected to be done in the fall of 2019, but may end up being completed in the spring of 2020 instead. The construction is expected to take approximately 3 months to complete. The duct will not impact the small degraded fresh wet meadow located on the north side of the substation.

The proposed location minimizes impacts by placing the duct bank within an existing electric utility easement beneath existing overhead power lines. Installation of the duct bank will result in temporary impacts to the wetland which will be restored once construction is complete. There will be no permanent structures above ground within the wetland.
